EXPERIMENTAL PROJECTS CONSTRUCTION REPORT AND ANNUAL EVALUATION

3M WET REFLECTIVE CERAMIC ELEMENTS AND POTTERS VISIMAX PLUS: NEW BEAD TECHNOLOGY FOR ADDED RETROREFLECTIVITY IN PAVEMENT MARKINGS

Location:	US 310/US 212 (N4) Approximate Reference Point 43-53, Counties Carbon and Yellowstone Counties
Project Name:	Rockvale - Laurel
Project Number:	HSIP 4-1(63)43
Experimental Project No.	MT-12-12
Type of Project:	Pavement Markings Retroreflectivity
Principal Investigator:	Craig Abernathy: Experimental Project Manager (ExPM)
Date of Installation:	September 2013
Date of Inspection:	April 2016

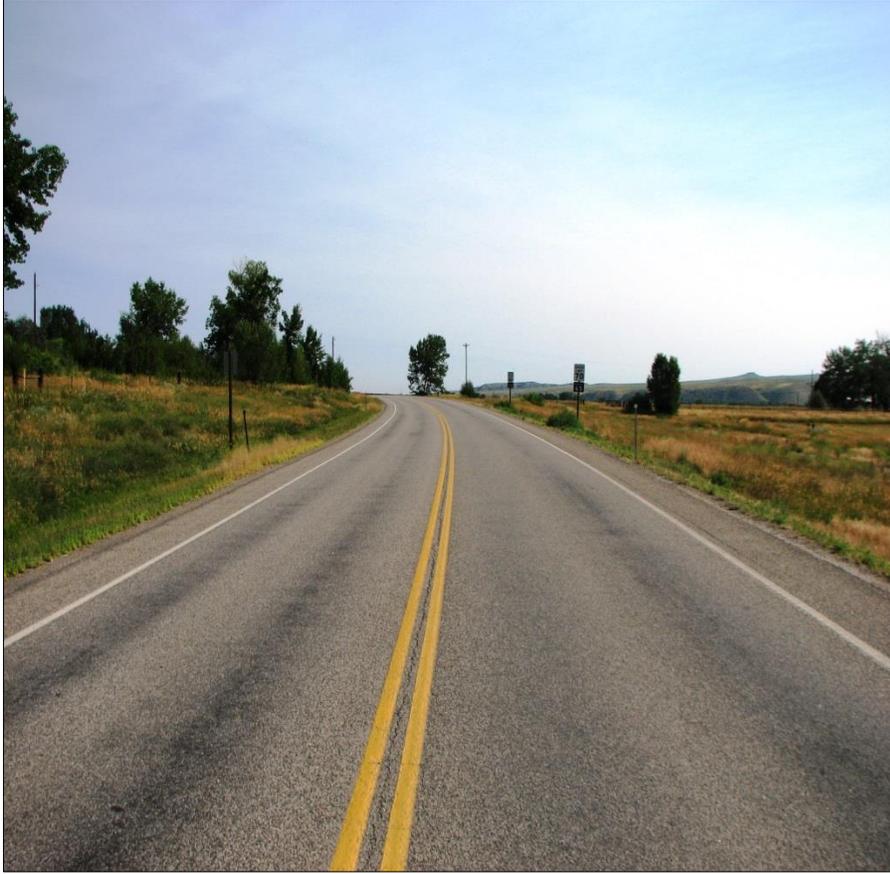
← Representative image taken in July of 2013 prior to new pavement markings application. View north.

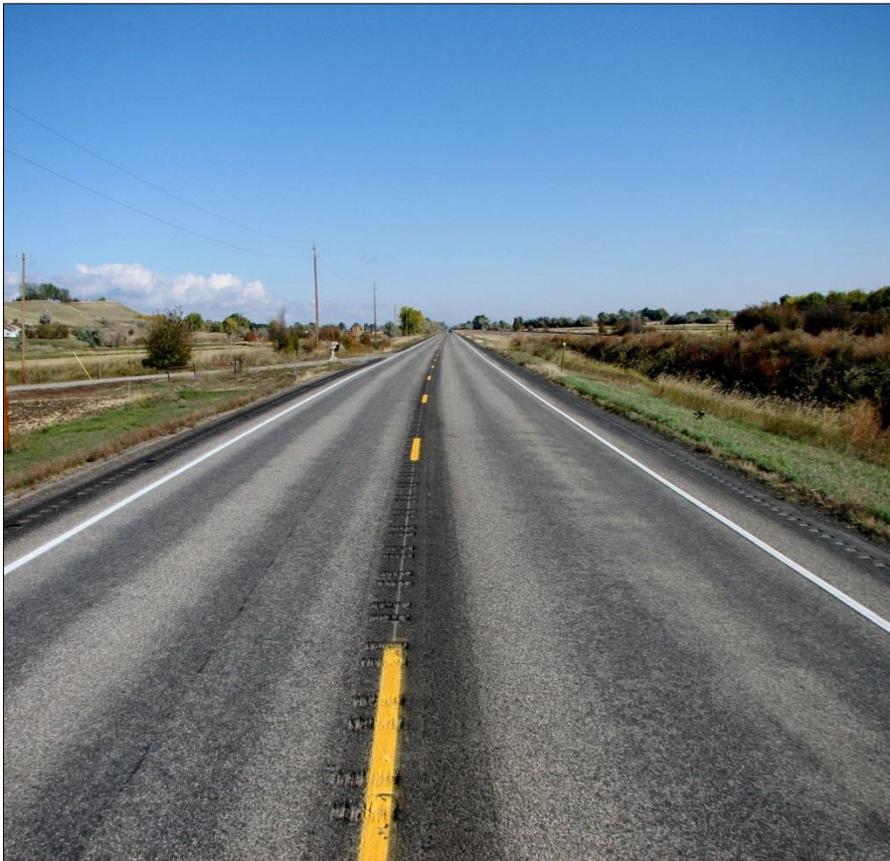
← Representative image taken in September of 2013 after pavement markings application, showing added centerline and shoulder rumble strips. View north.

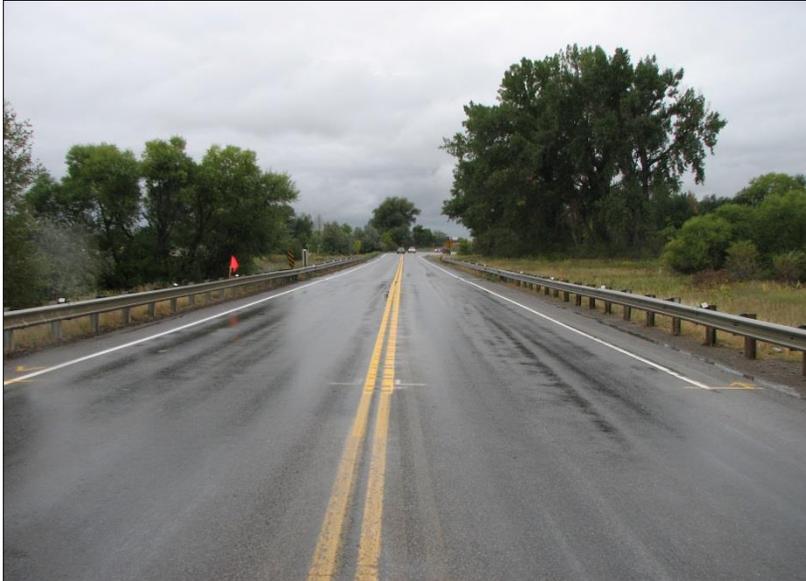
← Beginning of VISIMAX PLUS pavement markings at reference point 53 looking south.

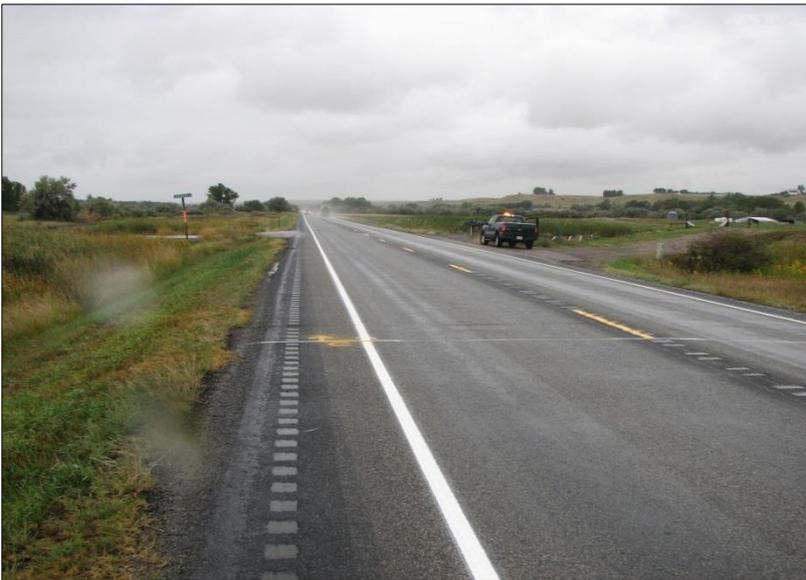
← Beginning of Control (Type 2) pavement markings at reference point 49 looking south.

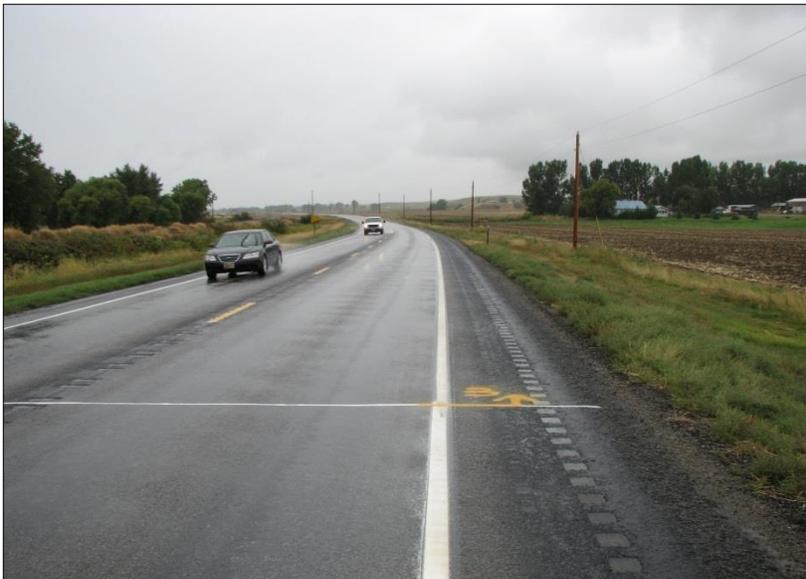
← Beginning of 3M Wet Reflective Elements pavement markings at reference point 47 looking south.

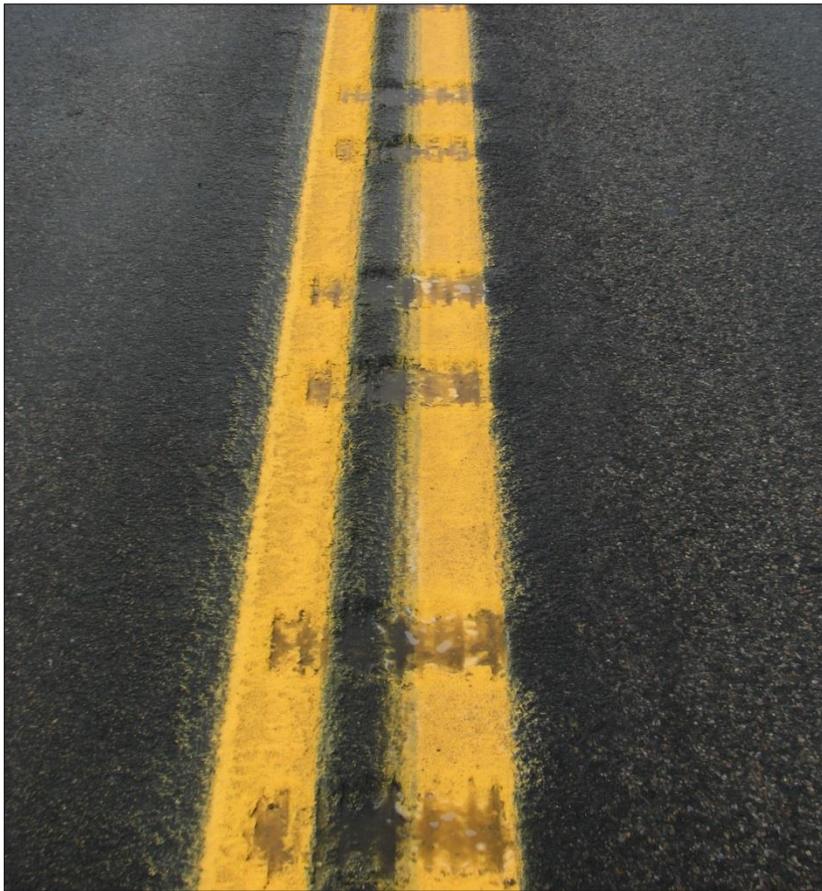
← Representative image of no-passing stripes placed over center-line rumble strips (wet condition).

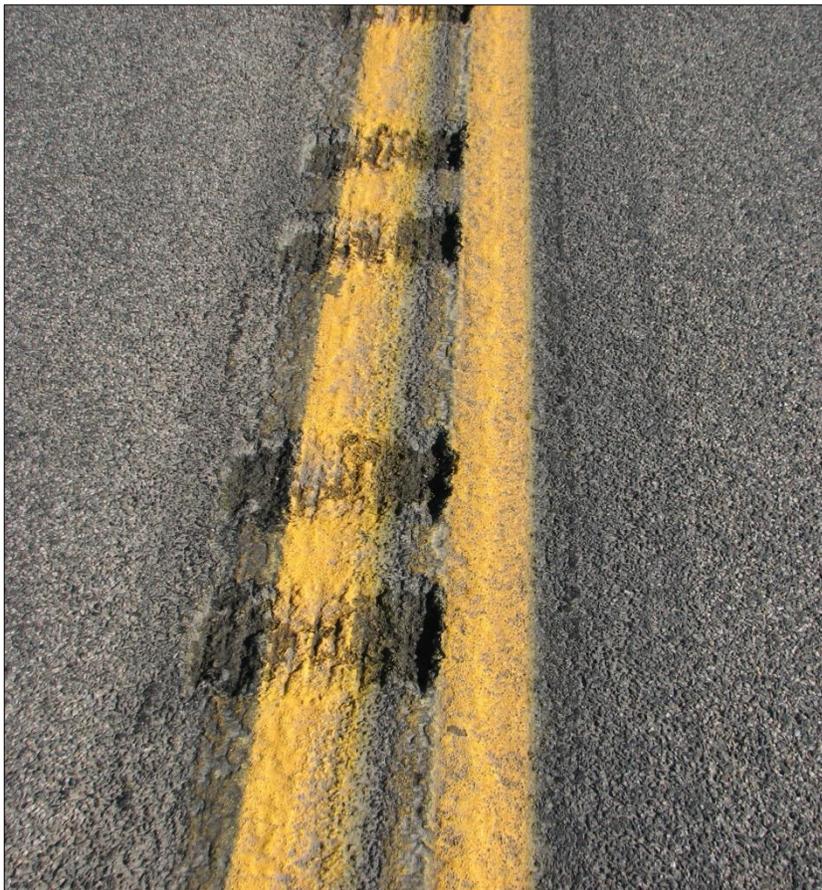
← Representative image (taken in mid-October 2013) of no-passing lane stripes placed over center-line rumble strips (dry condition).

Note that centerline striping did not receive a 60 mil recess groove treatment.

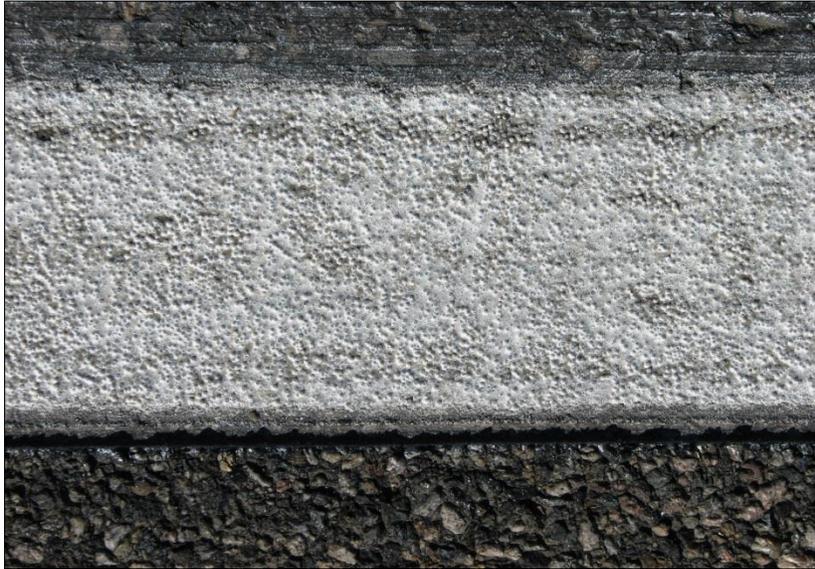
← Close-up of the VISIMAX PLUS white pigmented pavement markings.

Note that (for the most part) the pavement stripe falls well within the parameters of the 60 mil recessed groove; which should aid in the durability of the stripe. This is indicative of all three (3) sections on the project.

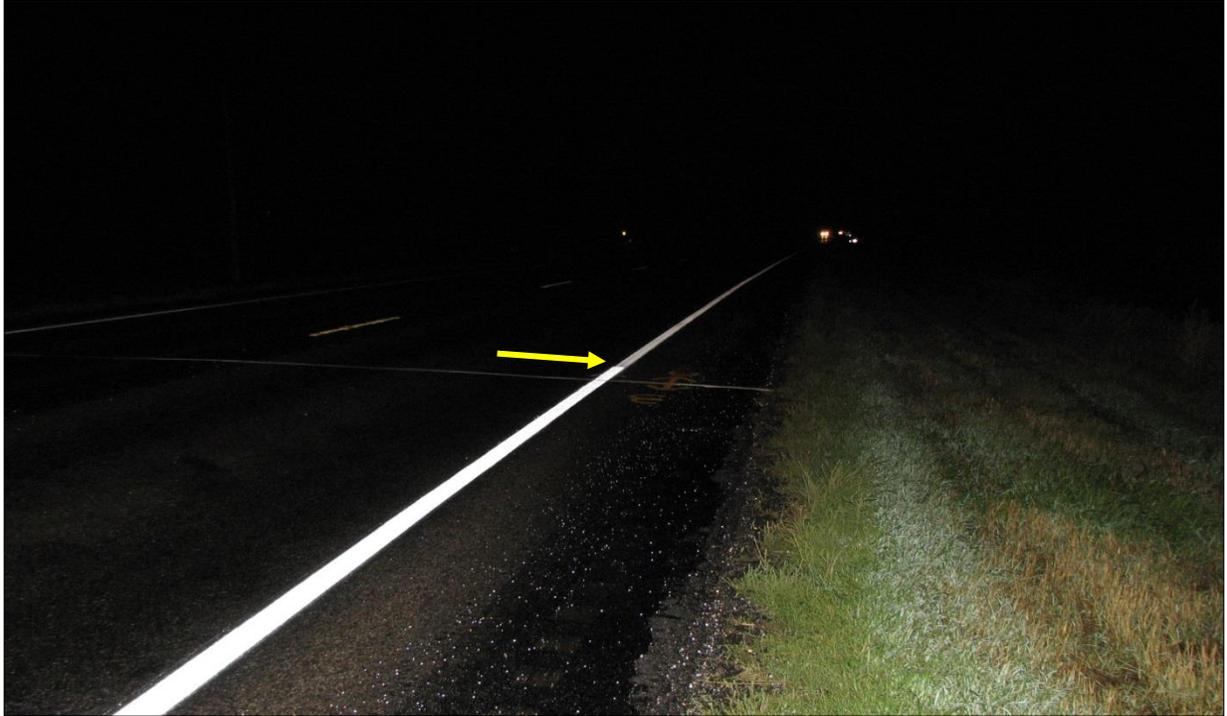
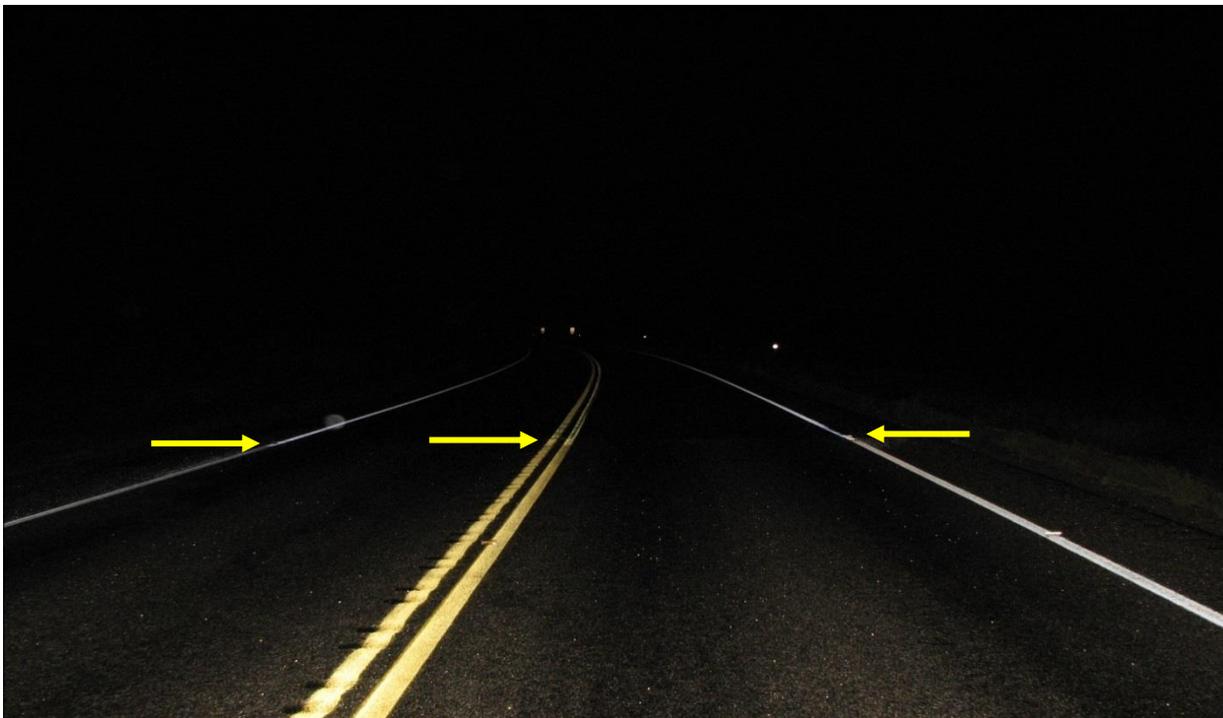
↑ This is the transition of the 3M striping and control section at approximately RP 47 (yellow arrow); view east. It was actively raining at the time. ↓ The image below is the transition of the conventional striping and 3M striping at approximately RP 43.

Although difficult to see in these images; during actual field observation, the difference in luminosity and contrast between the 3M and control section was apparent under wet, nighttime conditions.

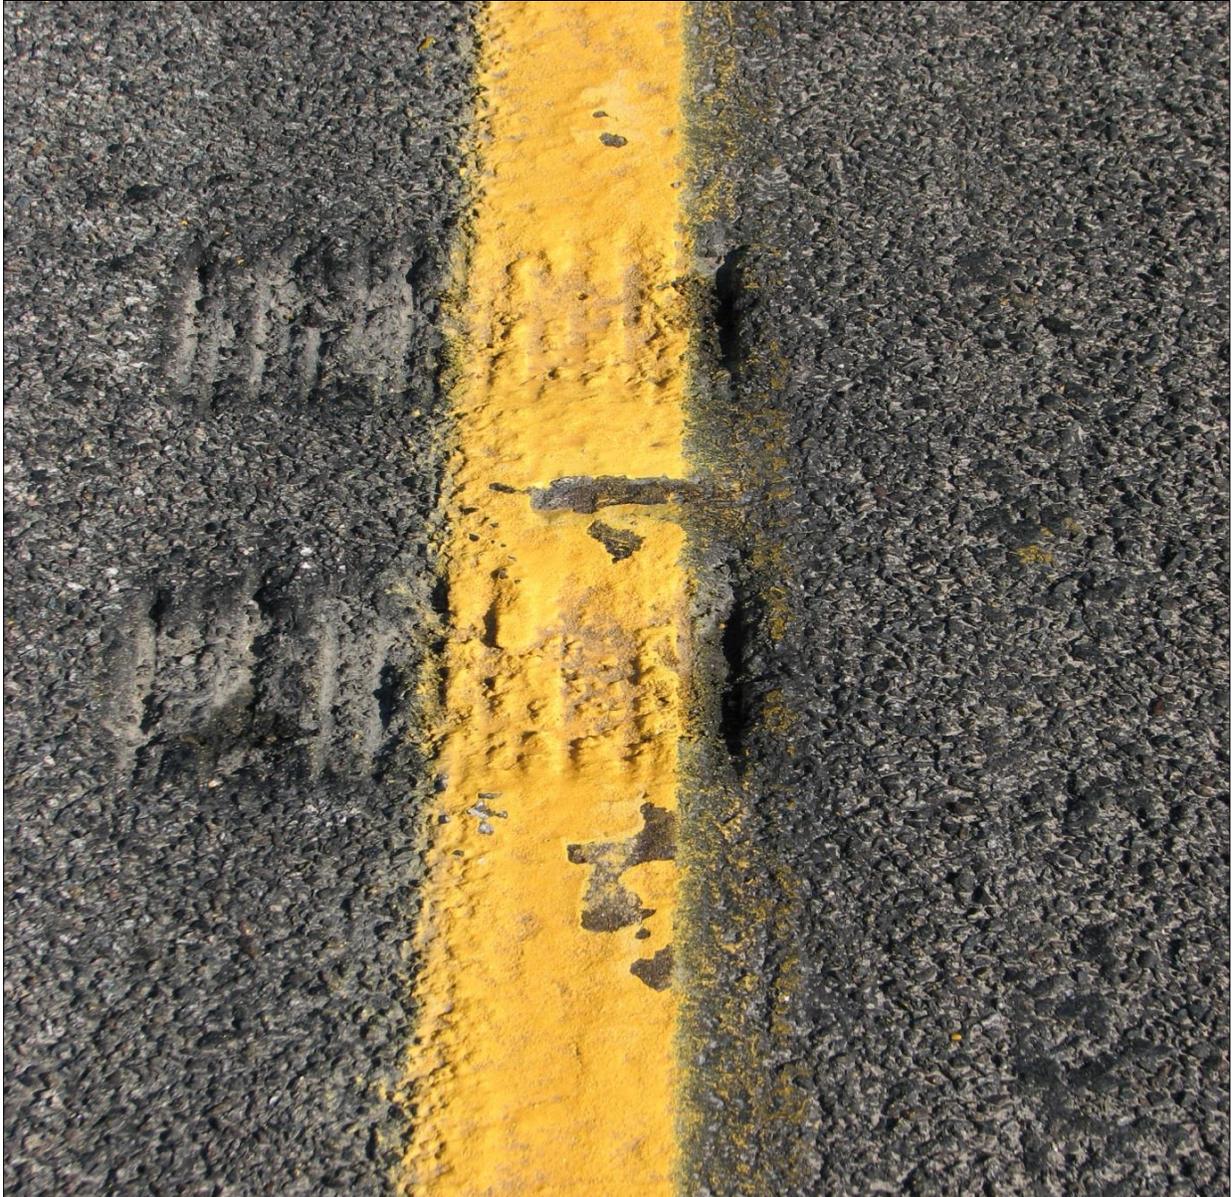
↑ This image taken on October 15, 2013 of the centerline markings is showing distress of debonding of the striping binder to the pavement surface commonly associated with snow plow damage or some other type of metal to binder contact.

District Maintenance staff reported in November they are noticing more of this kind of distress and since it is not in a milled groove is expected to increase over time.

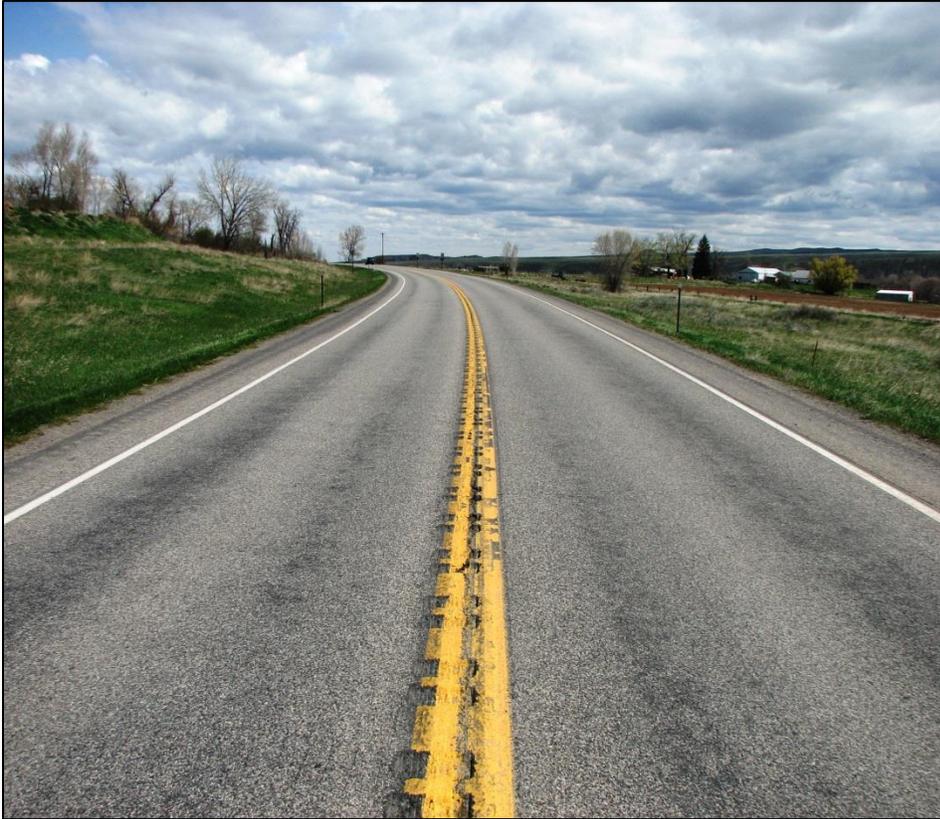
← Beginning of the 3M section at reference point 43; view east.

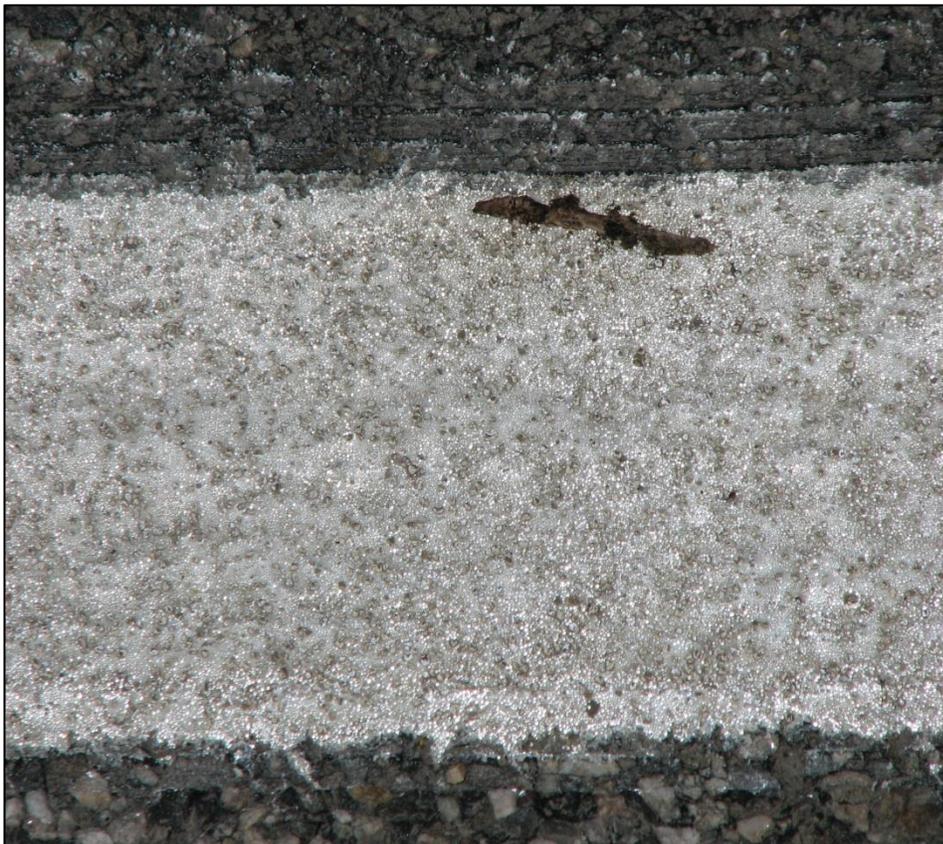
← Close-up of 3M Elements marking.

This image is representative of the overall condition of the stripe on the project.

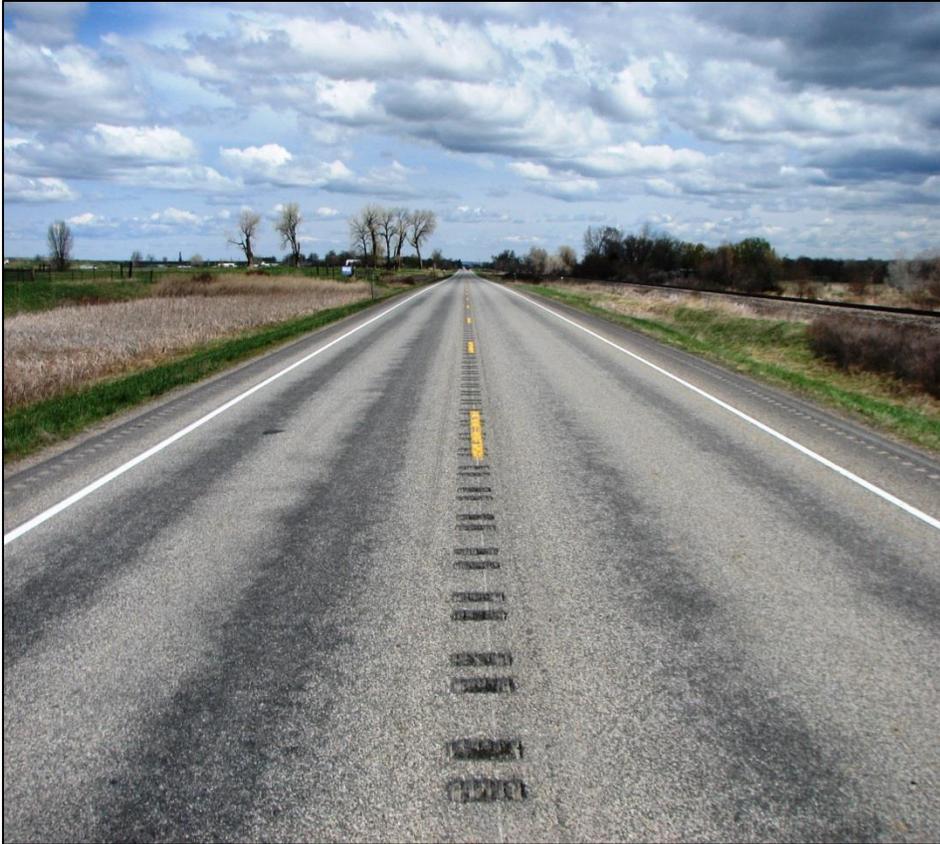
← Beginning of the Visamax section at reference point 49; view east.

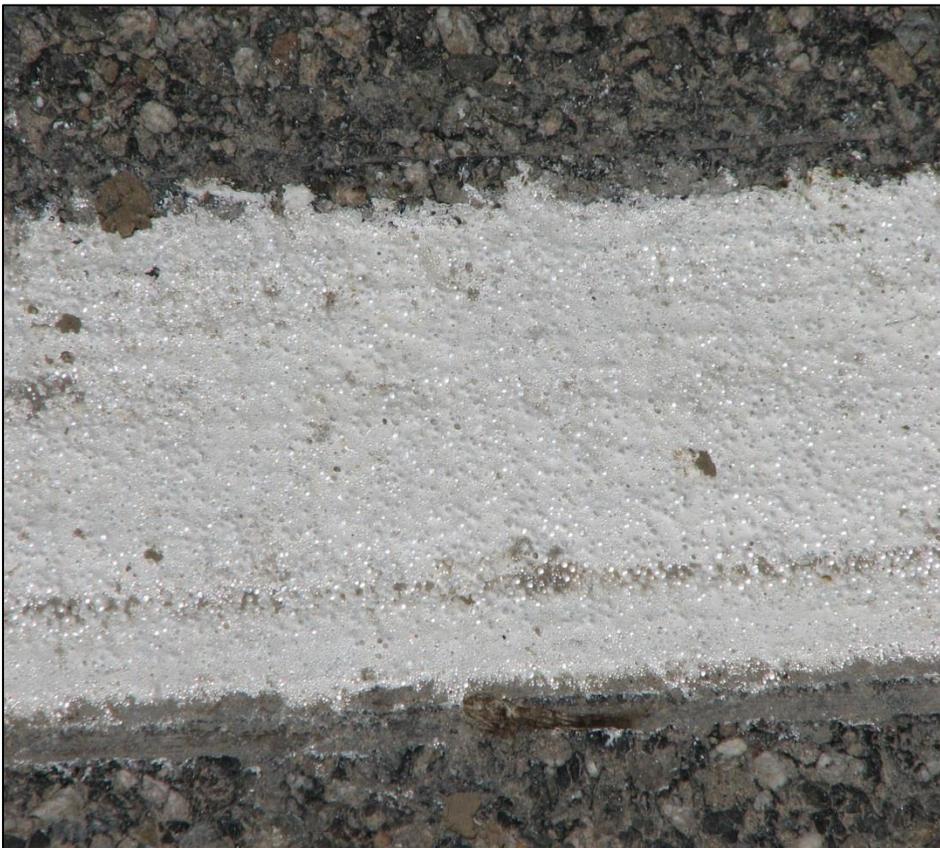
← Close-up of Visamax marking.

This image is representative of the overall condition of the stripe on the project.

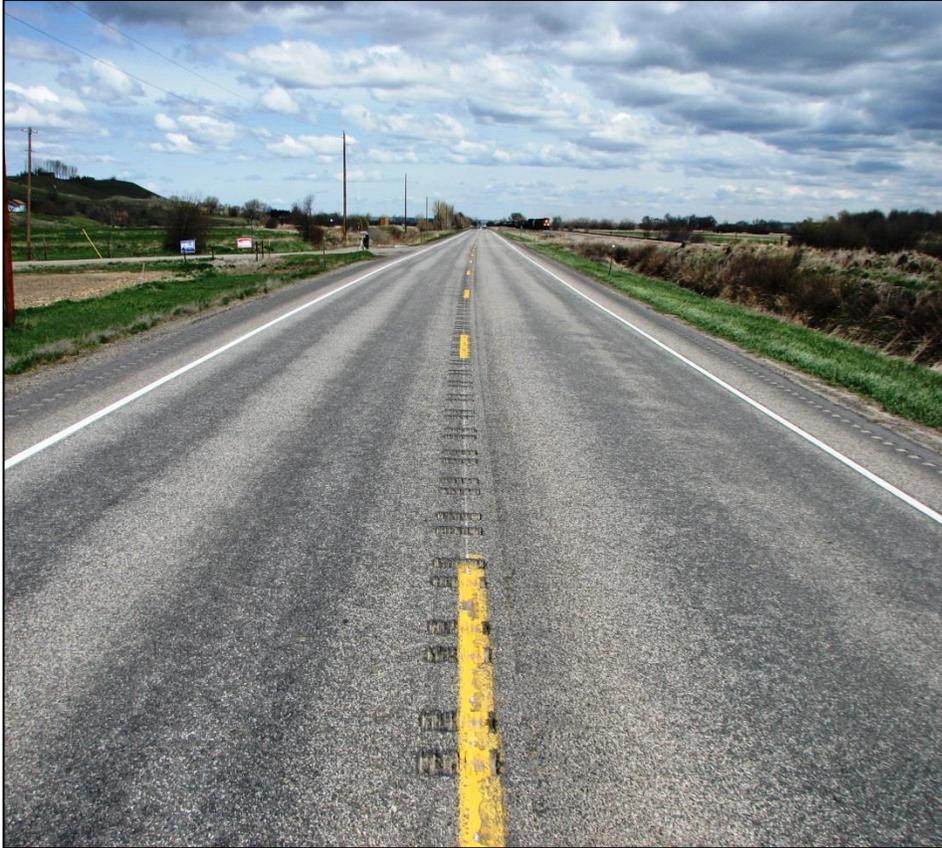
← Beginning of the Type II control section at reference point 47; view east.

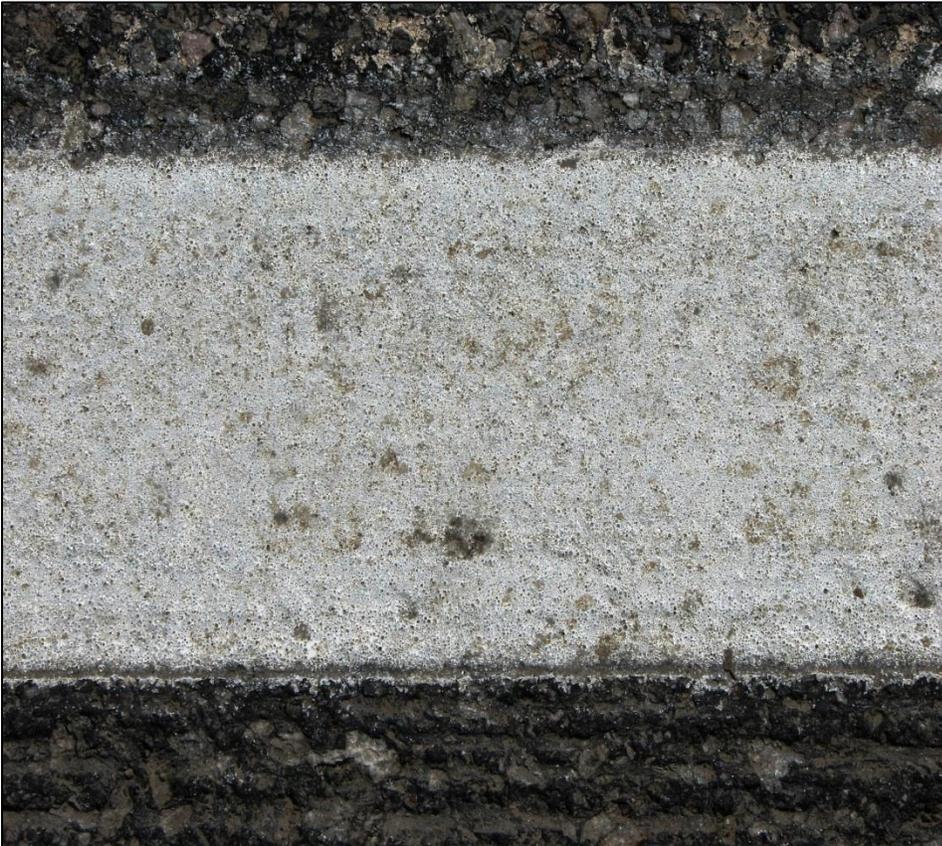
← Close-up of Type II marking.

This image is representative of the overall condition of the stripe on the project.

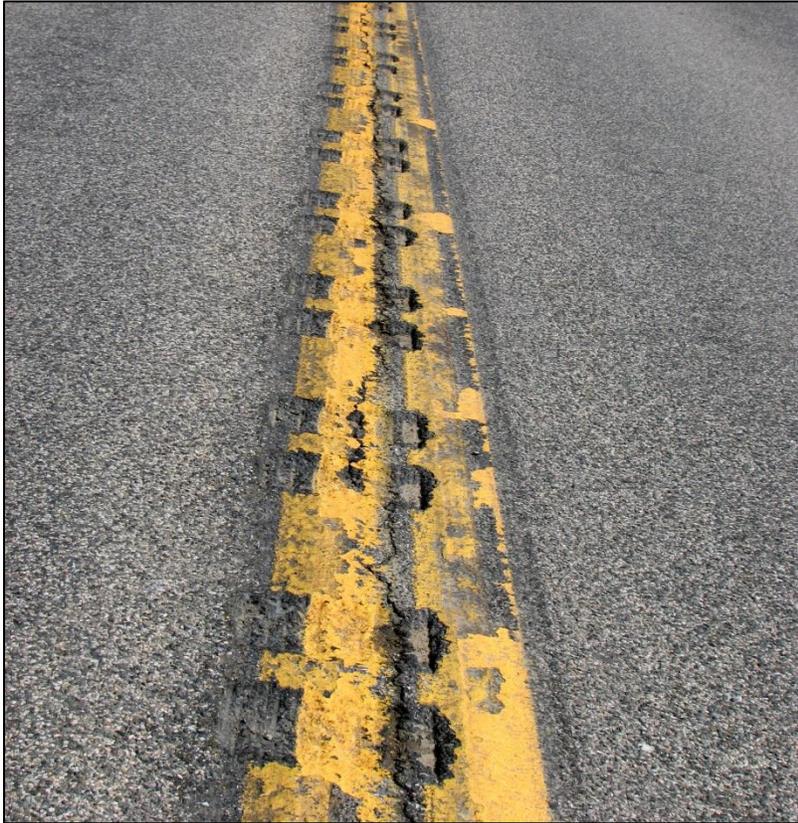
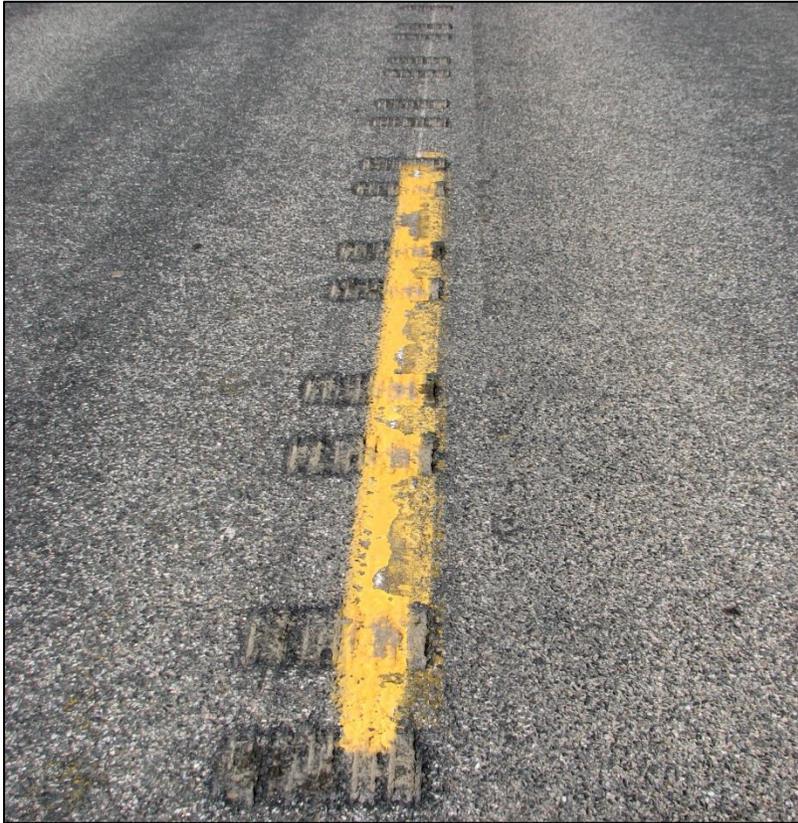
↙↘ Images representative of the general condition of the stripe over rumble strip on the project.

Loss of binder to pavement due to assumed snow plow passes.

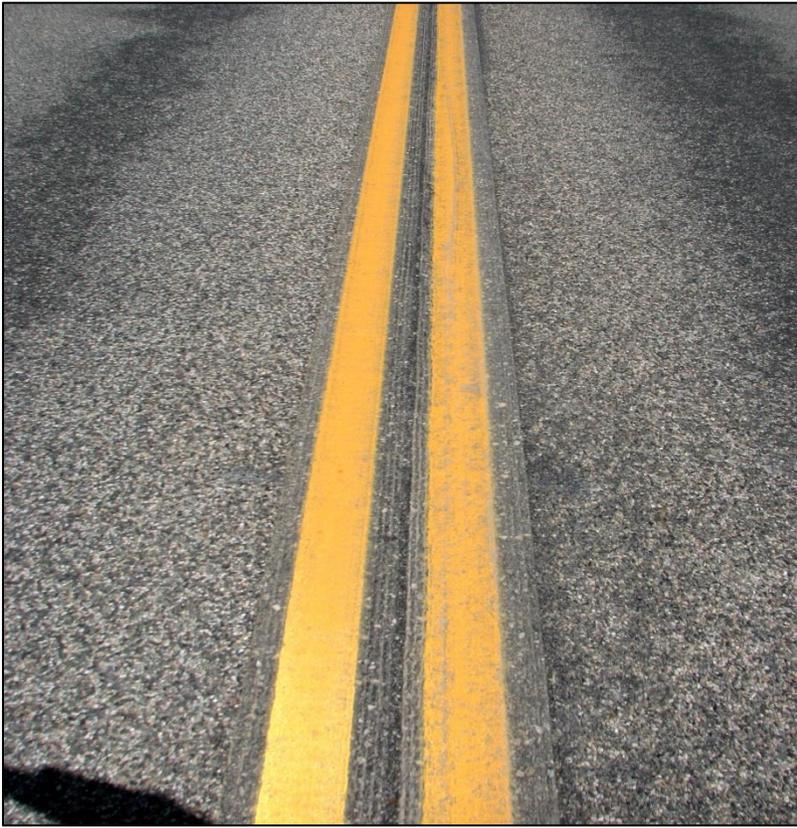
← There was a small linear section of no-passing zone that received a 60 mil grind within the 3M Element section. As seen in the 2014 inspection, the stripe is in good condition.

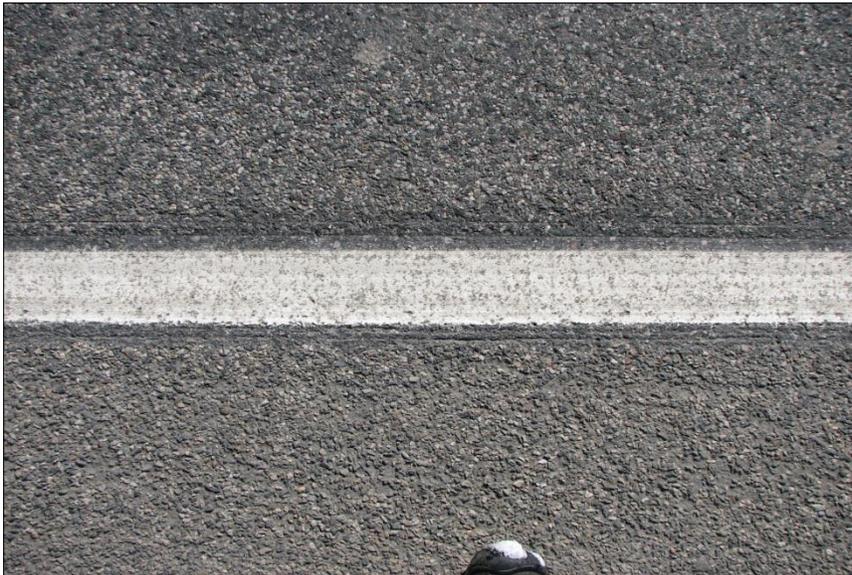
← Close-up of 3M Elements marking.

This image is representative of the overall condition of the stripe on the project.

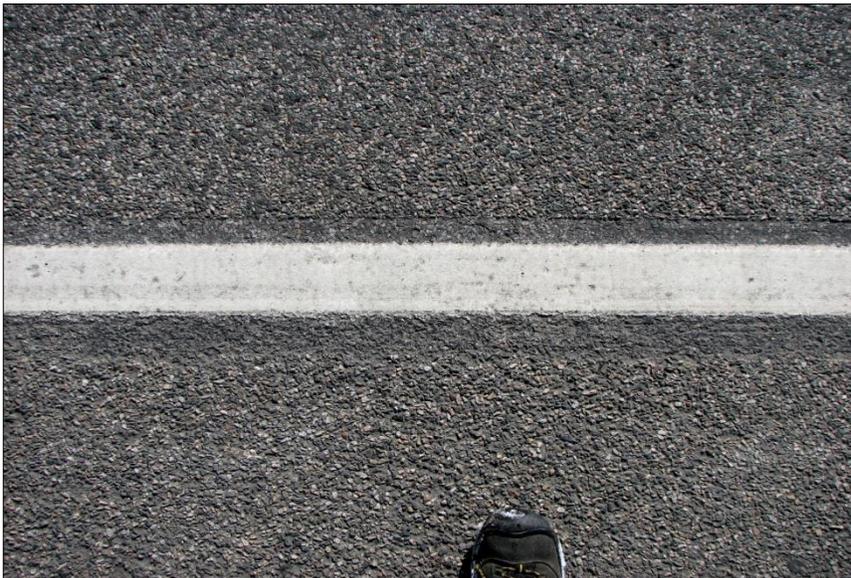
← Close-up of Type II marking.

This image is representative of the overall condition of the stripe on the project.

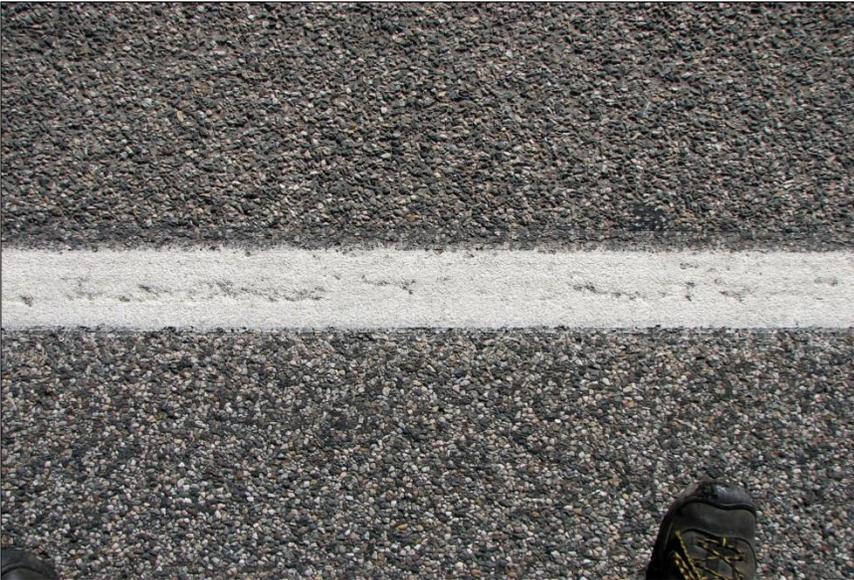
← Close-up of VISIMAX PLUS marking.

This image is representative of the overall condition of the stripe on the project.

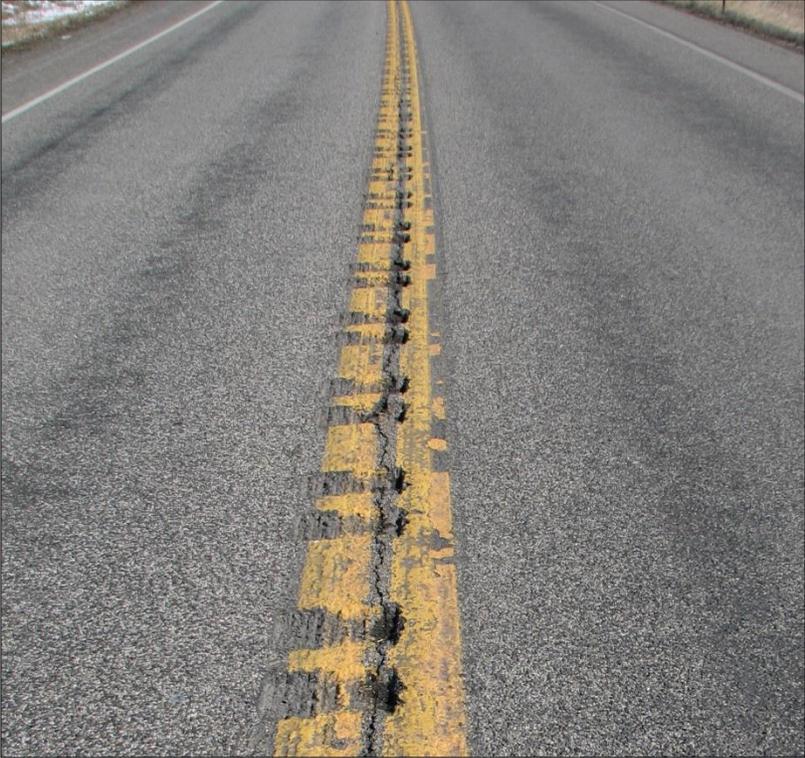
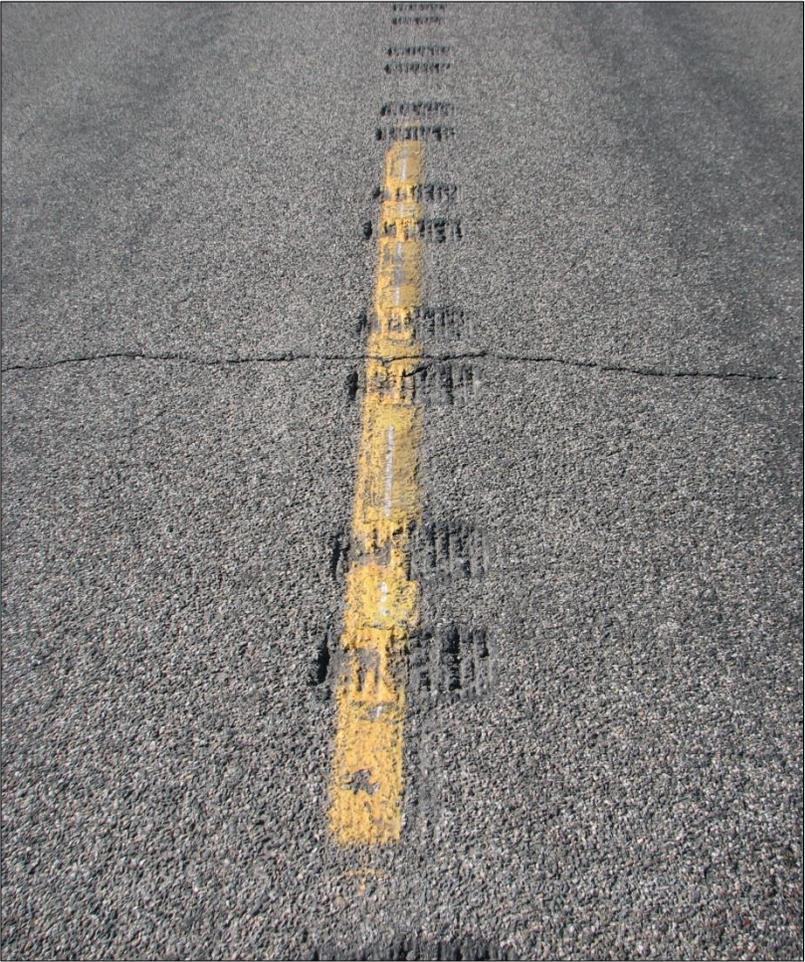
↔ Images representative of the general condition of the stripe over rumble strip on the project.

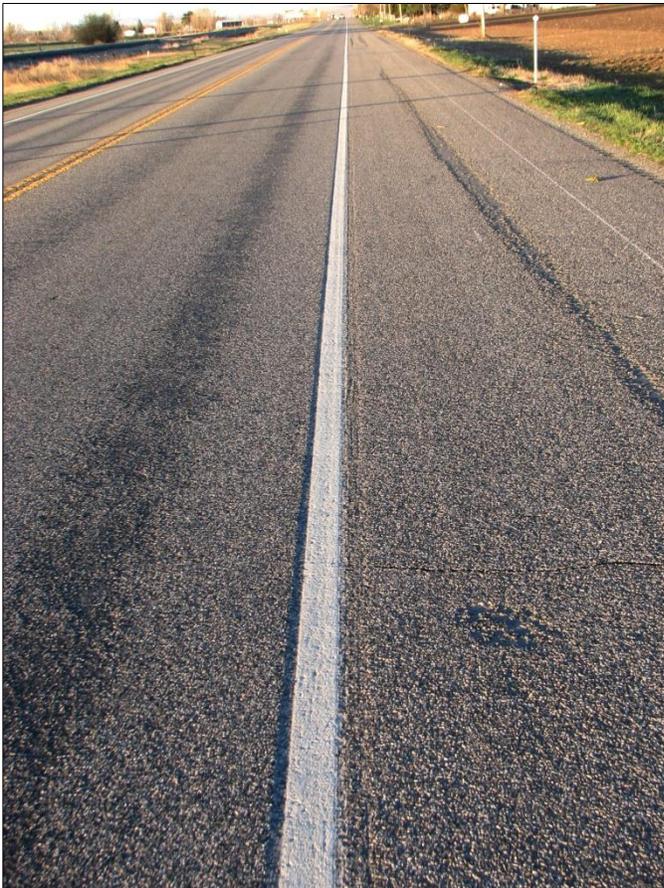
← Representative image of the condition of white stripe indicative of the entire section.

The applied 60 mil grind depth, to date, appears to protect the stripe from plow pass damage as compared to the un-milled centerline stripes.

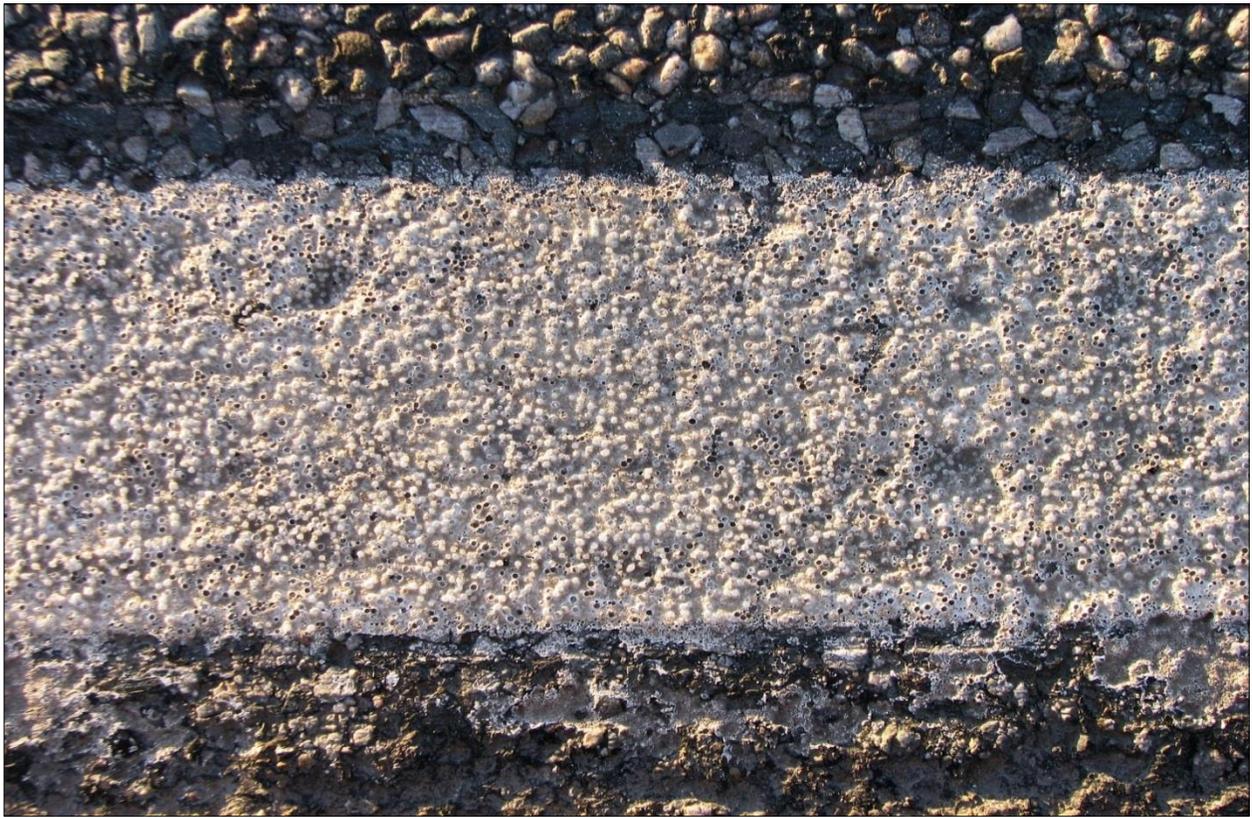
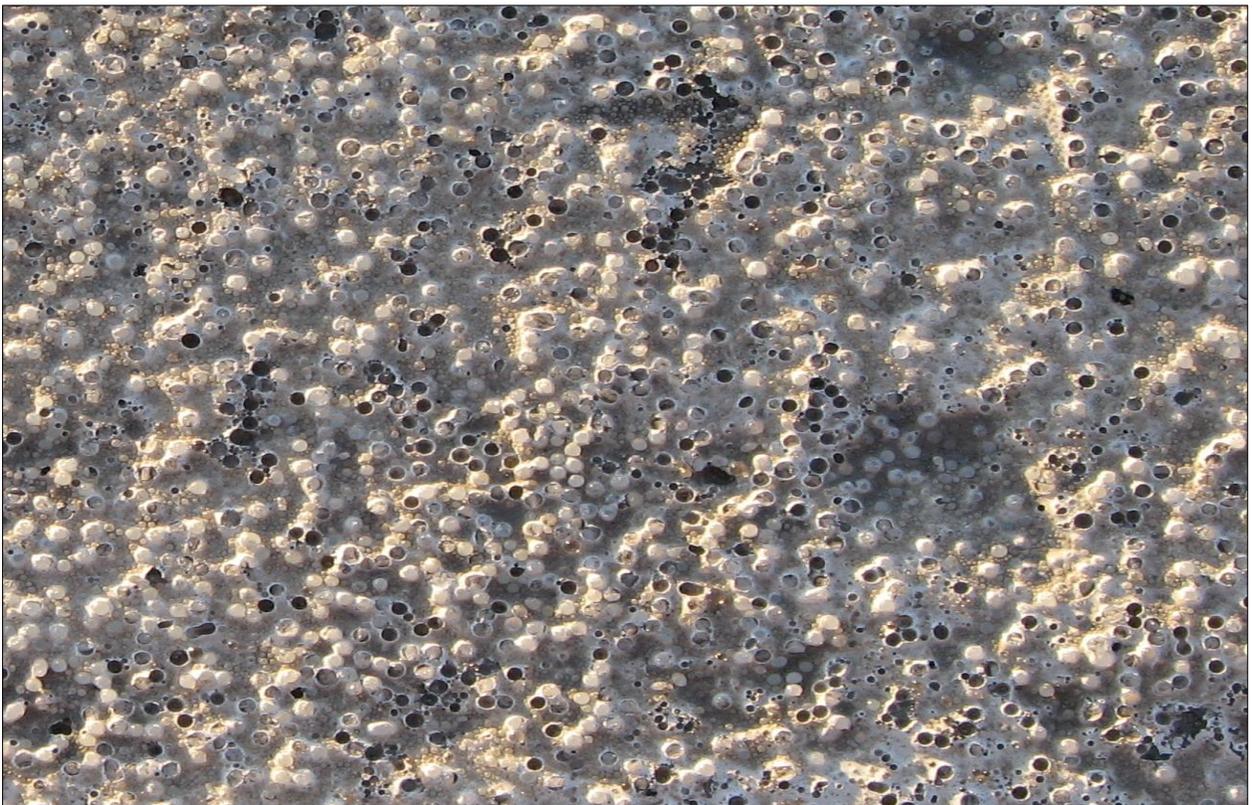
↕ Several close-ups of the Potters Visamax 50/50 blend with type II beads. Visually, it appears a small proportion of the larger bead spheres have debonded from the binder; either from inadequate embedment, environmental factors, or contact with vehicle tires.

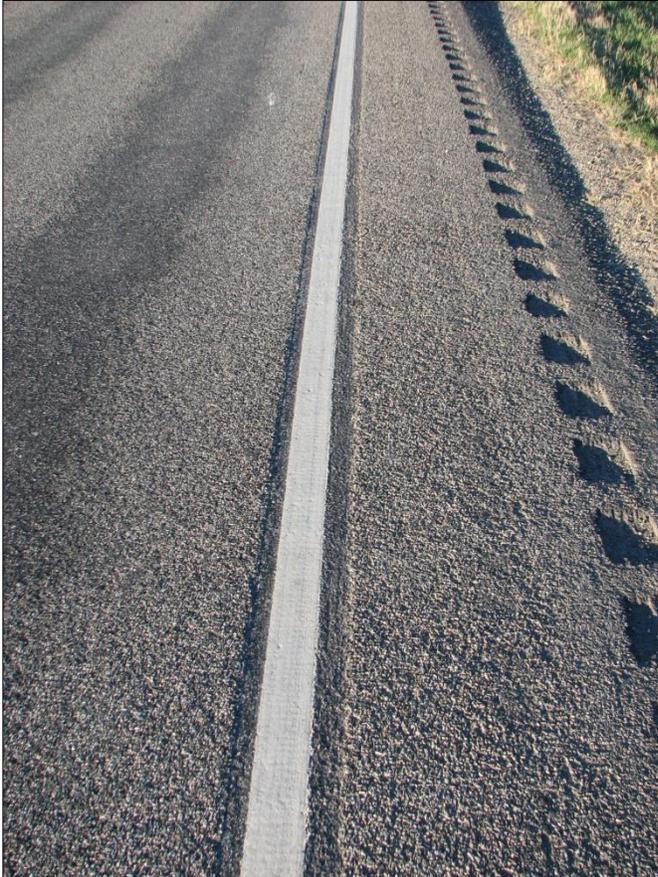
← Representative condition of the white stripe indicative of the entire section.

The applied 60 mil grind depth, to date, appears to protect the stripe from plow pass damage as compared to the un-milled centerline stripes.

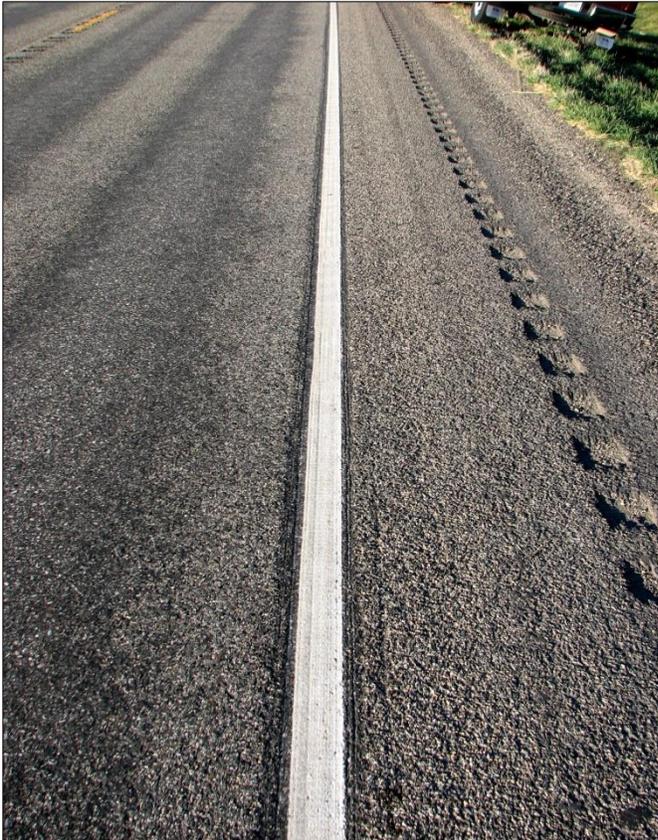
← Representative image of the condition of white stripe indicative of the entire section.

The applied 60 mil grind depth, to date, appears to protect the stripe from plow pass damage as compared to the un-milled centerline stripes.
