EXPERIMENTAL PROJECTS CONSTRUCTION REPORT AND ANNUAL EVALUATION

3M WET REFLECTIVE CERAMIC ELEMENTS AND POTTERS VISIMAX PLUS: NEW BEAD TECHNOLOGY FOR ADDED RETROREFLECTIVITY IN PAVEMENT MARKINGS

Location:	US 310/US 212 (N4) Approximate Reference Point 43-53, Counties Carbon and Yellowstone Counties
Project Name:	Rockvale - Laurel
Project Number:	HSIP 4-1(63)43
Experimental Project No.	MT-12-12
Type of Project:	Pavement Markings Retroreflectivity
Principal Investigator:	Craig Abernathy: Experimental Project Manager (ExPM)
Date of Installation:	September 2013
Date of Inspection:	April 2016

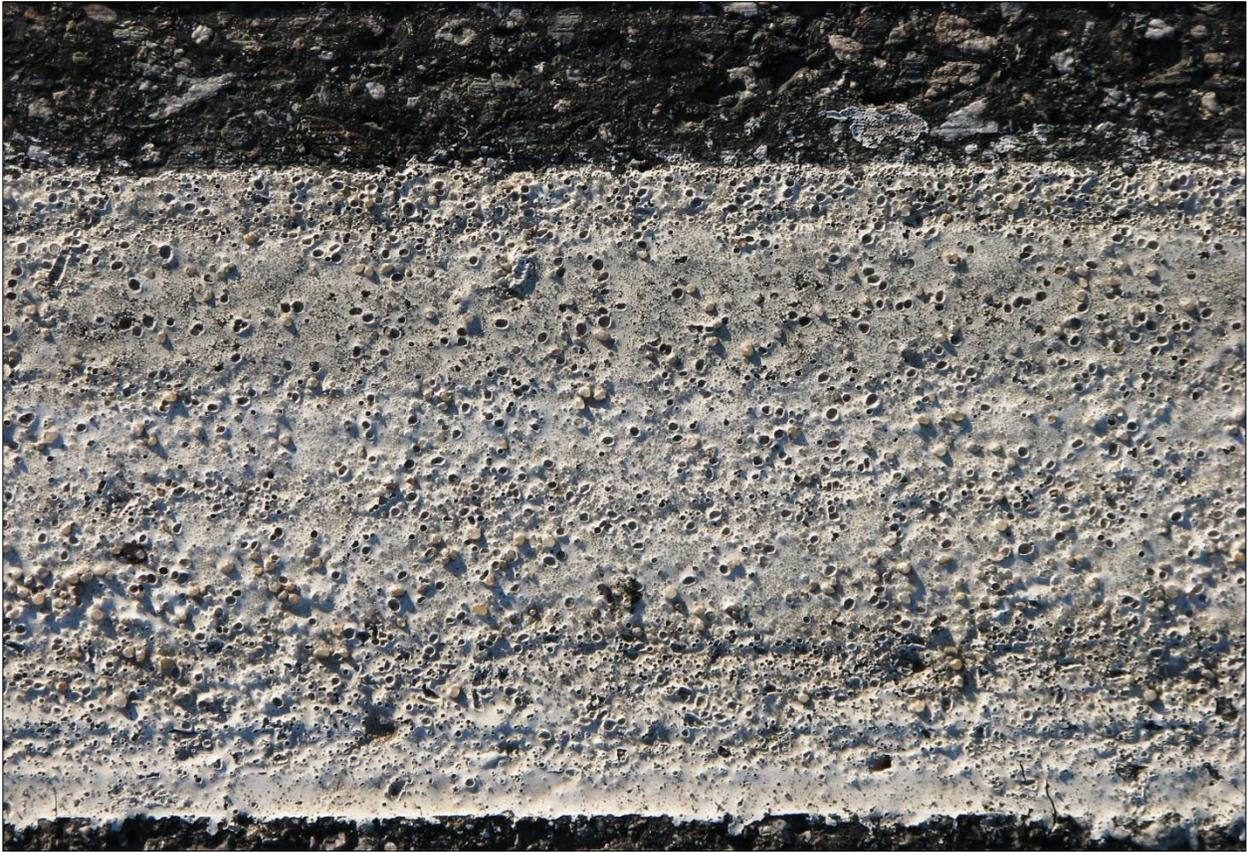
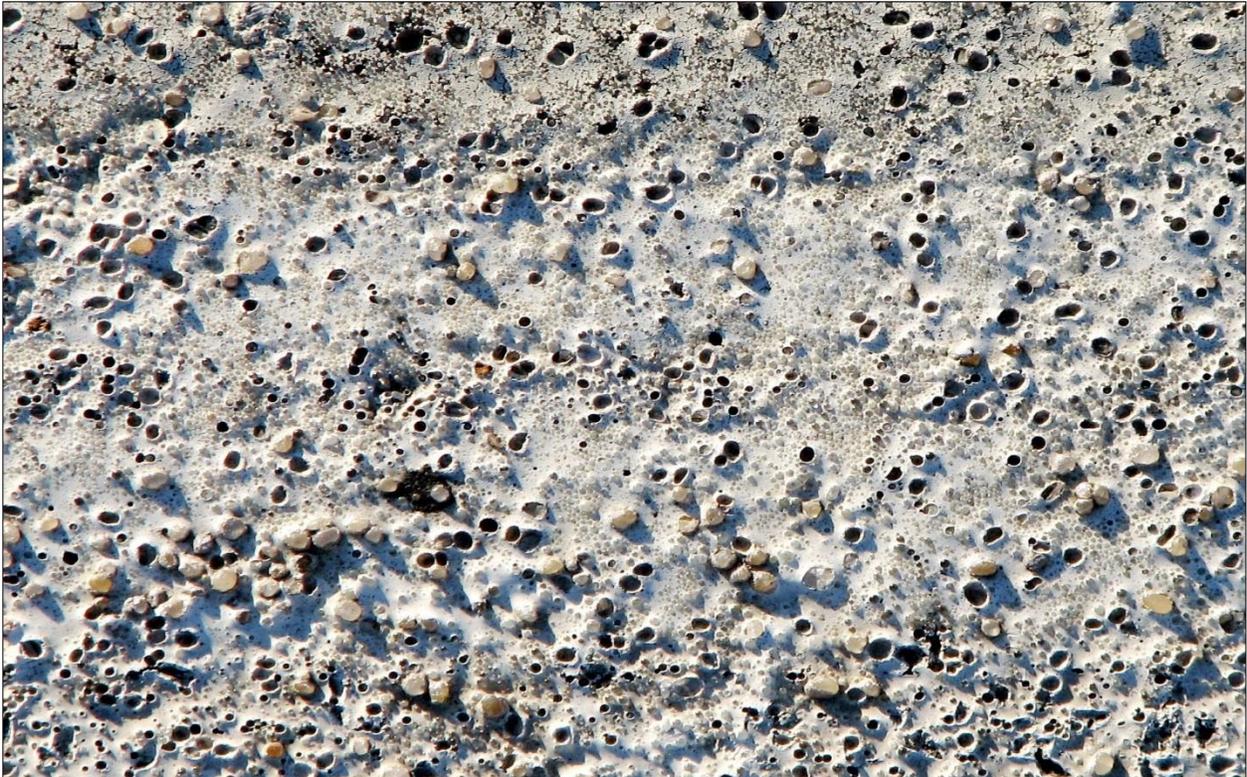
↑↓ Several close-ups of the 3M Elements 30% blend with type 2 beads. Visually, it appears a proportion of the larger bead elements have debonded from the binder; either from inadequate embedment, environmental factors, or contact with vehicle tires.
