**EVALUATION OF CRACK-SEALING MILLED PAVEMENT IN THE EFFORT
TO REDUCE TRANSVERSE CRACKING**

Annual Report 2015

Location: Teton County, Interstate 15, Approximately Milepost 312; Northbound Lanes

Project Number: Dutton N & S IM 15-6(35)309

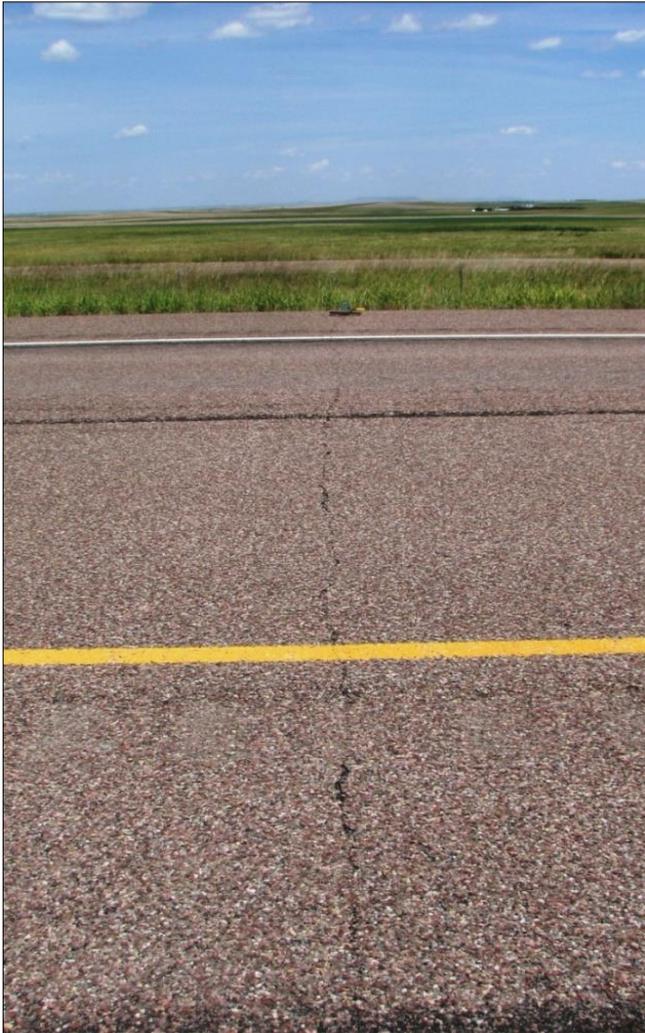
← Example of low-severity cracking on sealed north section (2009)

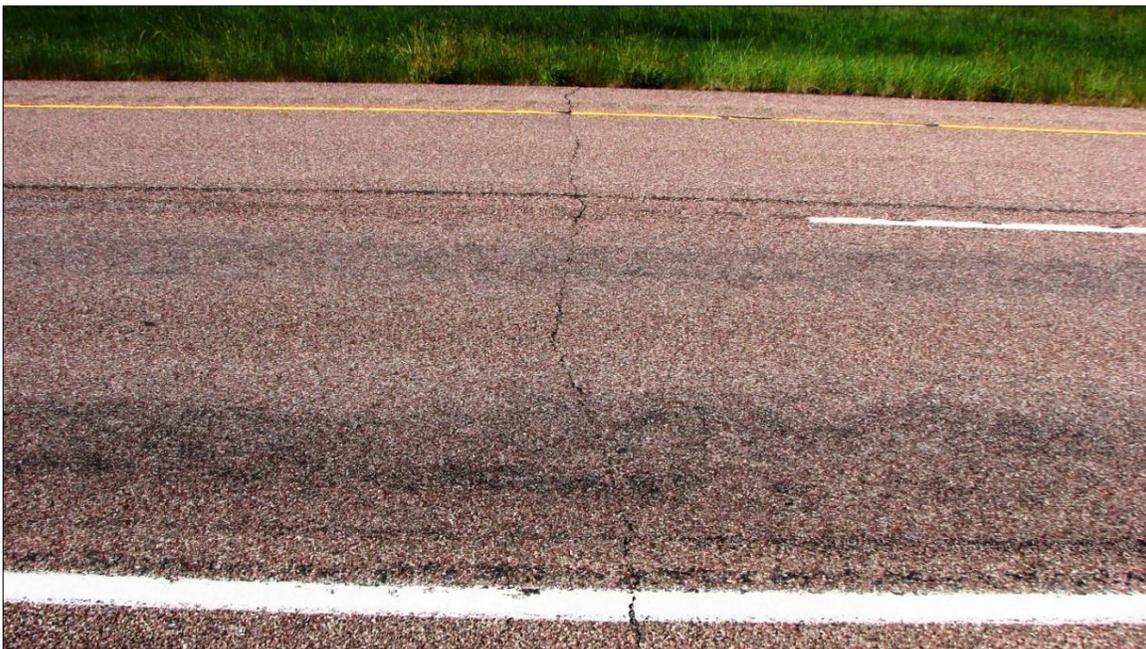
↓ Example of low-severity cracking on un-sealed south section (2011)

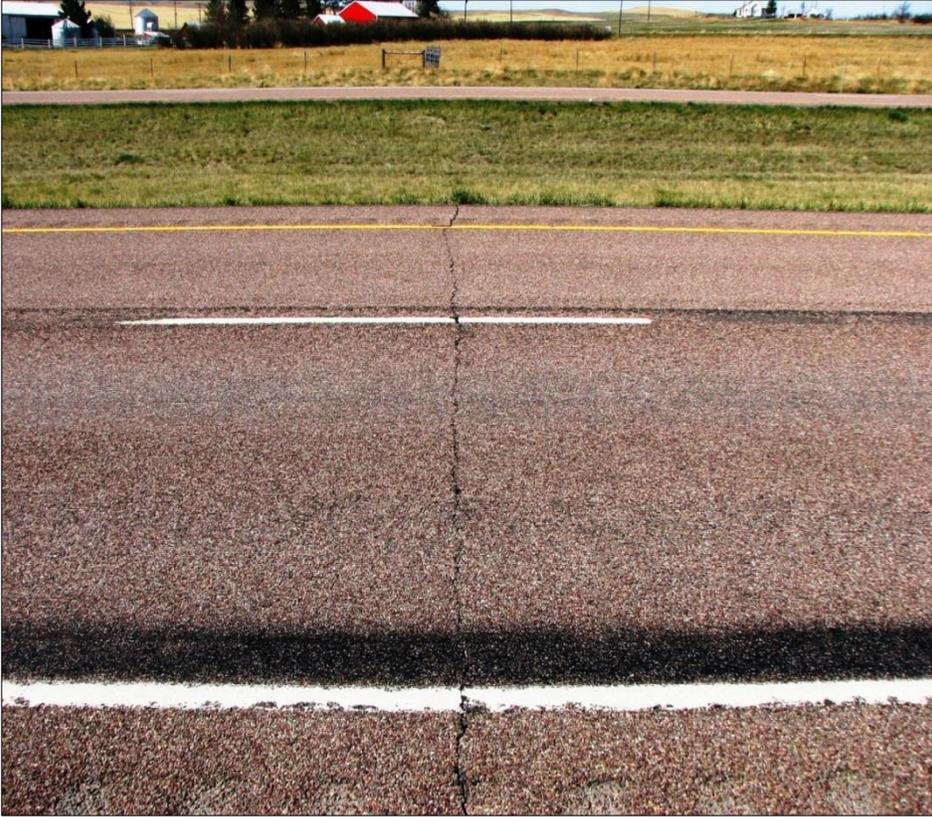
← Example of low-severity cracking on un-sealed south section (2012)

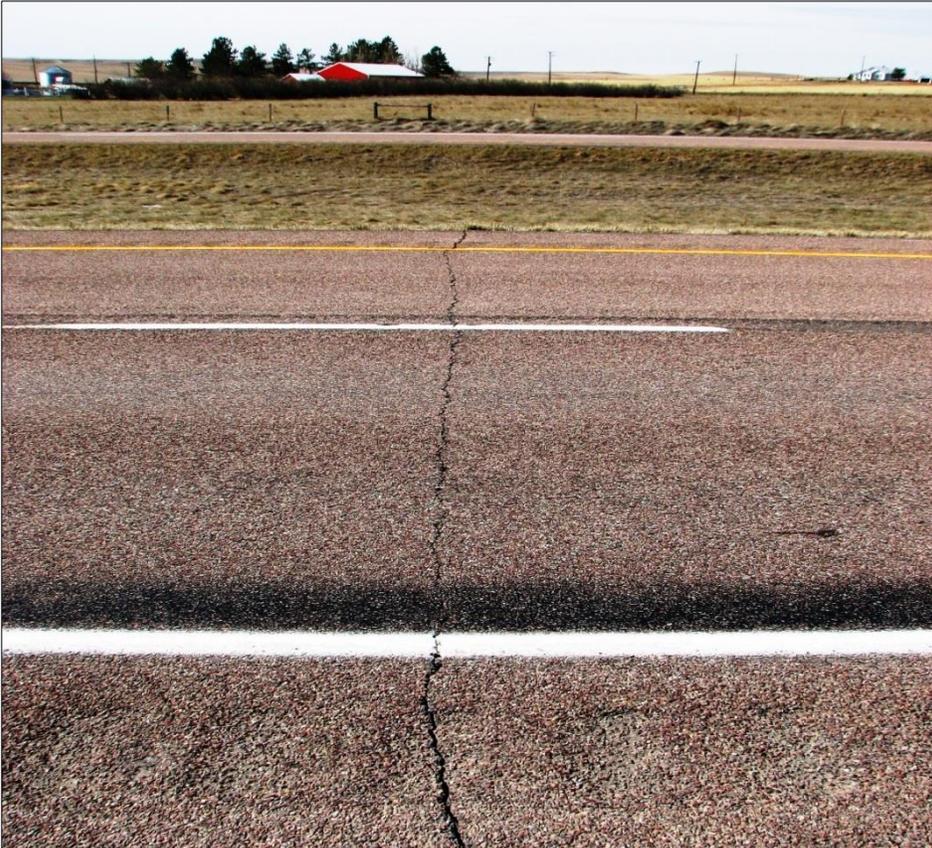
← Example of low-severity cracking on un-sealed south section (2013)

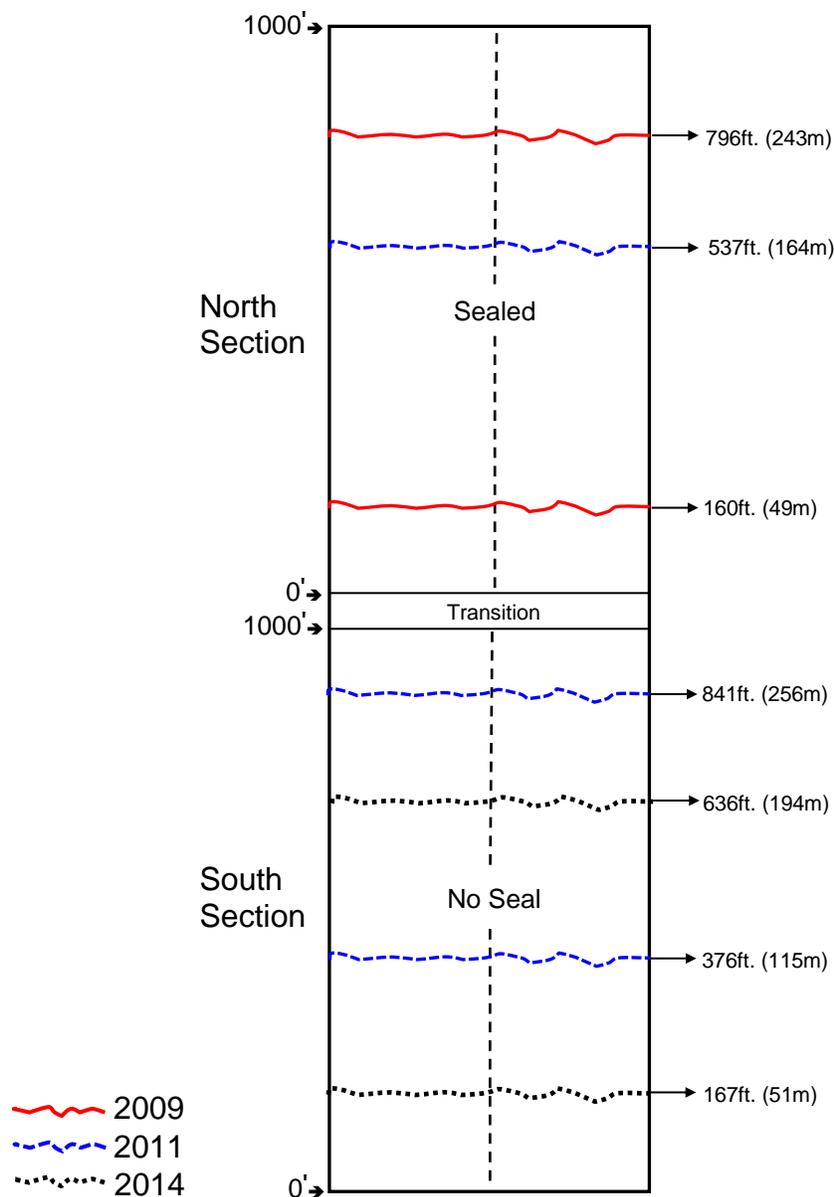
Documented Cracking – Interstate 15/Northbound lanes: Mile Point 312

The south and north sections were initially chosen due to the homogeneous condition and identical number of cracking on both sites. No transverse cracking occurred from construction date of 2005 to 2008. During the 2009 inspection the sealed north section had developed two low-severity cracks (red lines). The blue lines represent cracking to date (low-severity) documented with the 2011 site inspection; with two additional cracks appearing in the no-seal section between 2013 & 2014. To date all cracks on both sections have been crack sealed.

No additional cracking was observed since the 2014 site inspection. The graph depicts the approximate location and distance from the start of each test section, (crack locations approximate; not to scale).
