**EXPERIMENTAL PROJECTS CONSTRUCTION REPORT AND ANNUAL  
INSPECTION**

**EVALUATION OF THE METADOME TRUNCATED DOME USED IN EXISTING  
AND NEW ASPHALT APPLICATIONS**

**Project Name:** ADA Asphalt DWD

**Exp. Project Number:** MT-12-06

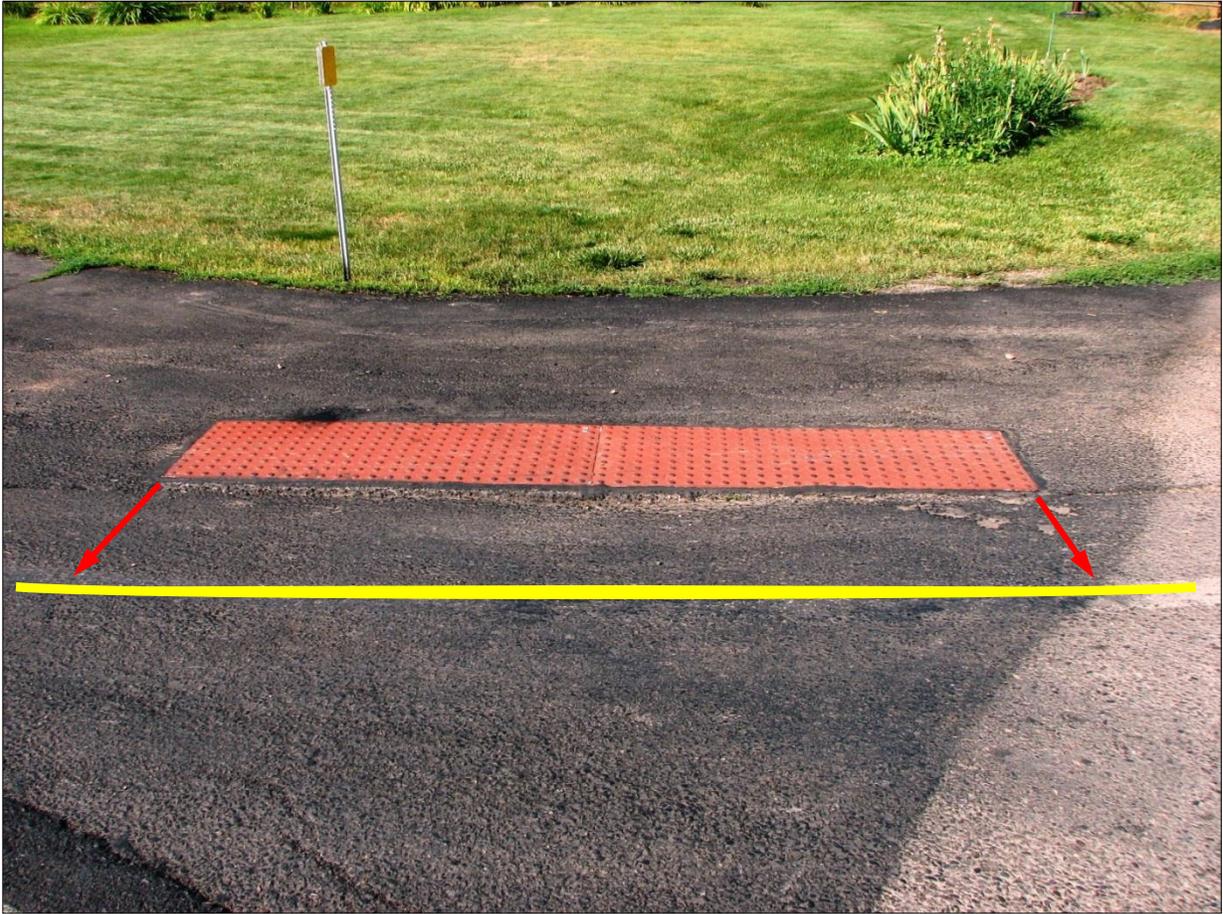
↑ The manufacturer's representative had a concern over the placement of the DWD located on the southwest corner at the intersection of North Ave. and Clements Rd.

As seen in the image above the panel is set on a radius within several feet of the white line (or fog line). The yellow line in the image is superimposed since sealing the bike path no longer made the stripe visible. The issue is the location of the panel may be prone to be plowed. Although the height of the panel lip to pavement is within ADA tolerance ( $< \frac{1}{4}$ " ), a plow blade hitting the panel at the right angle could damage the unit.

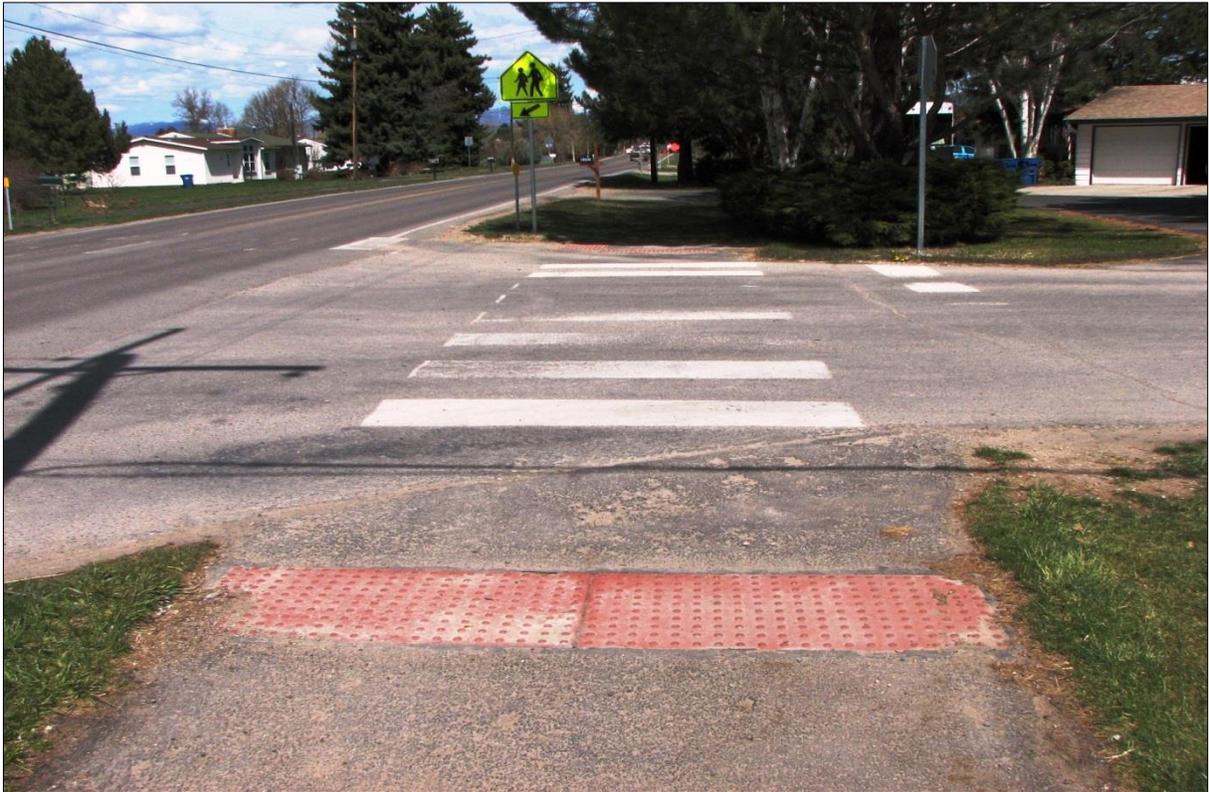
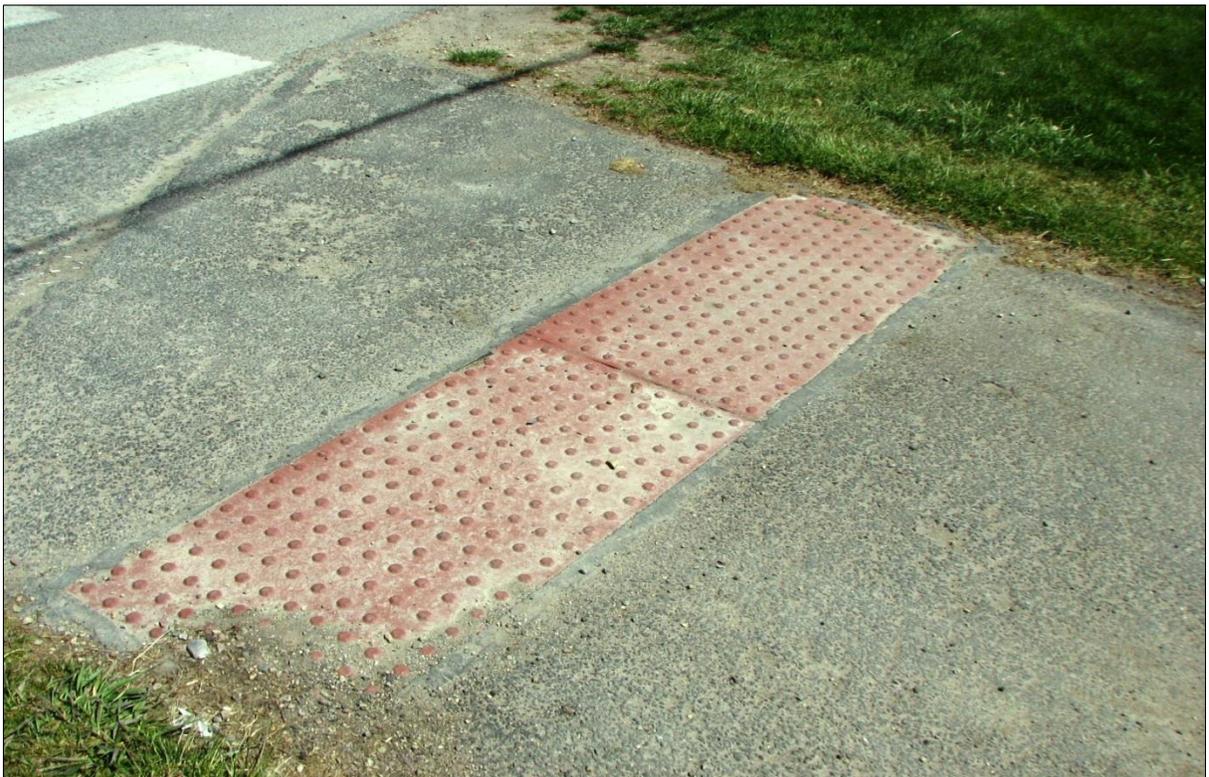
↑ ↓ Intersection of Mount Ave. and Clements Rd; east side of installation. The DWD's at this location were visually in good shape.

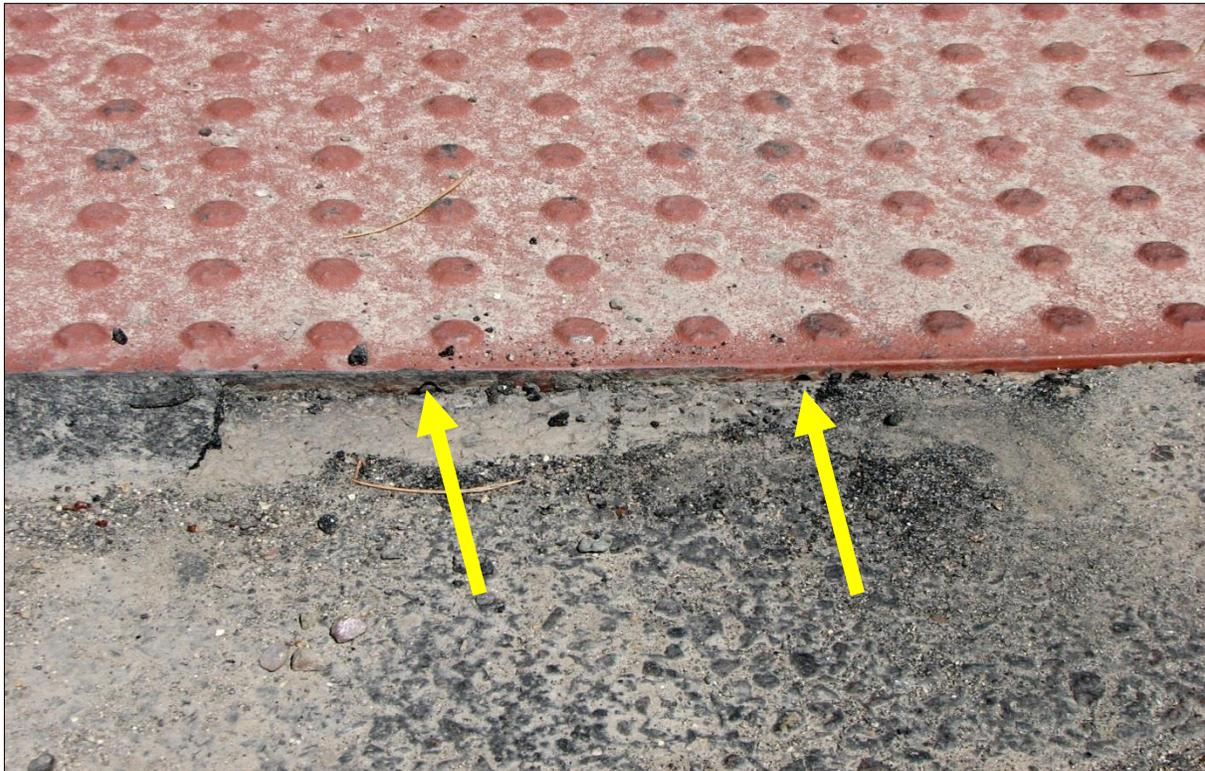
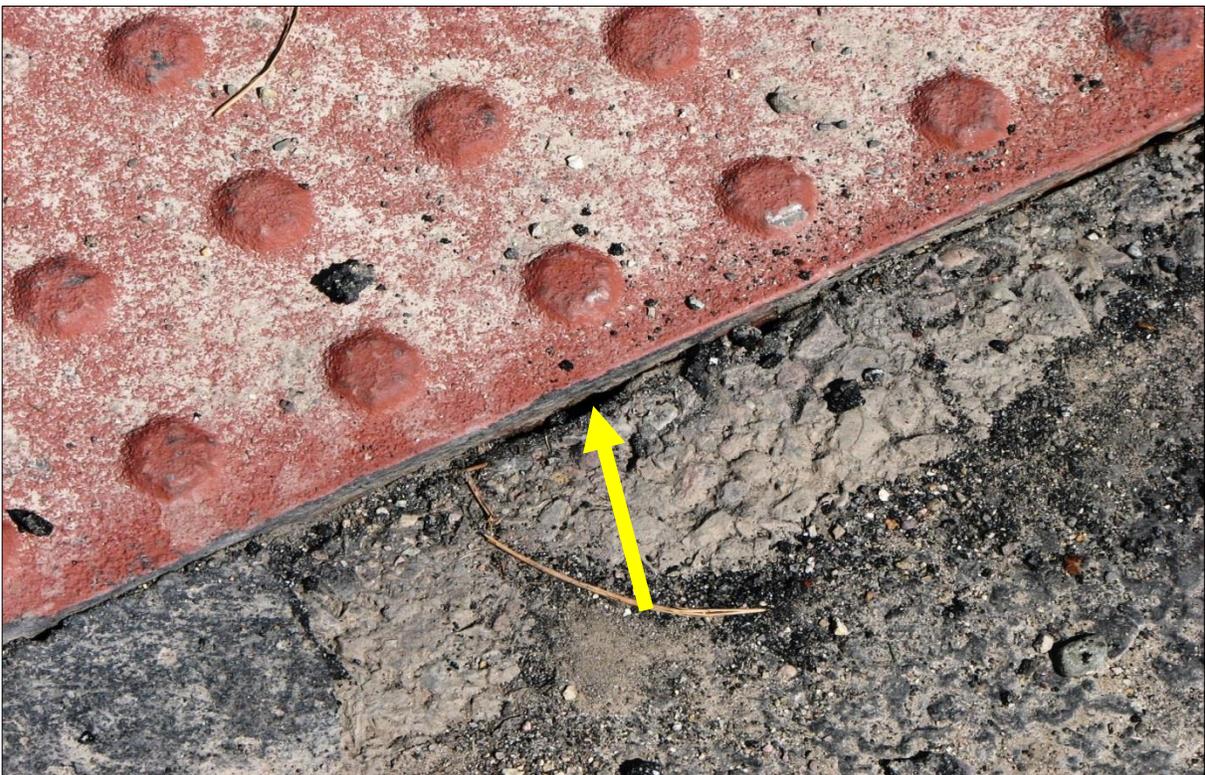
↑↓ The driveway patch used in the installation is beginning to crack and delaminate as seen in the above and below images. This is exposing the flange openings (yellow Arrow) to potential entry of moisture which may promote freeze/thaw activity.

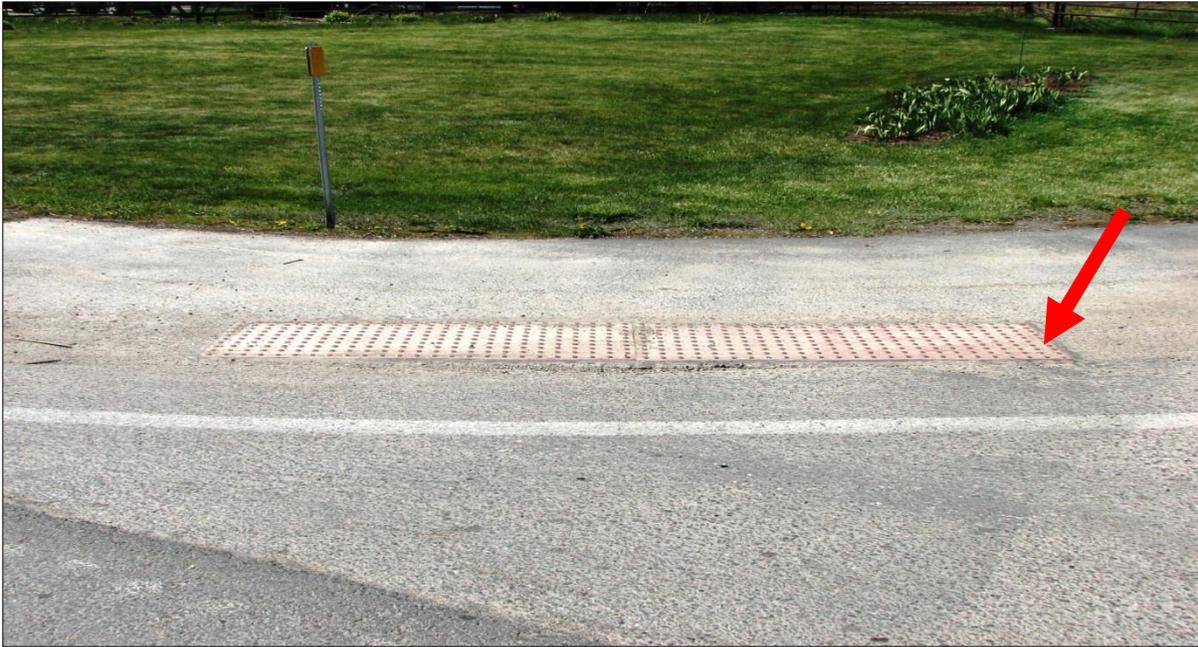
↑ Intersection of North Ave. and Clements Rd. View of DVD on west side of intersection.

← It was observed on the leading edge of the northeast corner (red arrow) of the DVD had visual plow damage of either the scraping off of the powder coating or actual depression of the domes.

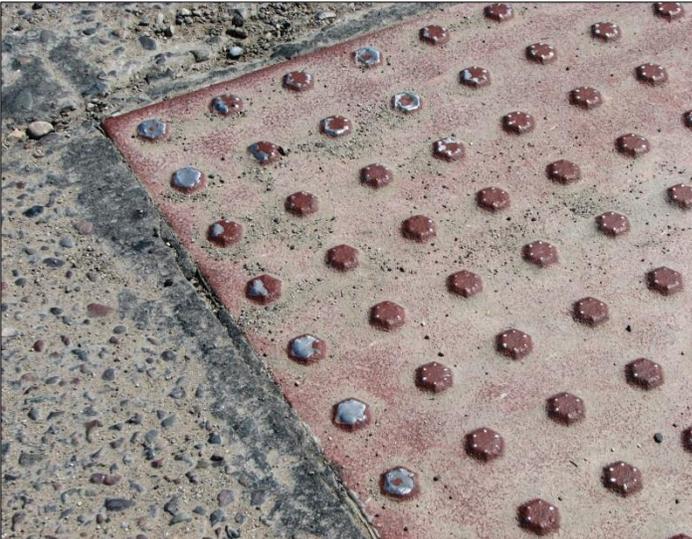
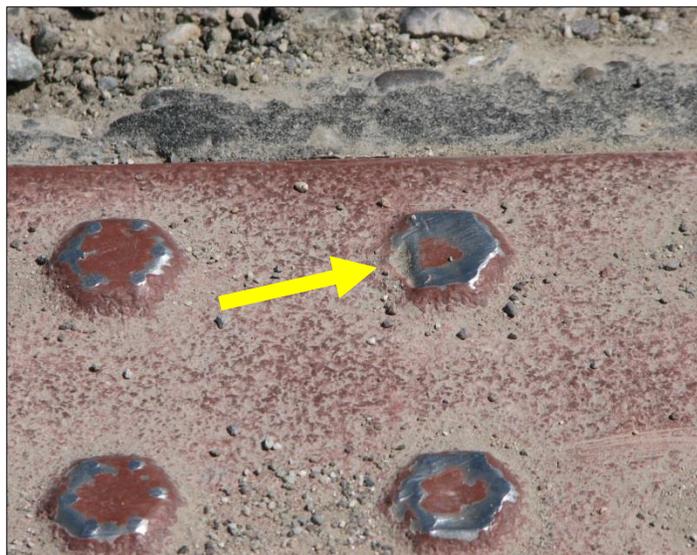
← A close-up of the damage done to the panel domes. The yellow arrow shows the direction of the hit.

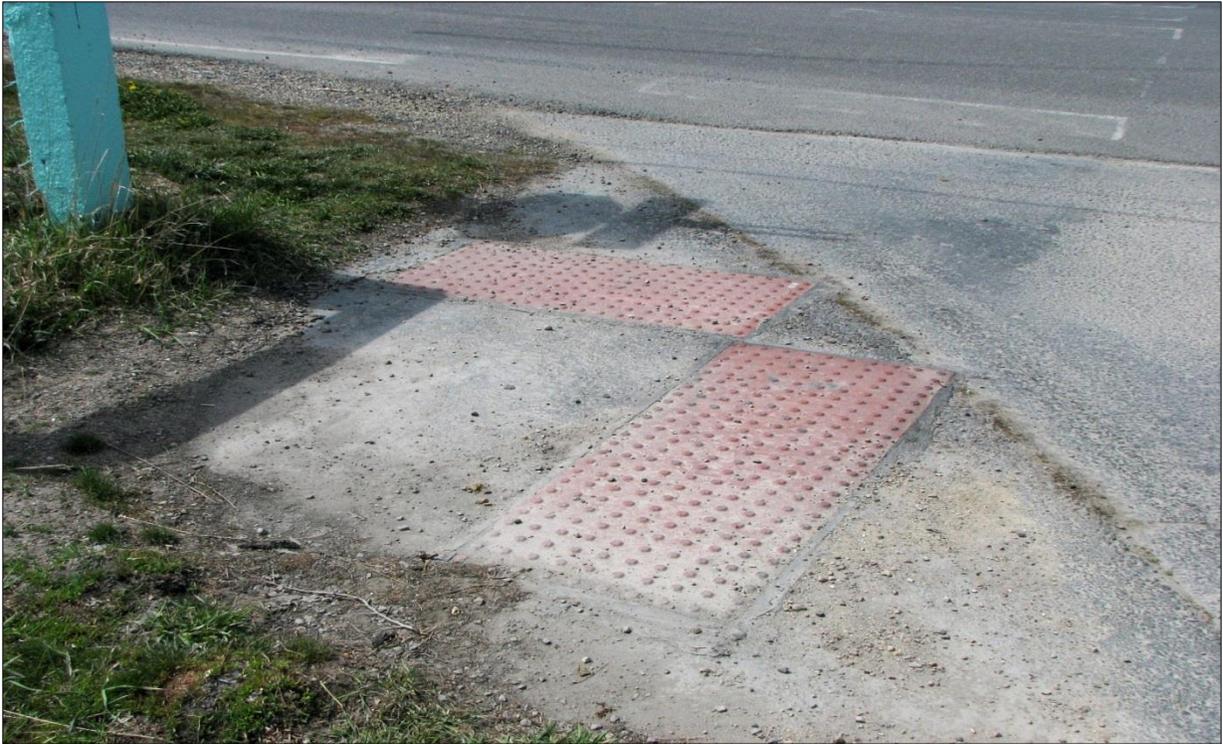
↑ Southeast DWD placement at intersection of North Ave. and Clements Rd. Panels are in good condition.

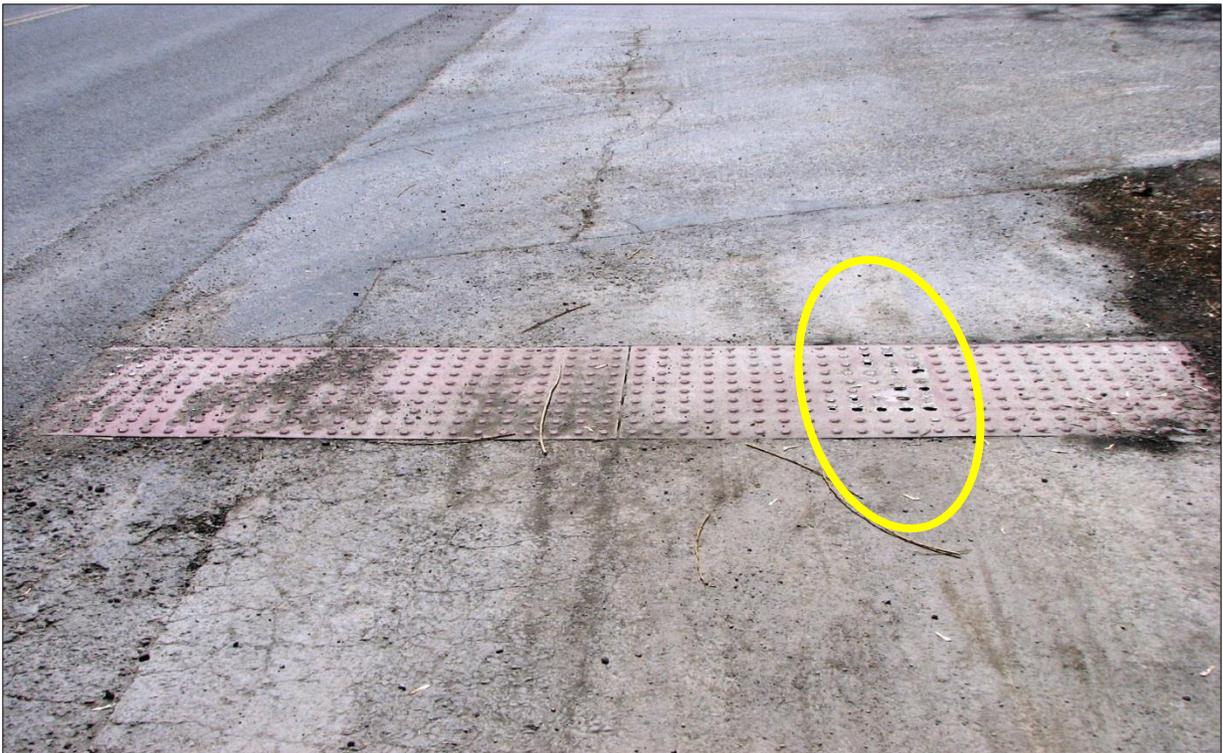
↓ **Intersection of Colonial Ave. and Clements Rd.** West panel placement has severe plow damage of sheared or flattened domes as defined in the area of the yellow circle.

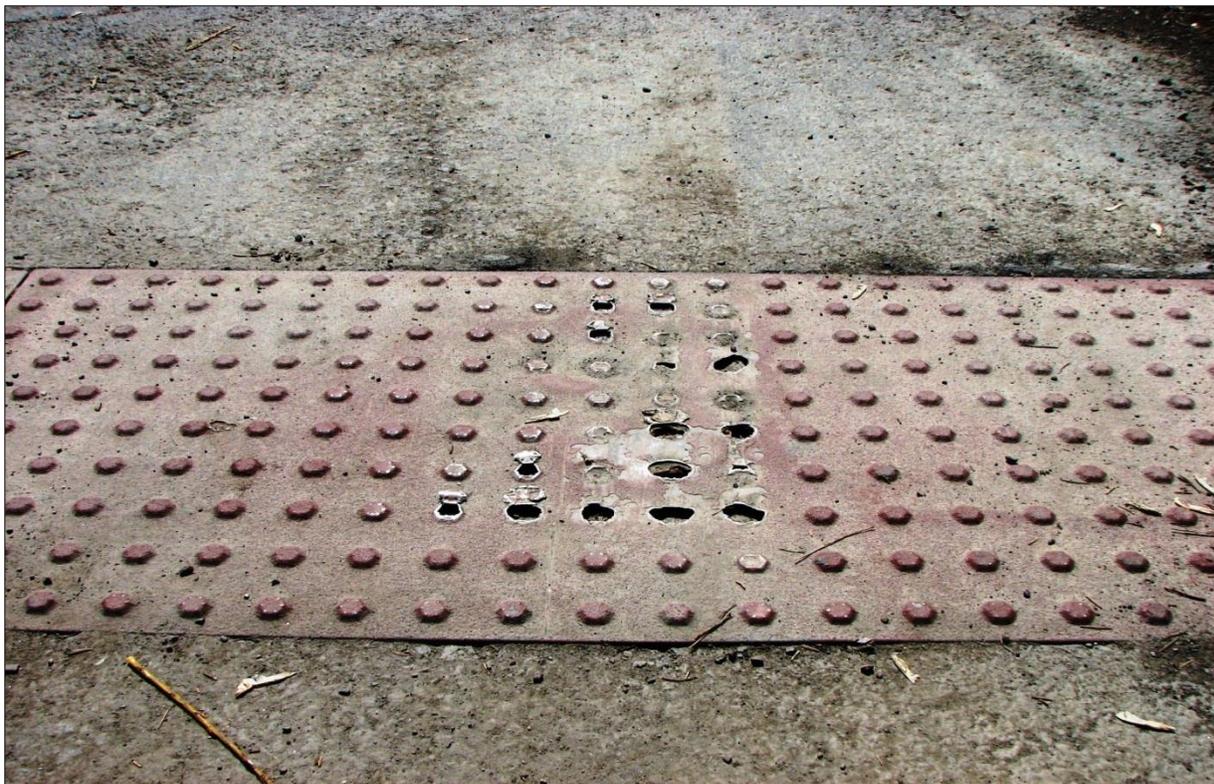
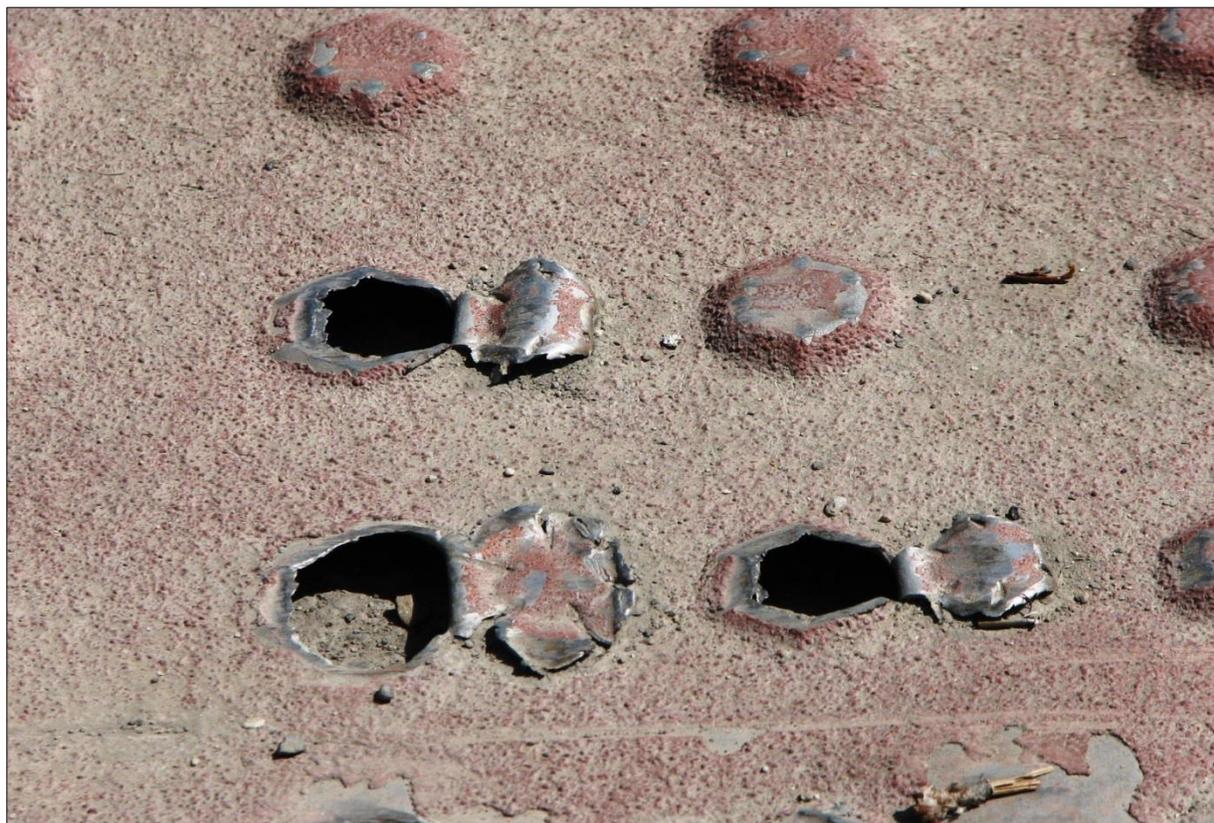
↑↓ Several close-ups of the damaged domes. Some domes were flattened; others completely removed, or peeled back as seen in lower image. The peeled back domes may be a safety hazard since they are razor sharp to the touch.

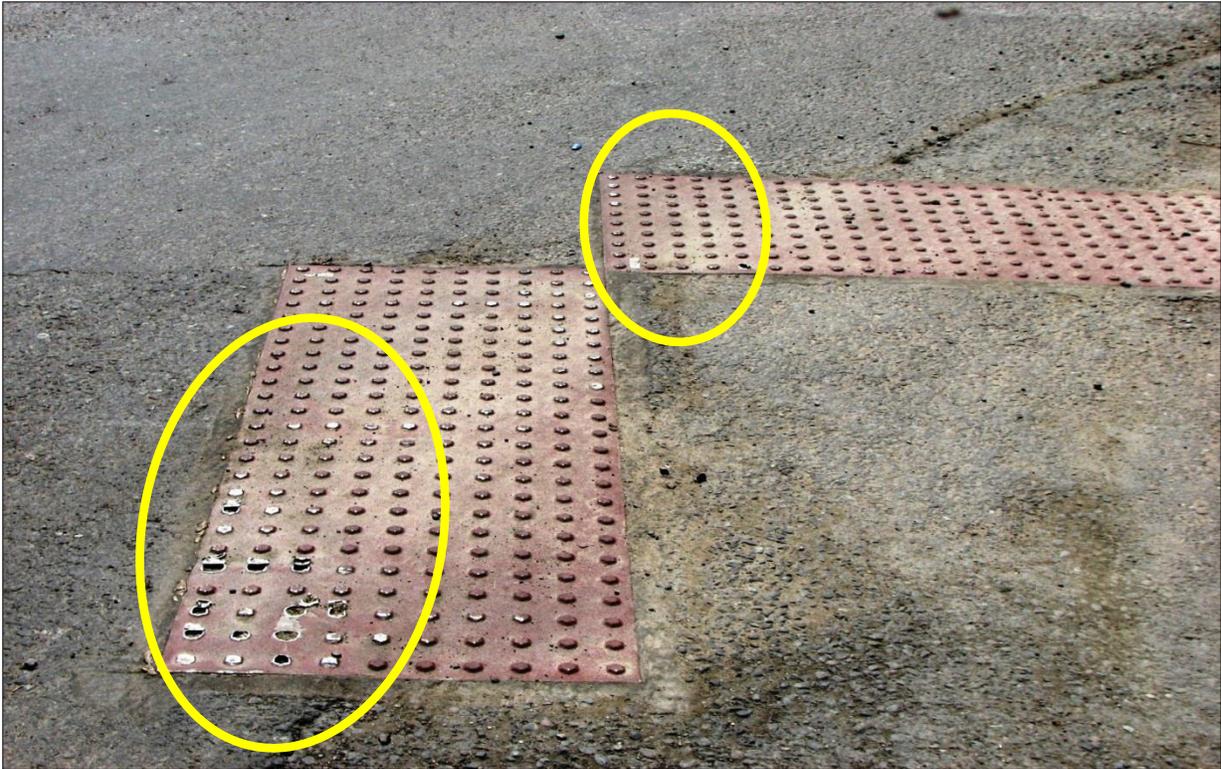
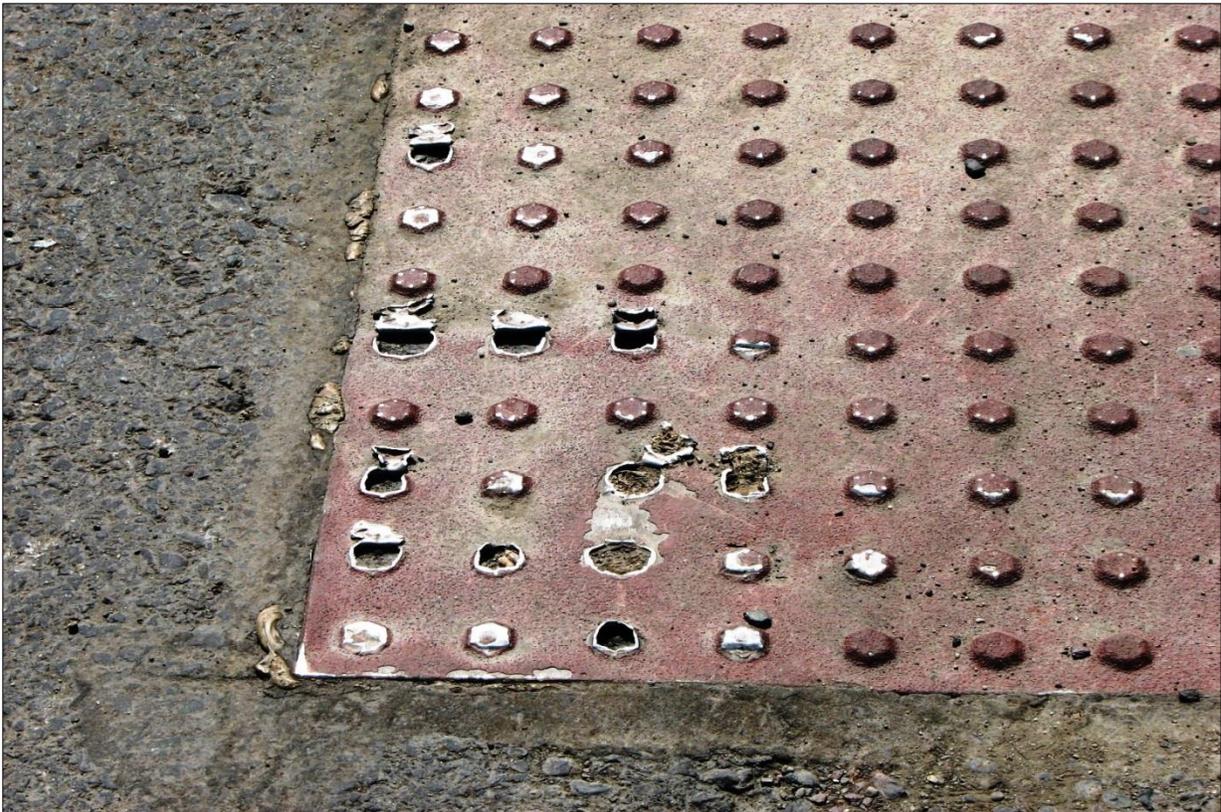
↑↓ **Intersection of South Ave. and Clements Rd – West placement:** Additional damaged panels by plow as defined in the area of the yellow circles. Lower image is a close-up of the damaged domes.

↑↓ All panels which exhibited damage from plowing activities were located on the west side of the project with the pedestrian/bike path essentially an extension of the roadbed as seen from these images. This allowed the plow truck to treat the path as an extended lane. The east side DWD installations is a basic widened sidewalk which to date has no visual damage since it can be assumed it was not cleared by fixed-blade.

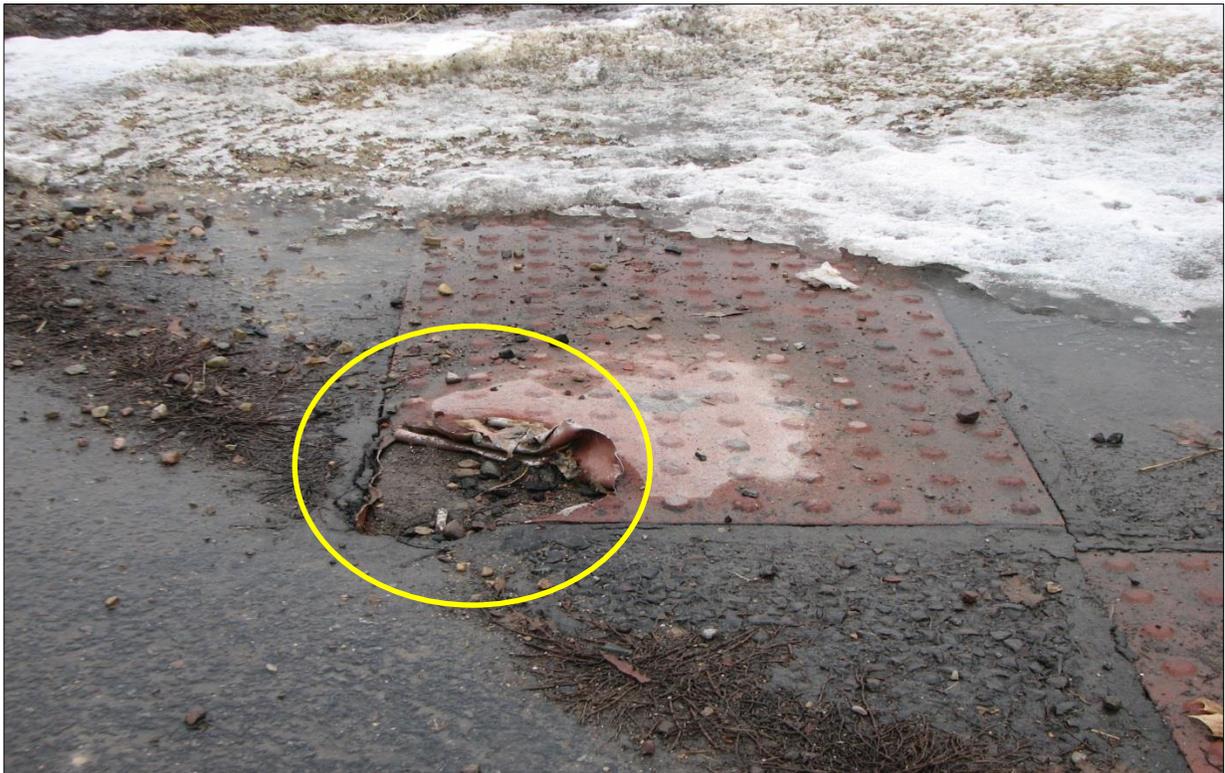
↓ **Intersection of North Ave. and Clements Rd – Southeast placement:** Original stainless steel DWD exhibiting heavy plow damage at the corner (yellow circle).

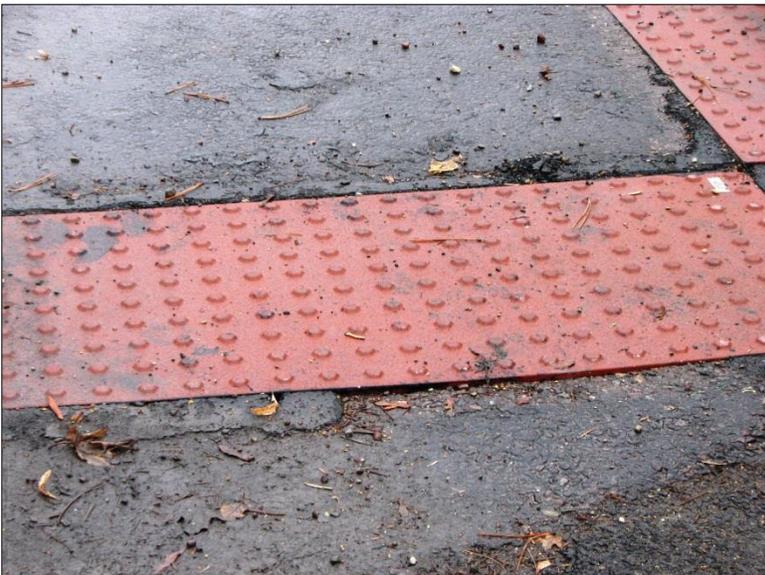
← This stainless steel DWD at the intersection of Spurgin and Clement has signs of slight plow damage and the asphaltic patch used to seal the perimeter has mostly deteriorated exposing the DWD lip.

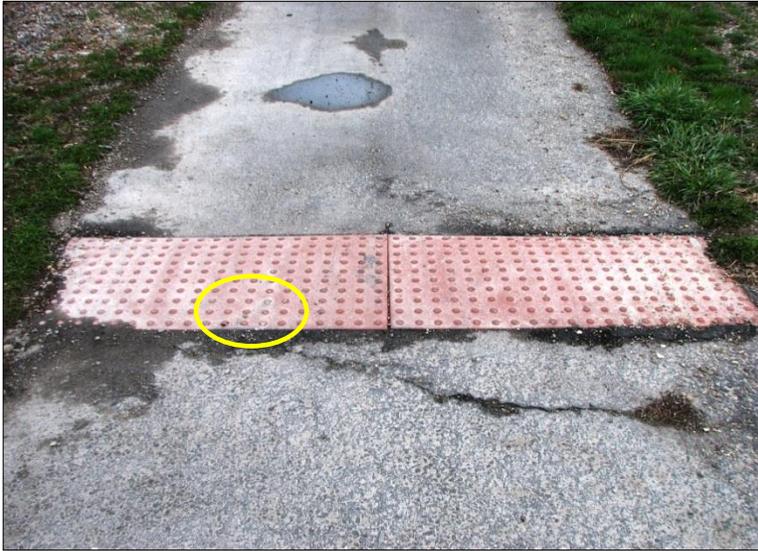
This unit located at Spurgin Rd. road is in good shape but does have minimum plow damage indicated by the yellow arrow.

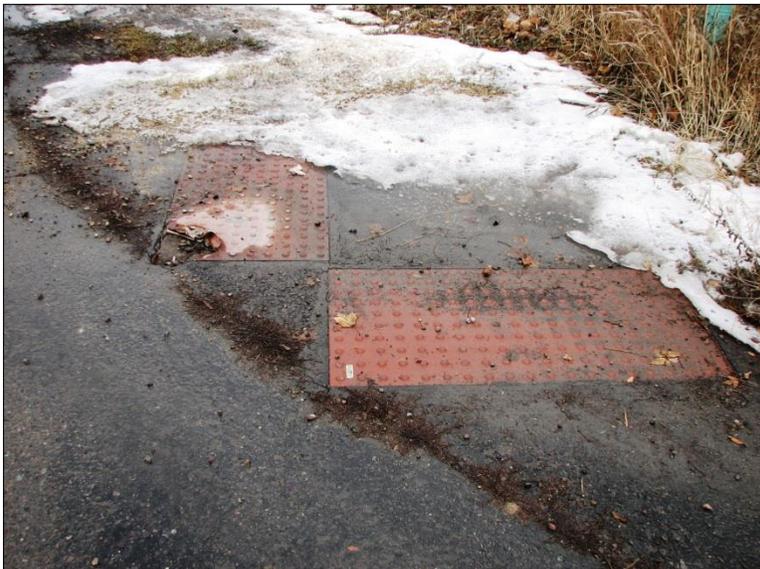
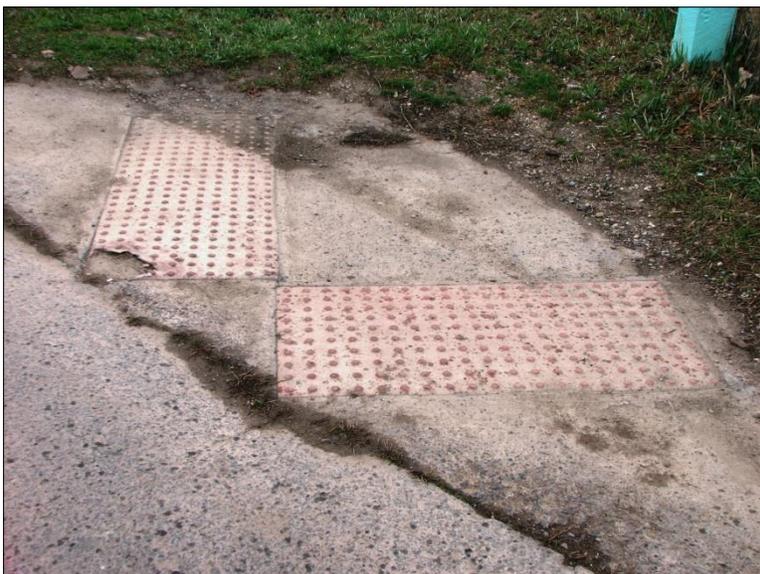
←↓ Intersection of Clements Rd. & North St.

Condition of plow damaged DWD as documented in February 2014.

The below image of the same DWD taken in April 2015.

As stated in earlier site inspections the District is replacing the damaged stainless steel DWD's with cast iron units.

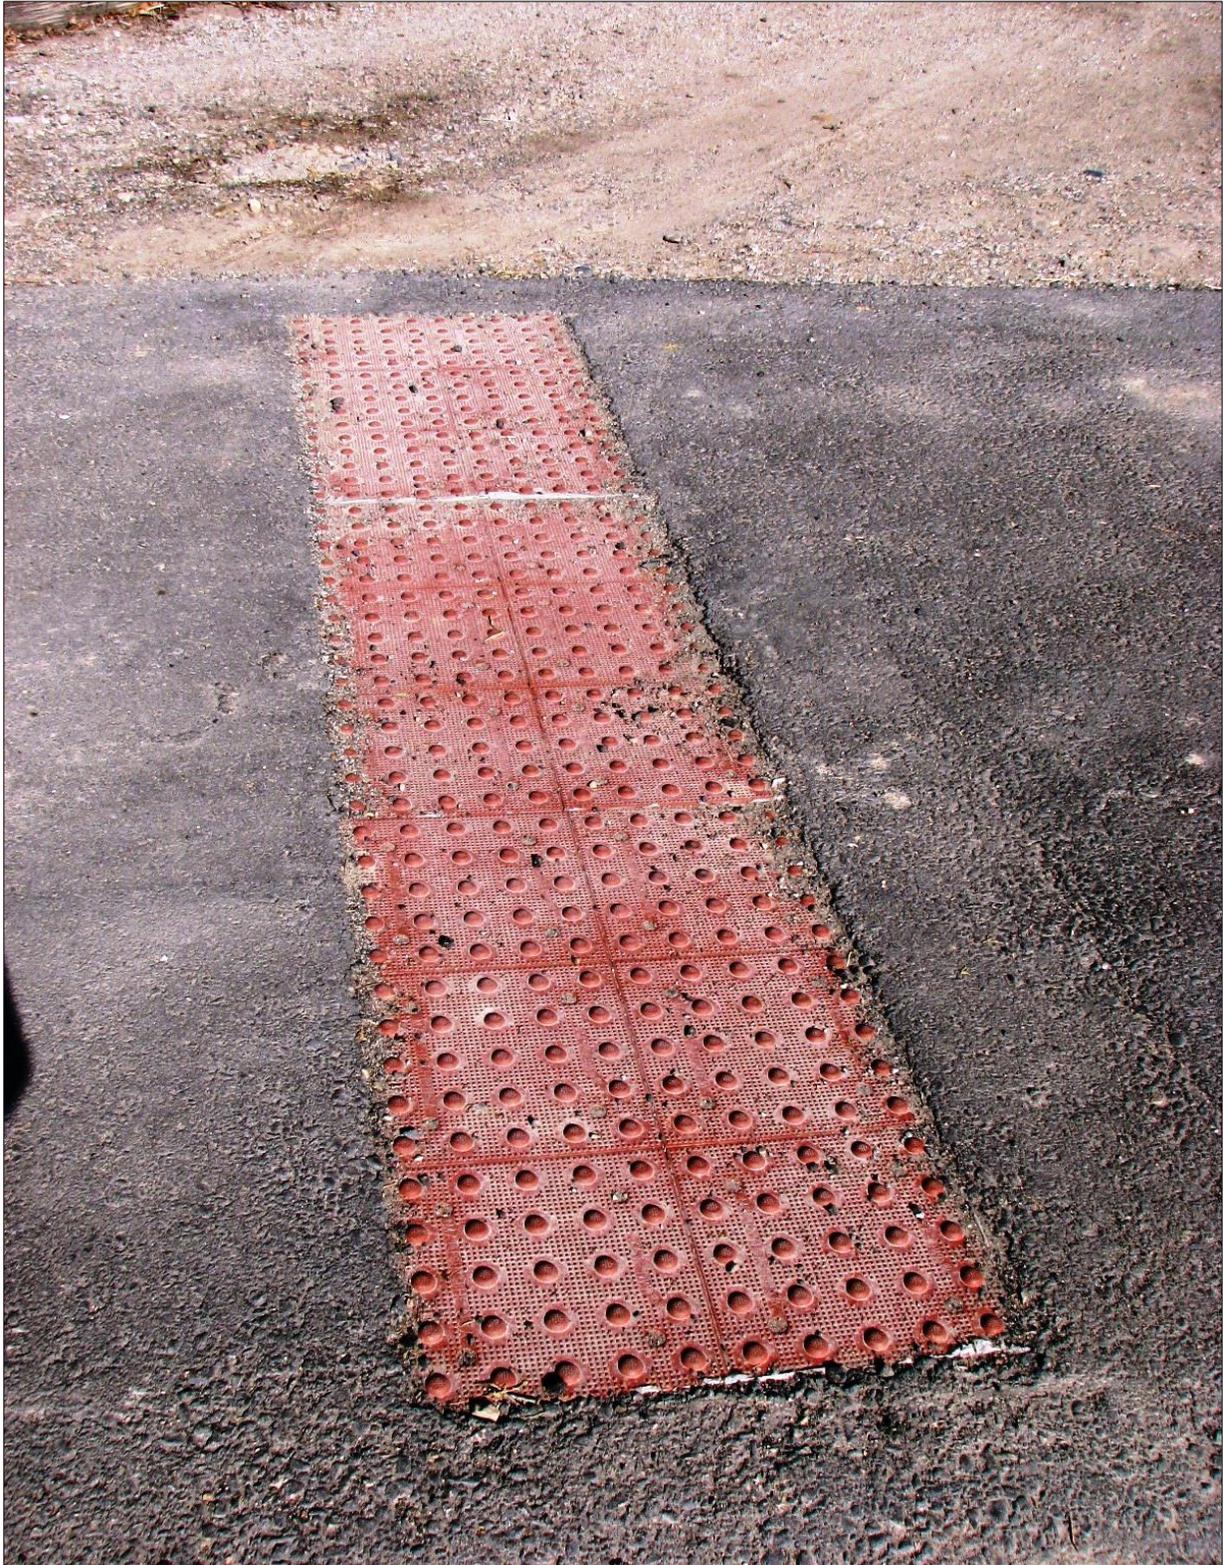
↑ Representative image of the cast-iron DWD placement. All sites exhibited no visual distress. All eleven (11) panels were in tight with no evidence of debonding or faulting with the asphalt cement (AC) base.

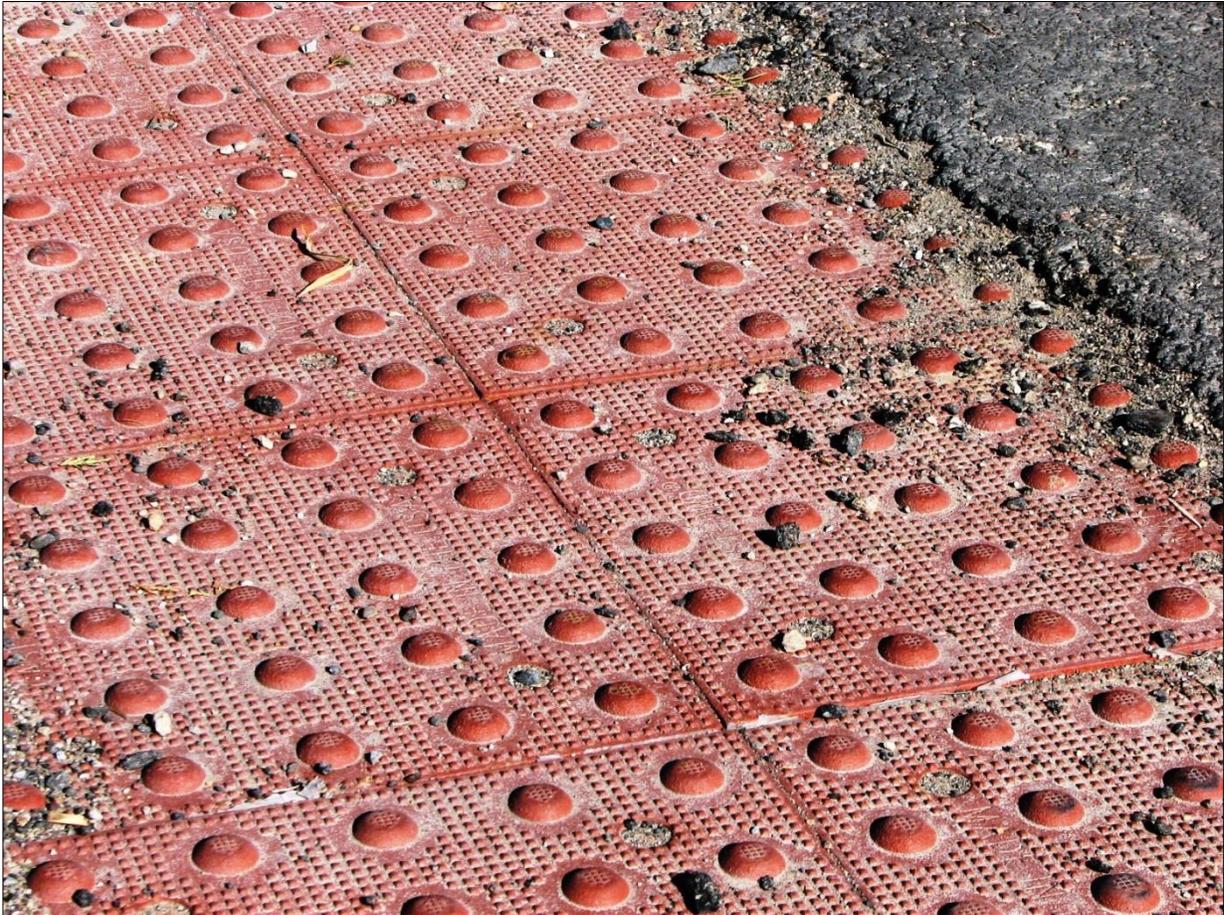
↑ Close-up of panel domes. It is unclear on how the Three Forks installation was maintained if not at all. The powder coating on all sites were undisturbed, if a fixed-blade had been used you may see some abrasion on the exposed domes.

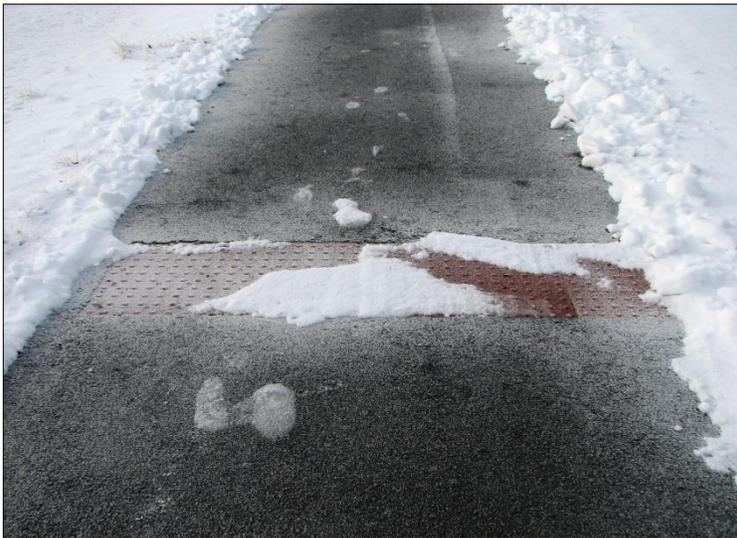
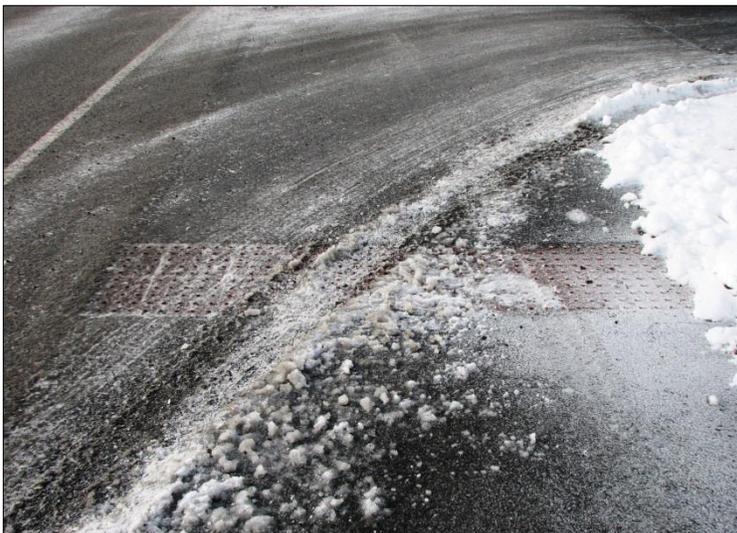
↙ This is the DWD unit at the northwest corner of the entrance of the Three Forks Market on Jefferson River Rd.

As you can see this unit is actively being driven by vehicles entering the store's parking lot.

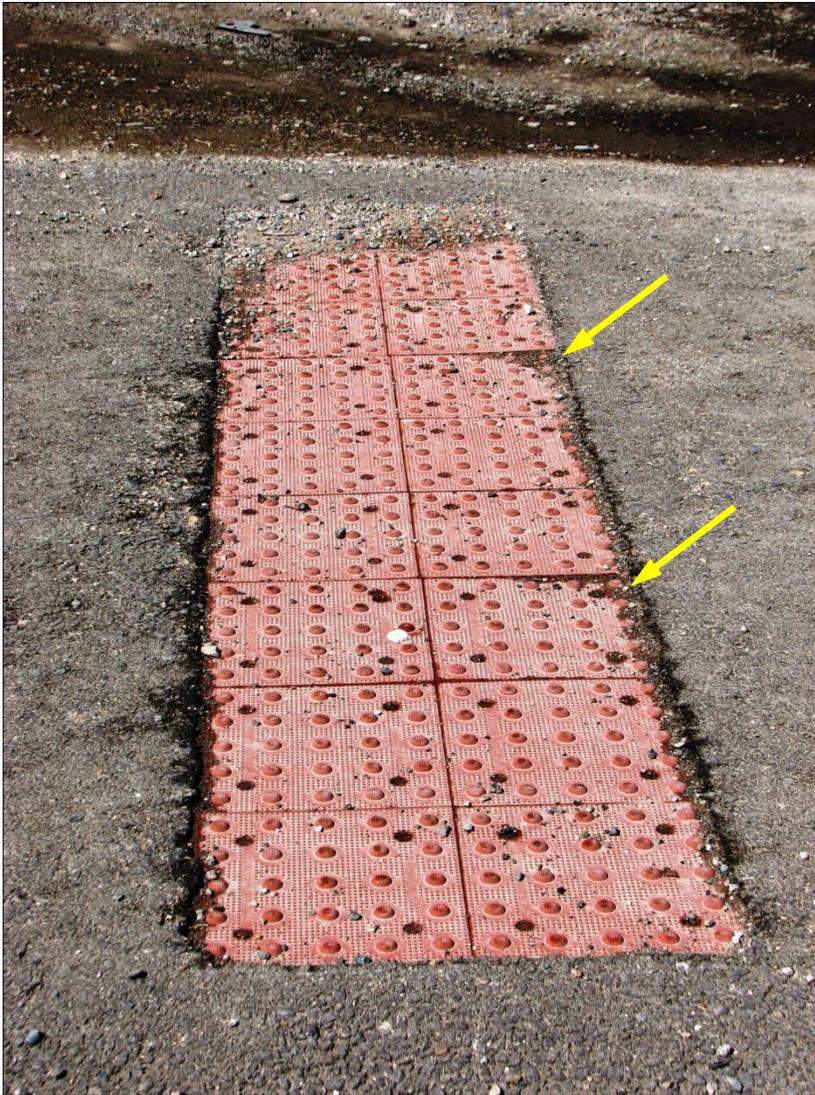
← One DWD unit had a noticeable depression (yellow arrows) at the edge of the connection plates.

Since snow removal is done by truck-mounted plow this apparent faulting may be the cause of the vehicle weight pushing the edge of the DWD down.

The unit plates are connected by male/female tabs (see page 25), which may limit the indent to the extent as seen in this image.

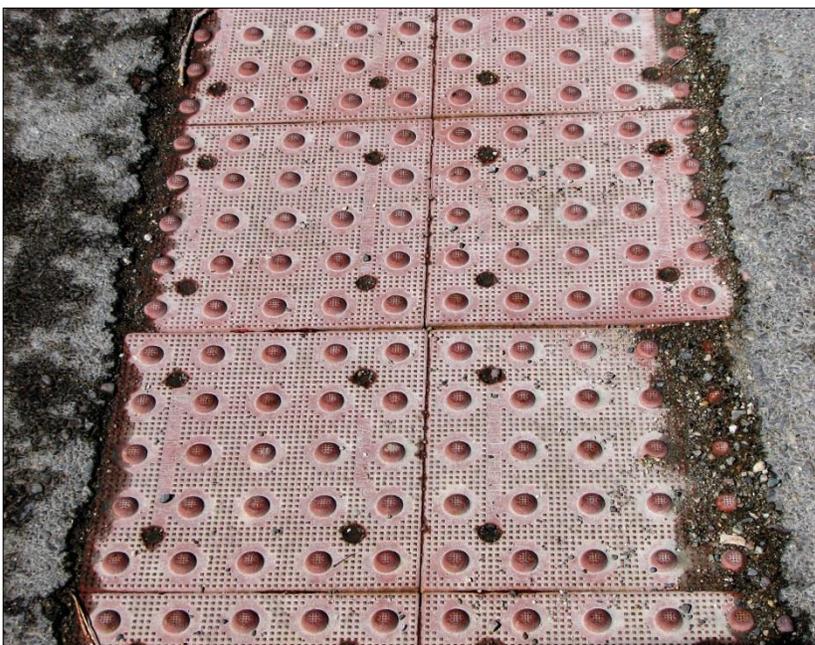
← Close-up in the shift of the cast-iron plates.
