EXPERIMENTAL EVALUATION REPORT

Thin-Whitetopping Bonded Composite

Location: Glendive, Montana – Dawson County

Project No.: STPP 20-1(6)0 P-20, Highway 16, Milepost 0-.6

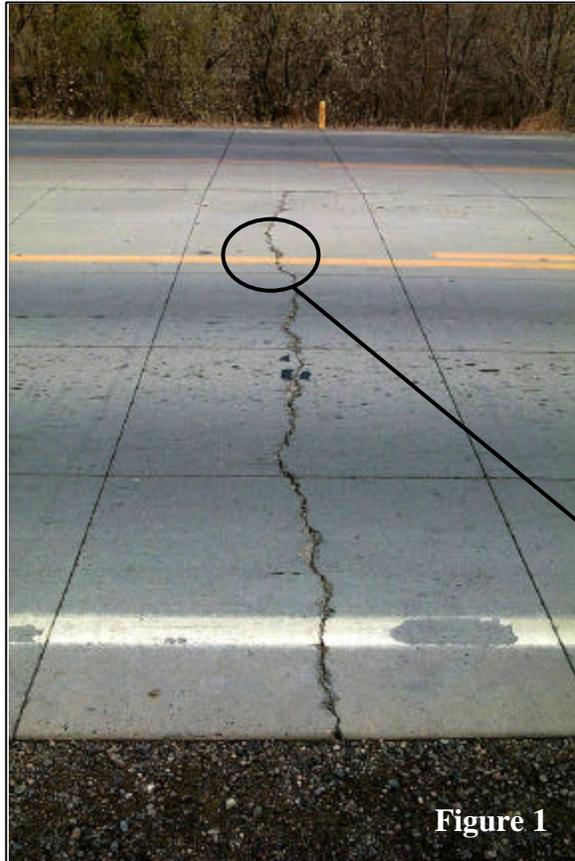
Figure 1

construction. These cracks are widening rapidly since construction and are rated as severe in nature (example of crack in figure 1). Incompressible debris (rocks, friables etc.) are entering the cracks and will accelerate the deterioration of the fracture with freeze thaw events. It is suggested that these cracks be sealed in some manner to delay further damage.

Currently three transverse cracks are present on this project, all in the southbound lane. Location as follows (footage counted from the south end of the project going north), #1 at 1244' (541m), #2 at 1380' (420m), and #3 at 1480' (451m). Note that these cracks developed soon after placement during

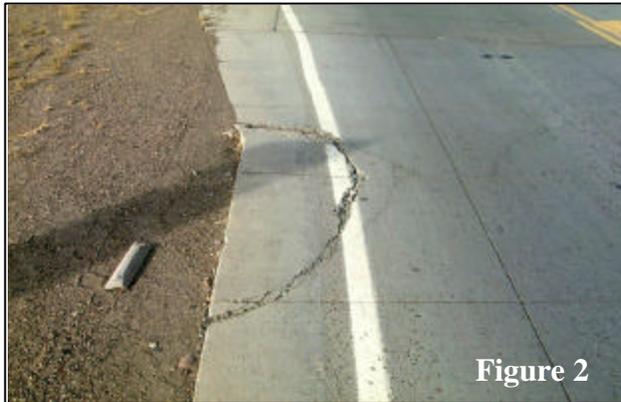
Additional panel cracking was located on the north end of the southbound lane on the west side of the road. It was originally observed that large truck traffic exiting off the interstate (due to the angle of turn) would roll over this section half on the pavement and partially on the gravel shoulder. The main reason for cracking at this location may be due to the lack of supporting shoulder and heavy loadings. The cracking pattern also reflects lack of

support. Figure 2 shows the most recent area of cracked panel that was first documented in the 2002 evaluation. Truck tire imprints can be seen in the gravel. Figure 3 is the condition of the panel in 2002. This area has expanded into two additional damaged panels (figure 4). The cracks have been superimposed with a dark line for better visibility. Due to the nature and location of the cracking, this area will most likely deteriorate to the point in which it will require repair of the pavement.

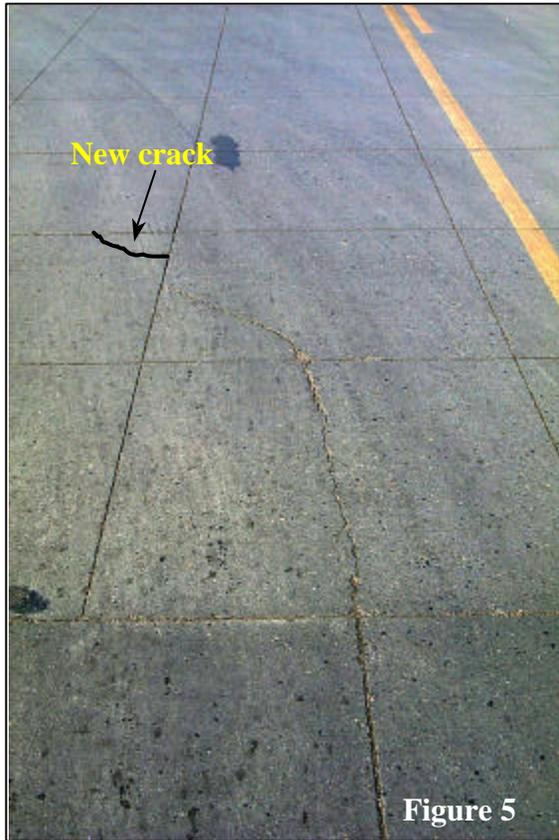
Cracking appeared at the south end of the project on both southbound and northbound lanes. This cracking was located adjacent to the full-depth PCCP at the Towne St. intersection (P-57), the cracks within these panels line up directly with the saw cuts on the full-depth PCCP (as seen in figure 5). This cracking is sympathy stress from

the full depth pavement. Installing a bond breaker between the full depth and whitetop sections may have alleviated this condition or (if possible) matching up saw cuts with the whitetopping and full-depth pavements.

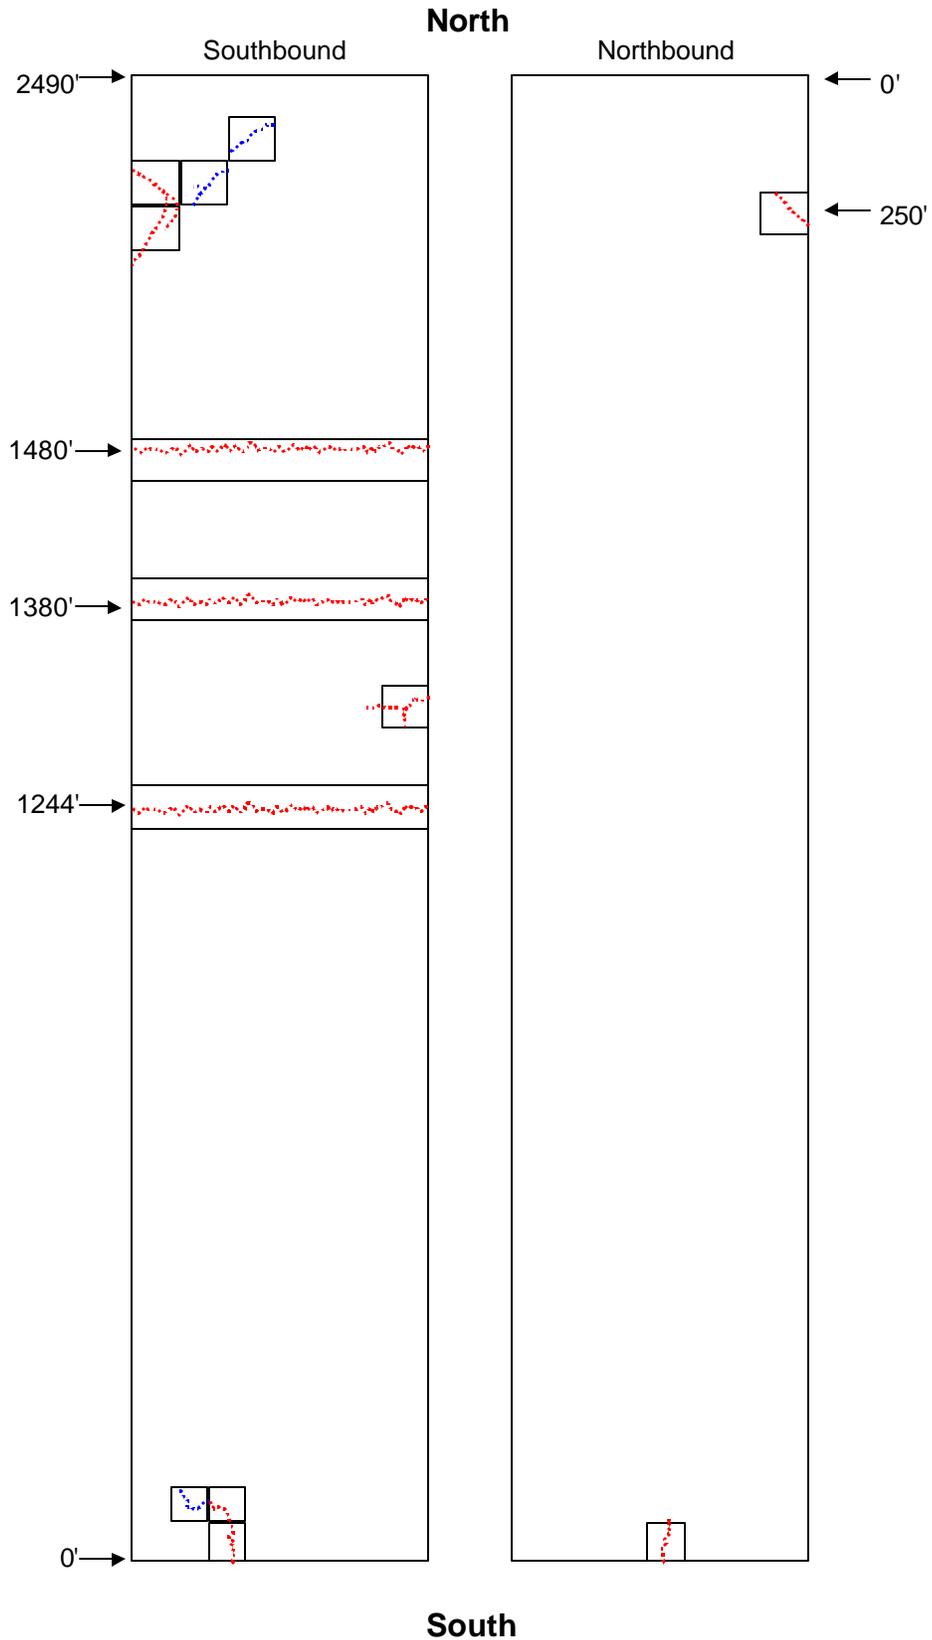
Glendive Whitetopping Representative Crack Map

various causes of cracking; which could entail debonding of the PCCP from the asphalt concrete, structural failure of the underlying AC layer, overloading of the composite panel or sympathy cracking. In addition, some panels that have cracked are at the curb edge. This lack of support, may have allowed cracking at these locations (refer to the crack map at the end of this document). The mid-way crack in the southbound lane
