ANNUAL EXPERIMENTAL EVALUATION REPORT

Thin-Whitetopping Bonded Composite

Project No.: STPP 1-2 (93)121, East Idaho St.

Evaluation Date: July 2008

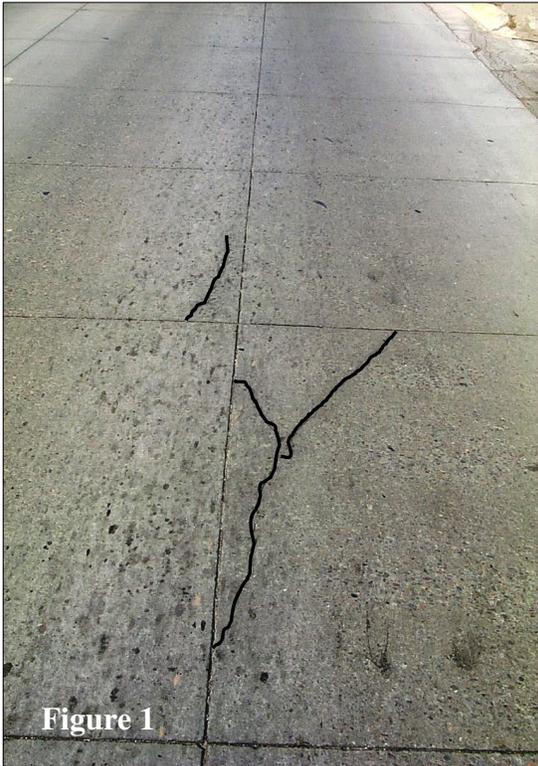
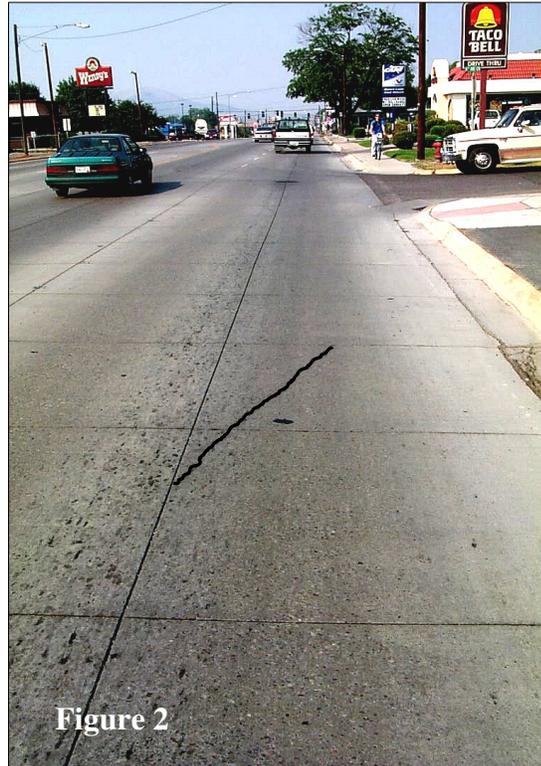
The overall appearance of the whitetopping is good. Thirty-one cracked panels were documented in the 2007 report. Seven additional panels were documented during this evaluation. The majority cracks are hairline in nature with no vertical displacement or debonding of the composite panels. Several cracks appeared to be at a ¼ " wide width or more. At this time, there is no indication of a pattern or reasons for the randomness of the cracked panels; therefore, it is premature to

Figures 1 & 2 are examples of the in-lane, hairline cracks. A black line has been superimposed over the images to better see the lay of the crack. It has been estimated that this project contains over 4200 sawed panels with an approximate Thirty-eight (38) panels exhibiting minor cracking since construction which represents a .009% of the entire project.

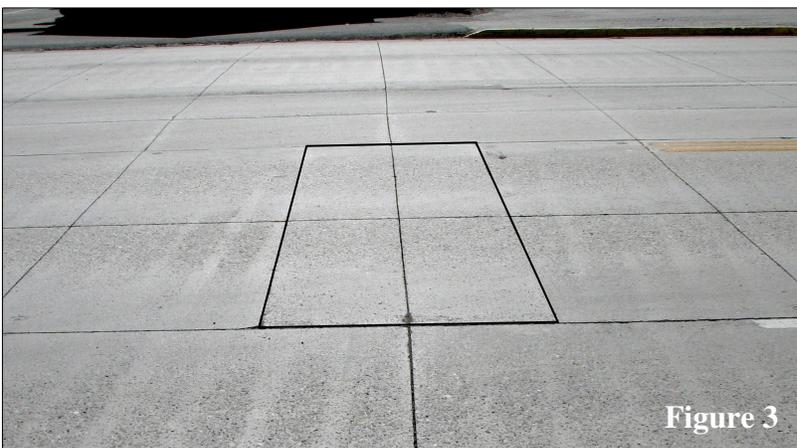
Figure 3 shows the performance of the doweled PCCP patch placed during construction due to un-consolidated concrete by lack of adequate vibration (documented in the project construction report). The black outline is the area of repair. Visual observation of traffic moving over this section displayed no

faulting or movement of the slab. At this time, no visual surface distress was noticed. This repair is approximately located in the center section of the westbound lanes 2 meters past the intersection of 6th Avenue EN and East Idaho St.

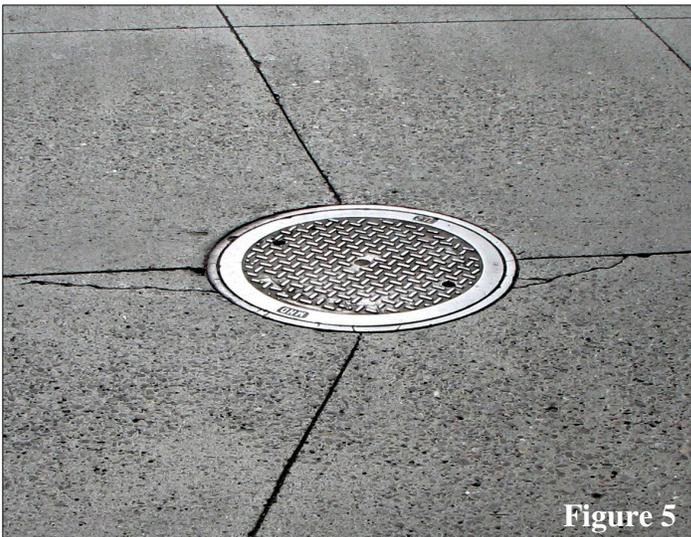
Minor spalling is beginning to appear but at a frequency that is not an issue to date. It was observed that cracking is beginning to appear around several of the manholes on the project. No debonding or faulting has been seen with traffic moving over those items. Figure 5 is an example of that distress.

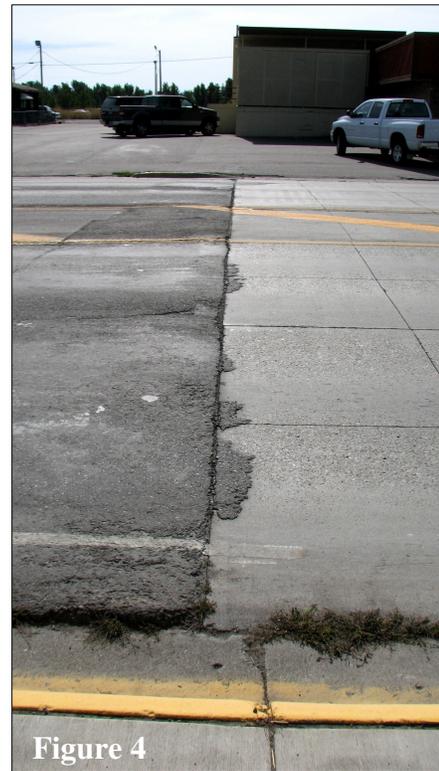
Figure 4 is showing the east-end transition area of the project. It is important to point this feature out due to the innovative way this approach was placed, please refer to the construction report for details. No evidence of distress to the east or west transitions was noticed during this evaluation.

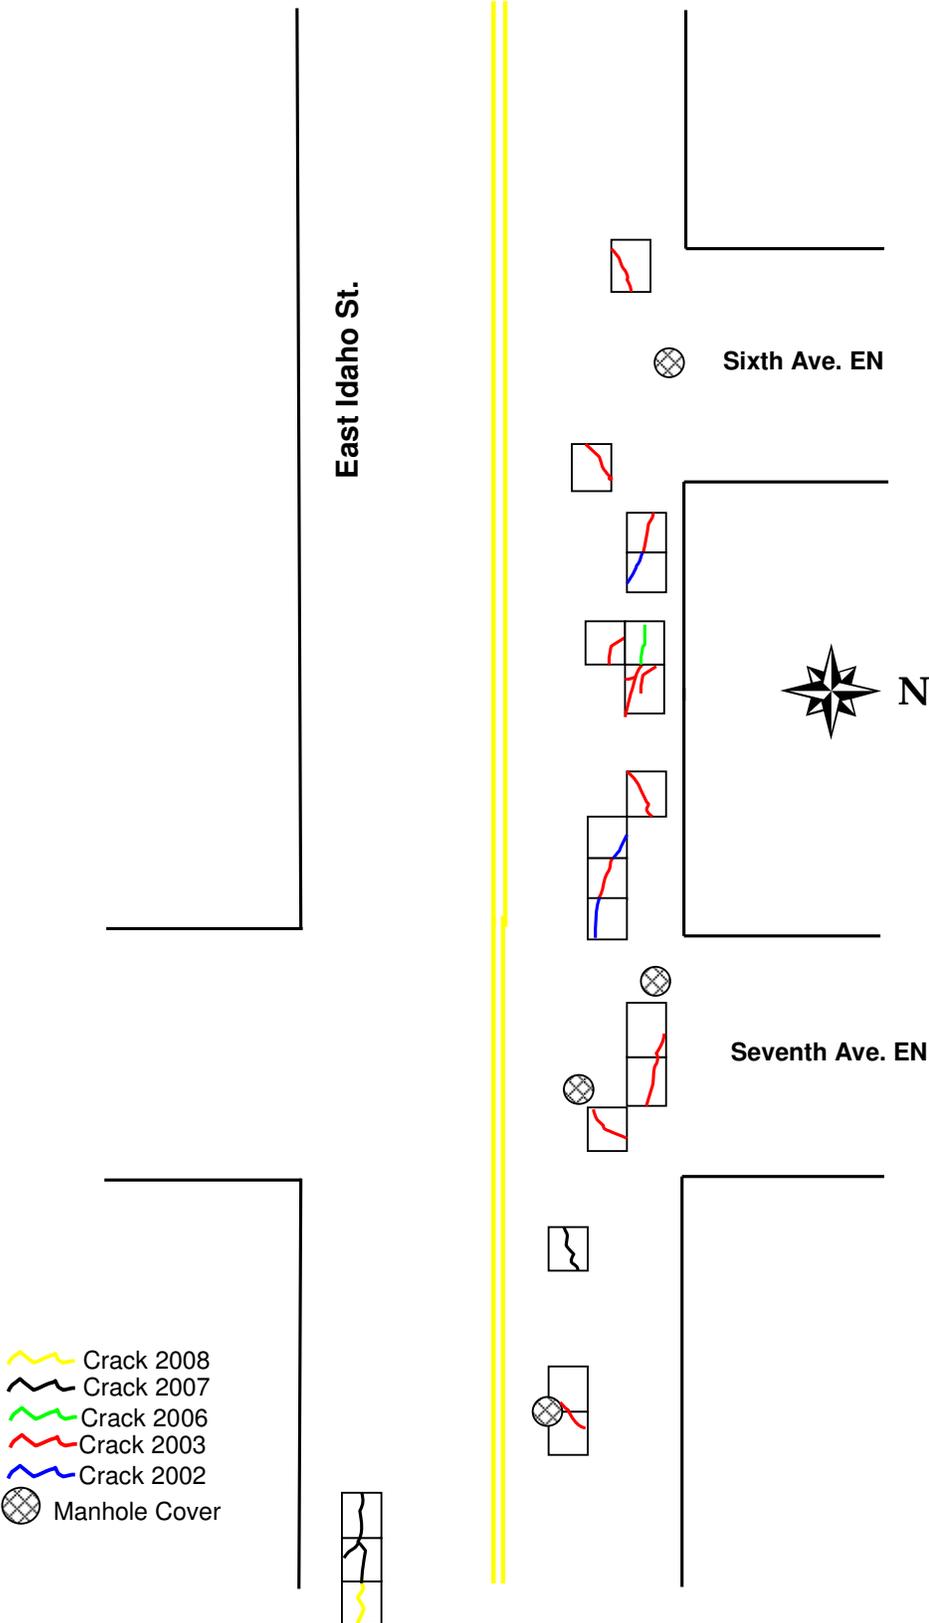
attempt to ascertain a cause. It should be noted that the majority of the cracking occurs on the north half of the project, west-bound (which was placed first) between the streets of 8th Ave. EN and 6th Ave. EN. The west half of the project is beginning to exhibit panel cracking. Refer to the crack maps at the end of this report for a general representation of cracked panel locations and the relationship of how the crack is located within the panel itself. The crack map is strictly an illustration of approximate crack locations over time within the project. It is not to scale.

Thin-Whitetopping Overlay Composite - STPP 1-2(93)121 East Idaho St., Kalispell Montana
Representative Project Crack Map - Approximate Location - Not to scale
Note: Crack map only shows portion of project which contains distress information

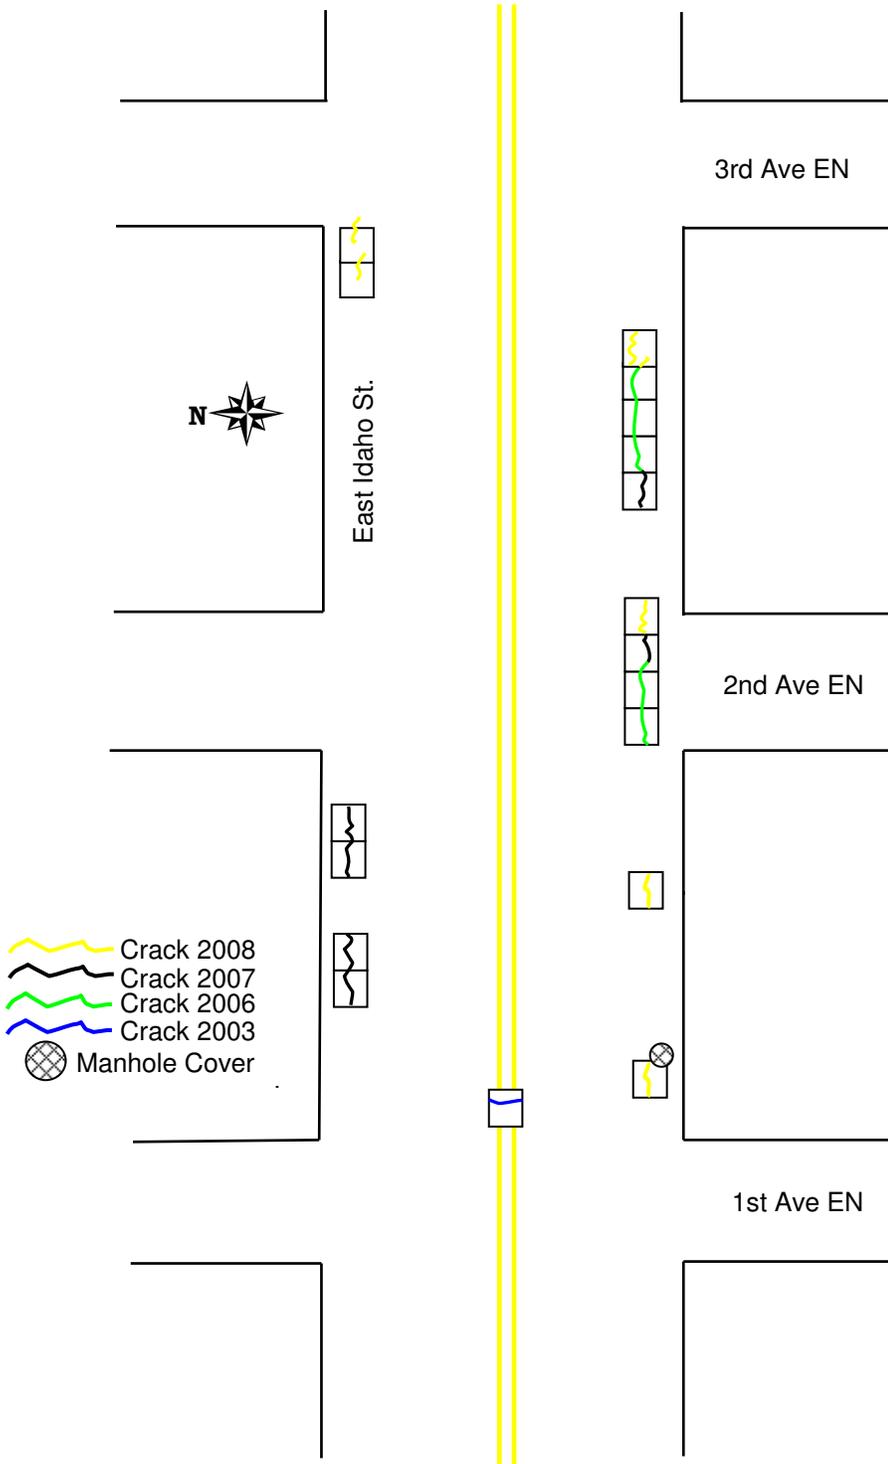
Thin-Whitetopping Overlay Composite - STPP 1-2(93)121 East Idaho St., Kalispell Montana
Representative Project Crack Map - Approximate Location - Not to scale
Note: Crack map only shows portion of project which contains distress information
