Montana Department of Transportation
Research Programs
October 2008

Experimental Project Construction Report

HIGHWAYS FOR LIFE (HFL) CULVERT REHABILITATION PROJECT

Project Name: NH-HFL 8-1(30)23 MacDonald Pass Guardrail/Erosion

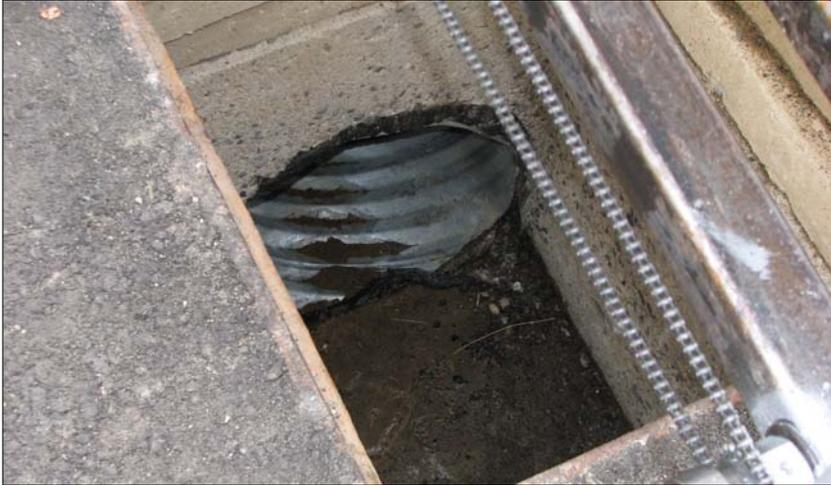
View of CSP inlet prior to insertion of CIPP liner. During insertion the installer does angle the incoming liner towards the opening as best as can be managed. The liner under pressure does follow the path of least resistance.

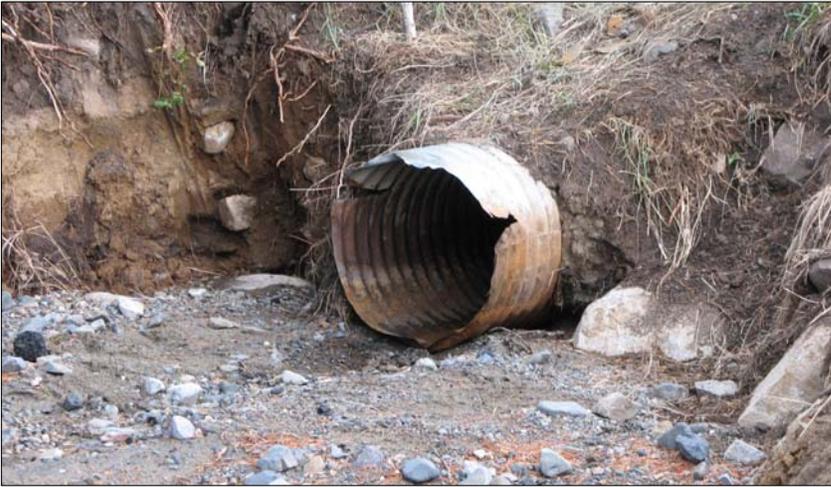
View of outlet end of a typical CSP on project.

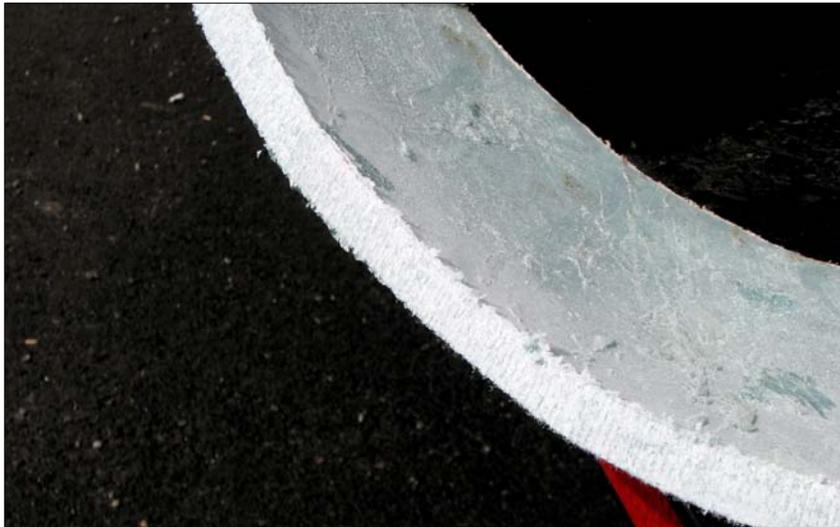
A close-up image of the fully cured CIPP. Note how all three polyester felt layers are bonded as one rigid composite. Average thickness of cured liner is at 5/8" (16 MM).

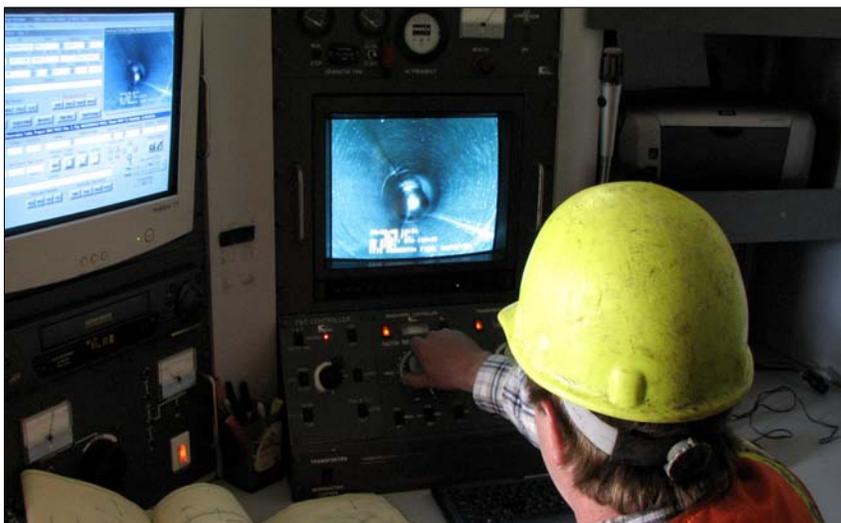
The contractor performs an interior inspection with a tractor mounted, remote-controlled closed circuit camera (CCTV) to insure proper placement of the CIPP.

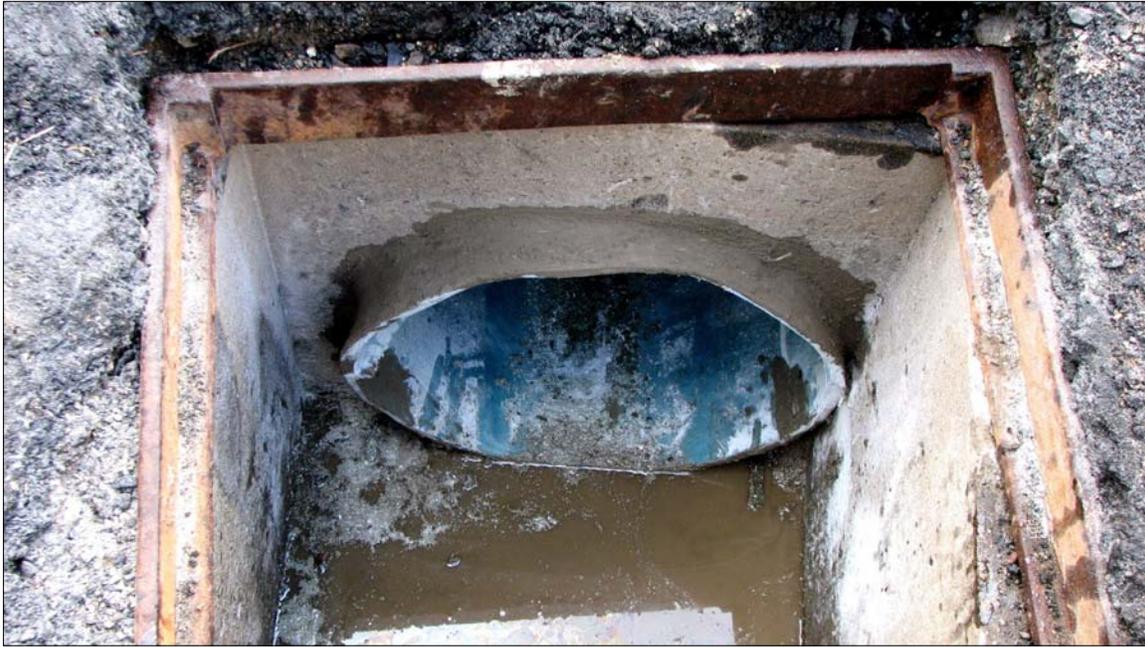
Completed CIPP at inlet

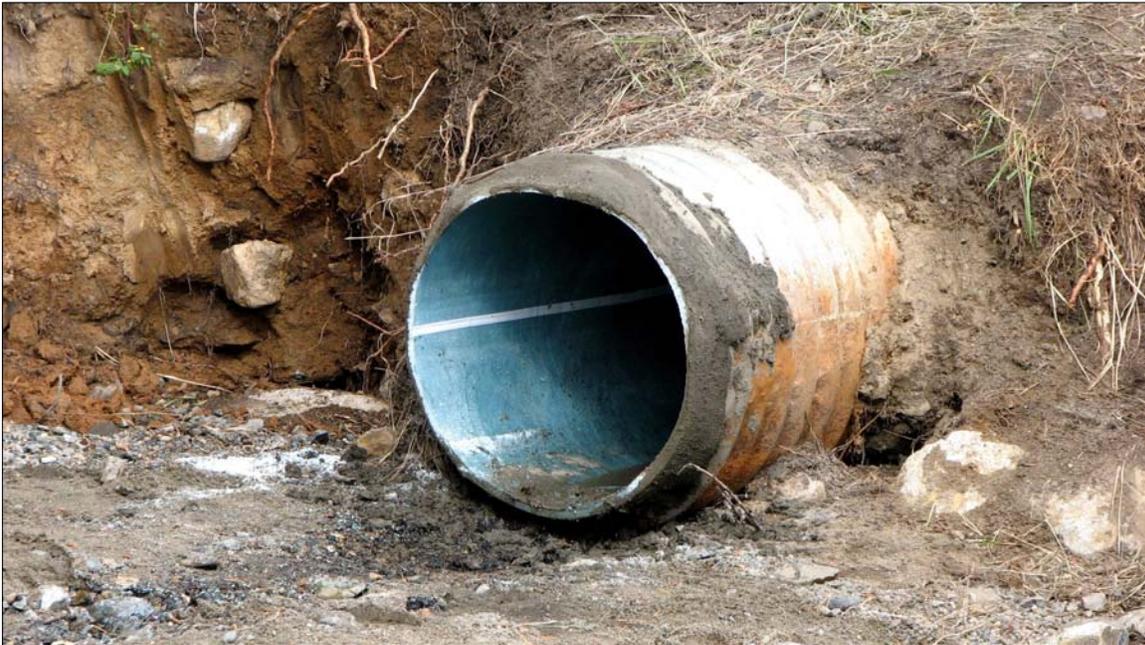
Completed CIPP at outlet. Fiber-meshed grout was used to seal the end treatments. Note that this type of culvert rehabilitation retains almost full capacity of the original culvert. Due to the reduced roughness of the liner (height loss of corrugation of the CSP due to the CIPP) may improve the hydraulic characteristics of the culvert; but that is speculation.

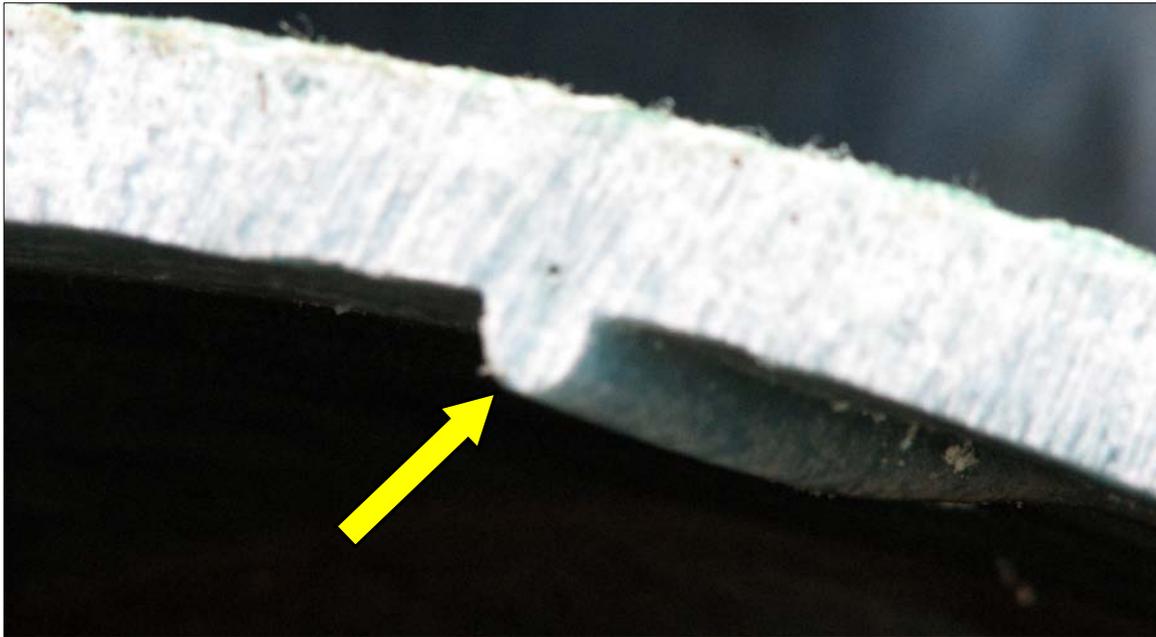
A condition called 'finning' may occur to the CIPP liner during insertion into the existing culvert. Finning is where the liner(s) may bunch up prior to curing and create a ripple in the polyester fabric or fin as seen in the below image (a cured section of excess liner). A severe fin may indicate a thinning or tear in the membrane of the liner which may affect performance of the CIPP. This condition is more of an issue with larger diameter liners than what was used on the MacDonald Pass project. Finning with less than 1 inch (25 mm) on the 24" lined CIPP is not considered a performance issue. No detrimental finning was found on any of the CIPP installations.

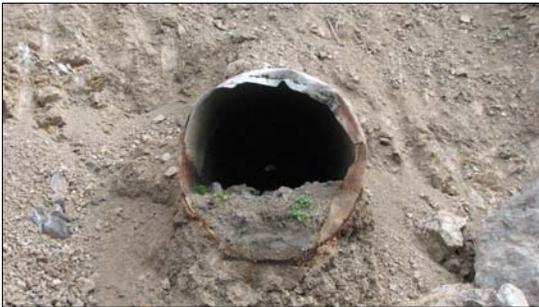
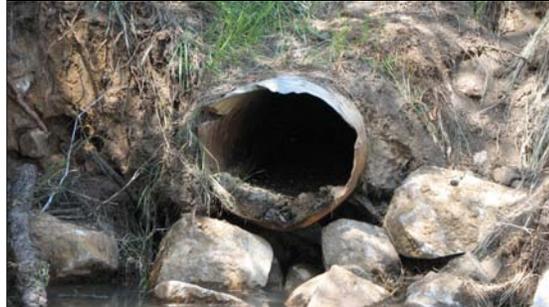
Prior to the installation of the liners, the contractor was required to clean the culverts of all accumulated debris. Initially a directional borer with an auger head began the cleaning phase but proved to be ineffective. The procedure was switched to high pressure jet wash which adequately cleaned the culverts for the insertion of the CIPP and HDPE liners. Below sample images of a few of the culverts prior to cleaning.
