Experimental Project Construction and Evaluation Report

EVALUATION OF VARIOUS PAVEMENT FABRIC AND MAT APPLICATIONS TO
RETARD REFLECTIVE CRACKING

Project Name: Flesher Pass - East
Project Number: STPS 279-1(15)22: Control No. 6234000
FHWA Project Number: MT 00-18
Project Location: Secondary 279, C000279; RP 22.2-30.5, Lewis & Clark
County: Experimental site locations at RP 24
Description: Pavement reinforcement to mitigate reflective cracking on
hot mix asphalt (HMA) pavement
Date of Installation: September 2008
Principal Investigator: Craig Abernathy
Experimental Program Manager

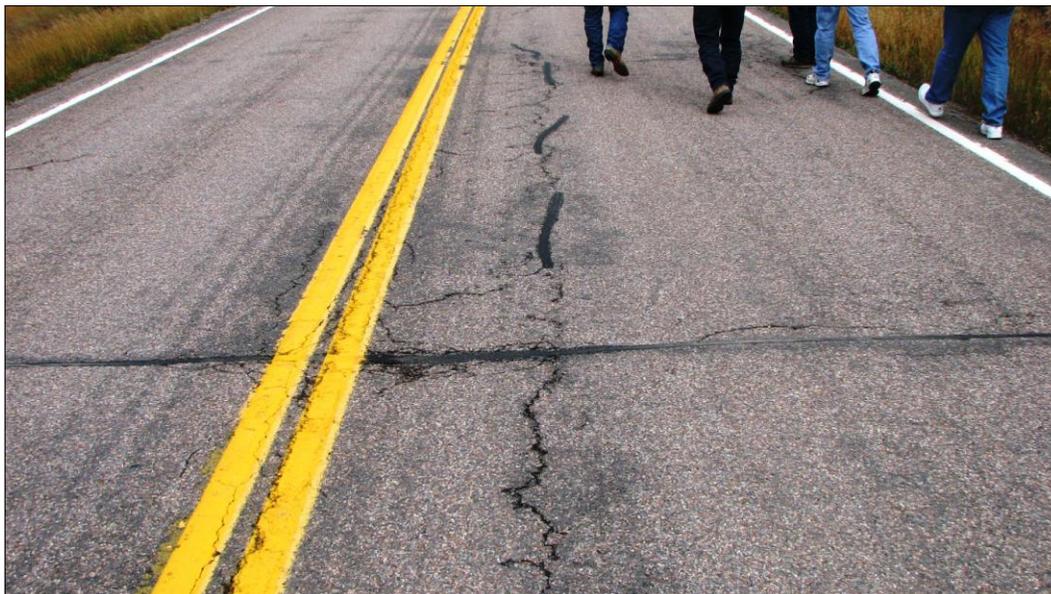
↑ Example image of pavement condition prior to construction

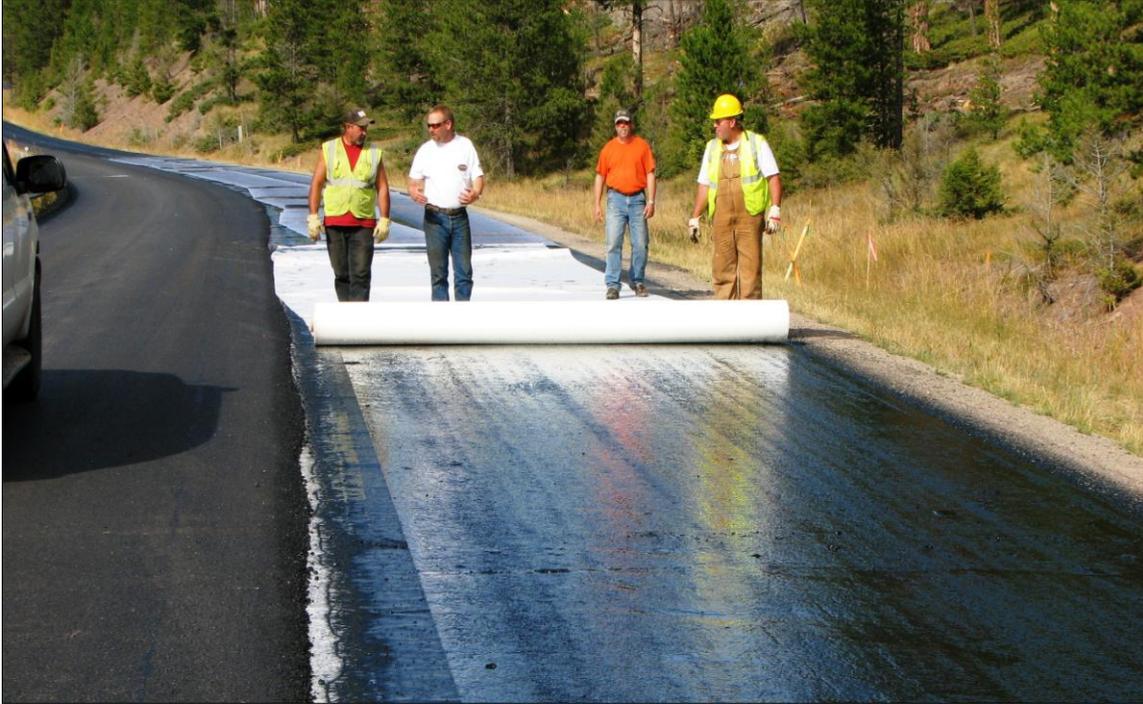
↑ Application of TruPave. A tack coat has been applied to the milled surface to adhere to the PVS. Workers manually rolled out the material.

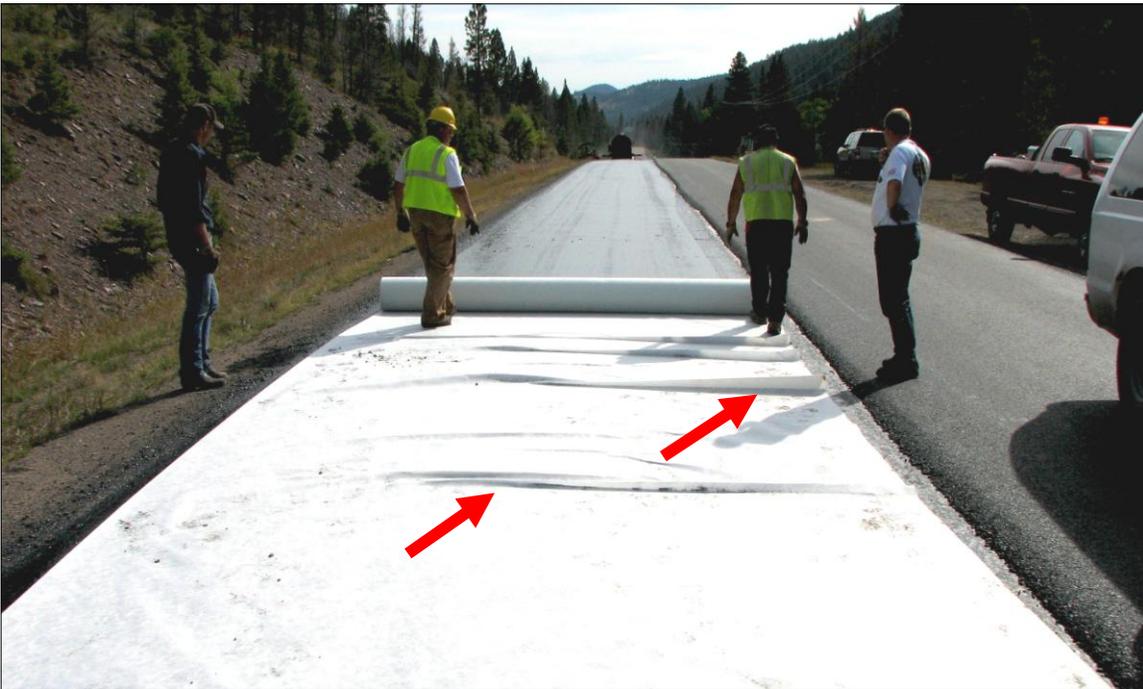
↑ Continuing application of TruPave. Note that the workers were unable to prevent fining or curling of the product to pavement (red arrows). Normally this material would have been applied using a vehicle mounted placement equipment which through tensioning would have eliminated the fining. Due to the short length of the test sites this was not feasible due to costs.

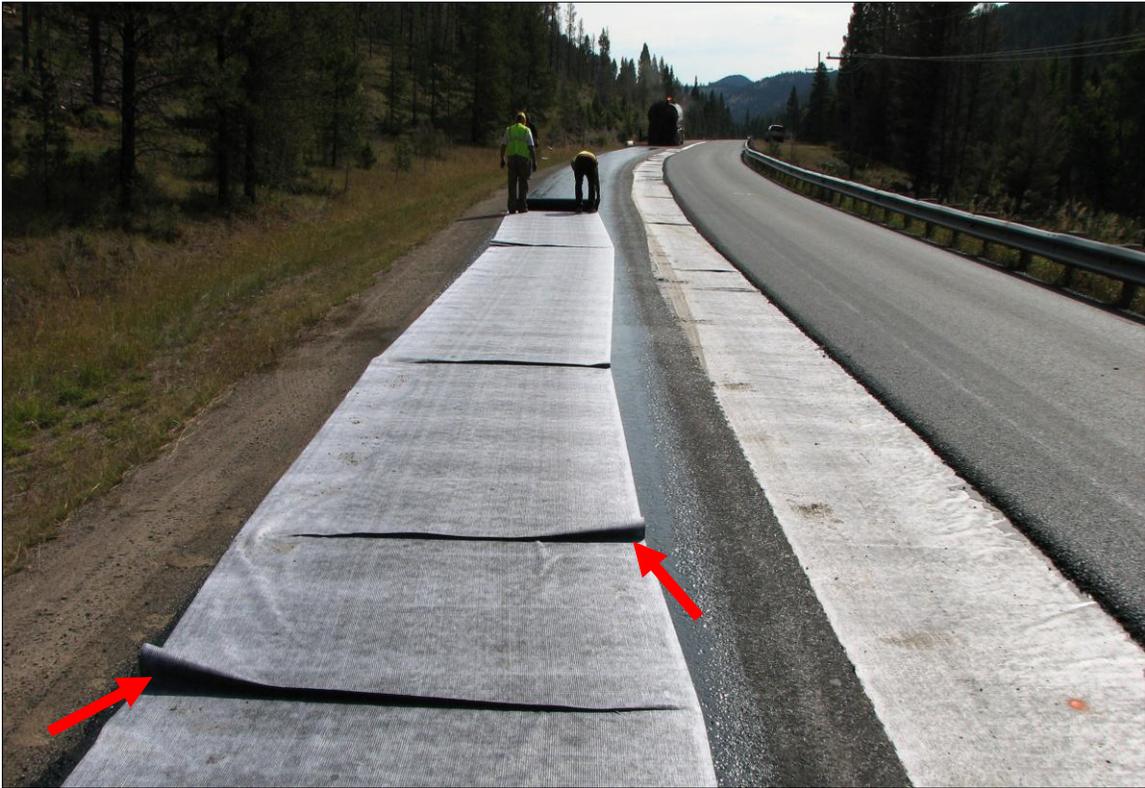
↑ Placing of GlasPave on tack coat. Note the large finning of the product while being rolled (red arrows).

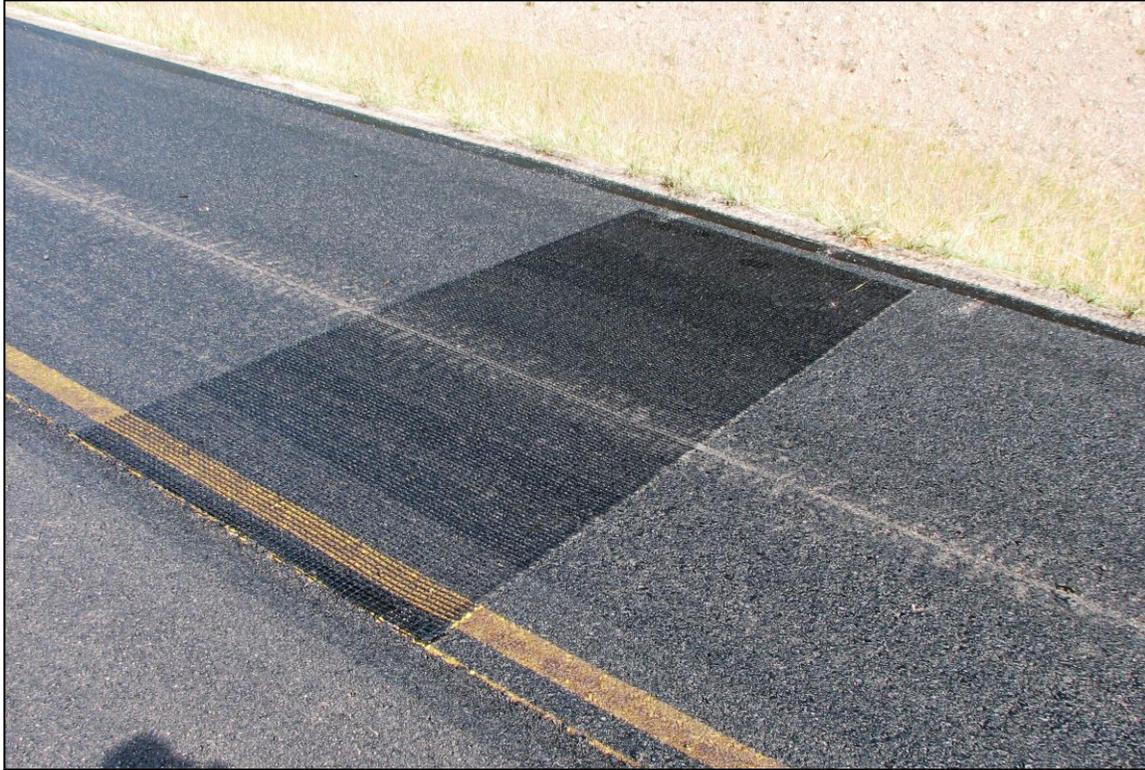
↑ Representative image of GlasGrid placement prior to application of HMA. GlasGrid was not a full lane application; applied only areas of known transverse cracking.

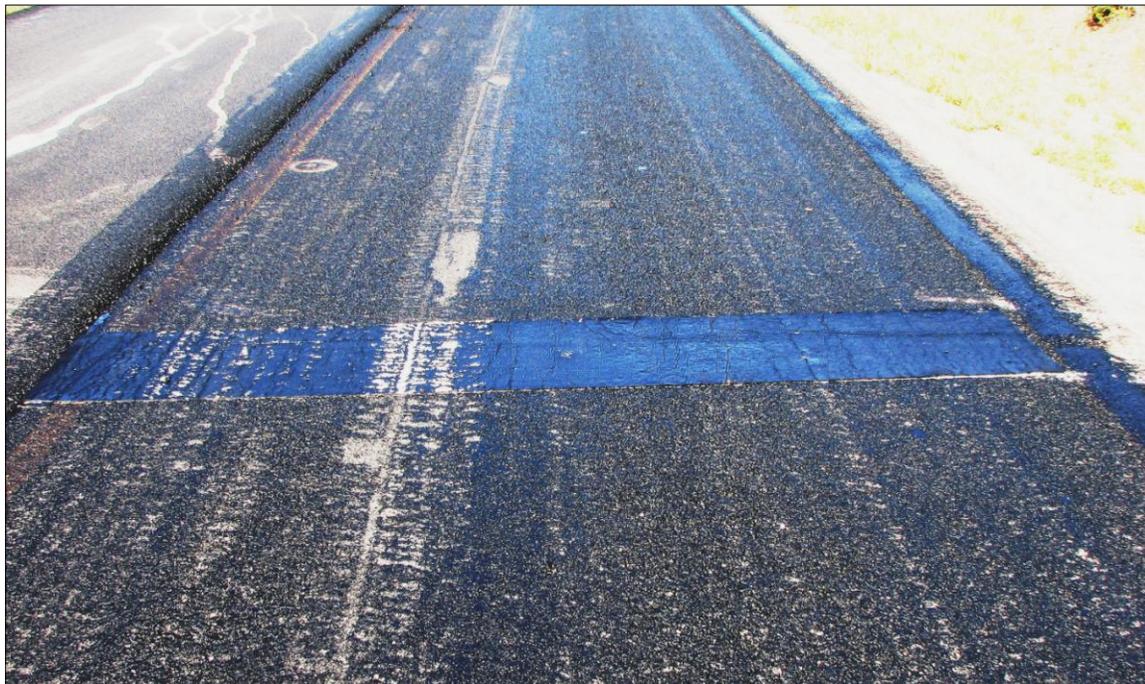
↑ Representative image of PavePrep placement prior to application of HMA. As with the GlasGrid installation, only the transverse cracking received treatment.
