Experimental Project Construction Report

**EVALUATION OF STRIETER-LITE WILD ANIMAL HIGHWAY WARNING
REFLECTOR SYSTEM™ ON REDUCING VEHICLE-ANIMAL COLLISIONS**

Project Name: Safety Improvement Project
Fencing – East of Whitehall

Project Number: HSIP 69-1(22)2

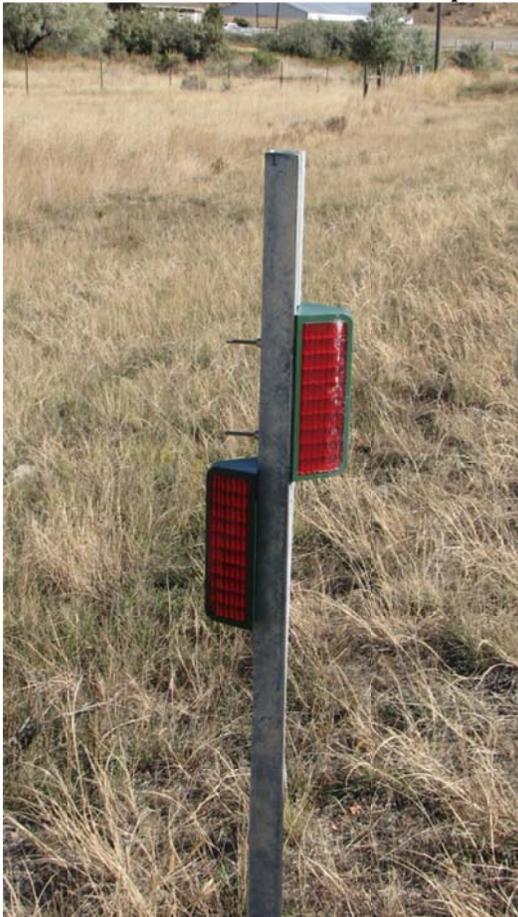
Installation followed Strieter Corporation instructions with post locations for the reflector system surveyed and marked by a Butte District construction crew. The installation method was an alternate back-to-back mounting method using standard U posts as seen in Figure 1. Post placement was staggered with spacing between posts ranging from 38 to 50 feet depending on the roadways inclines and curves (see Figure 2).

Figure 1- Alternate back-to-back mounting of reflectors

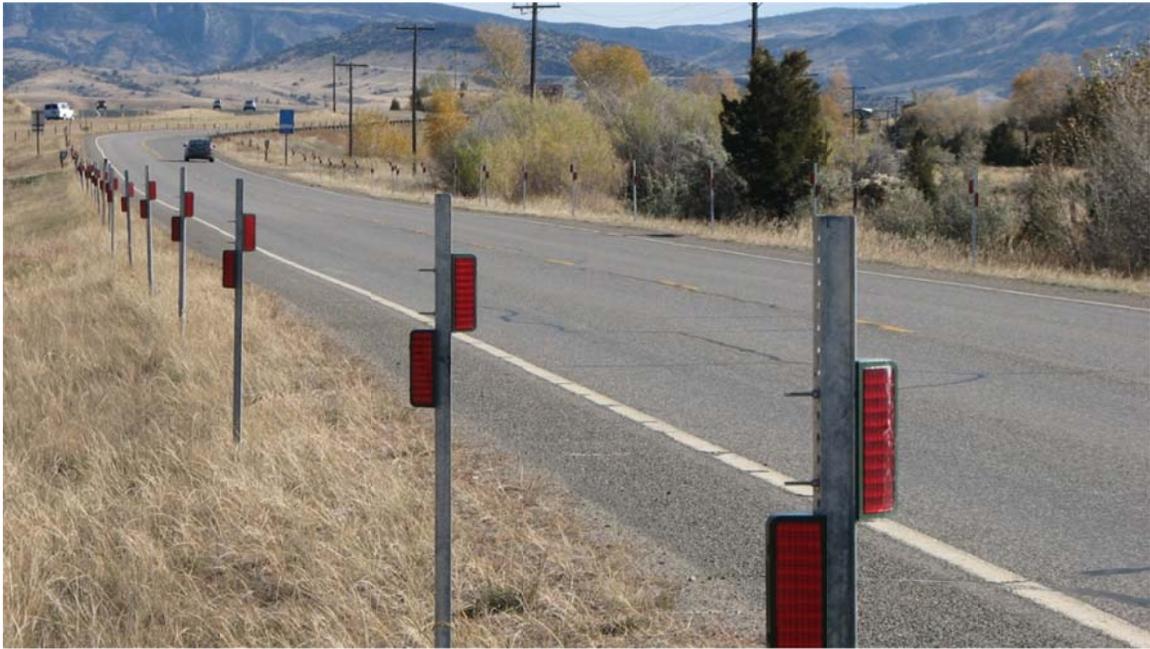
Figure 2- Staggered placement of reflectors

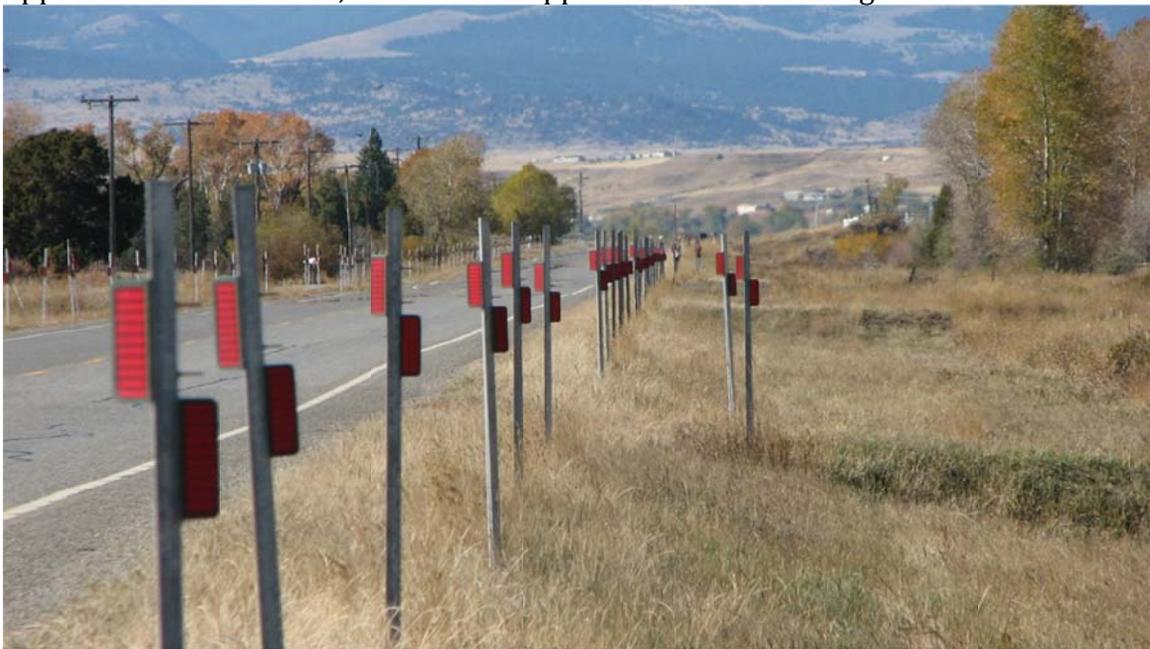
Additional reflectors were installed in areas where the roadside slopes downwards and when grade elevation is such that deer cannot view the reflectors on the opposite side of the road, such as near approaches as seen in Figure 3.

Figure 3- Additional reflector placement

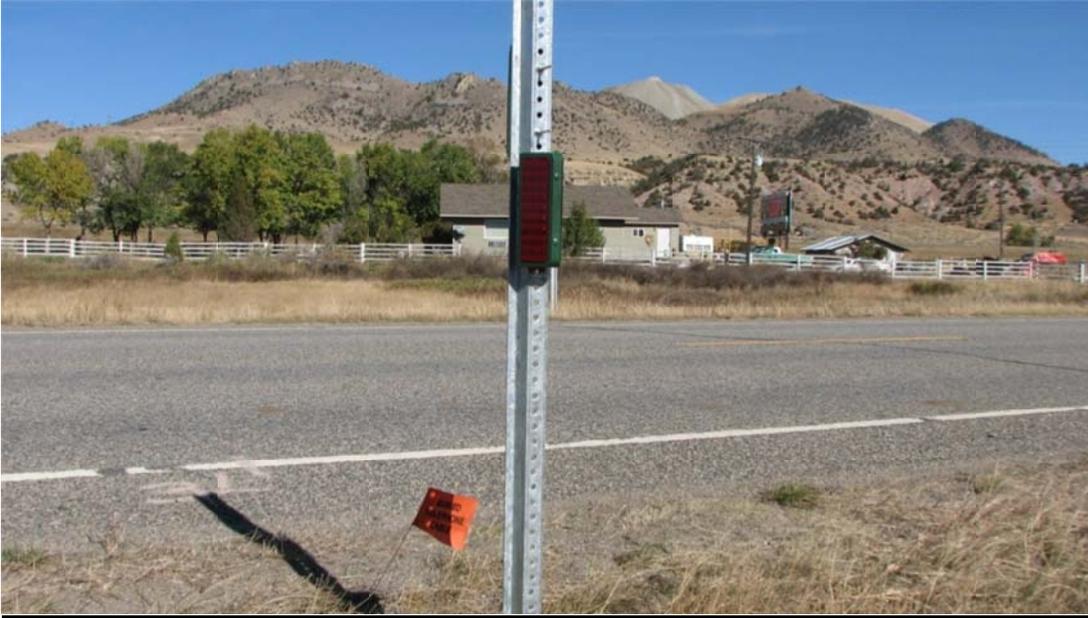
The westbound side of the road installation was done with a tractor driven post pounder; the eastbound side of the road was installed by hand due to utility locations. In addition, the eastbound side locations had to be resurveyed and moved because of utilities.

Figure 4- Reflector on eastbound side of roadway- notice the utility location flag and the surveyed location for post on road
