**EXPERIMENTAL PROJECTS FINAL REPORT**  
**URETHANE EPOXY PAVEMENT MARKINGS**

**Project Name:** Elk Park

**Project Number:** HWY-310386-RP

**Experimental Project No.** MT-12-02

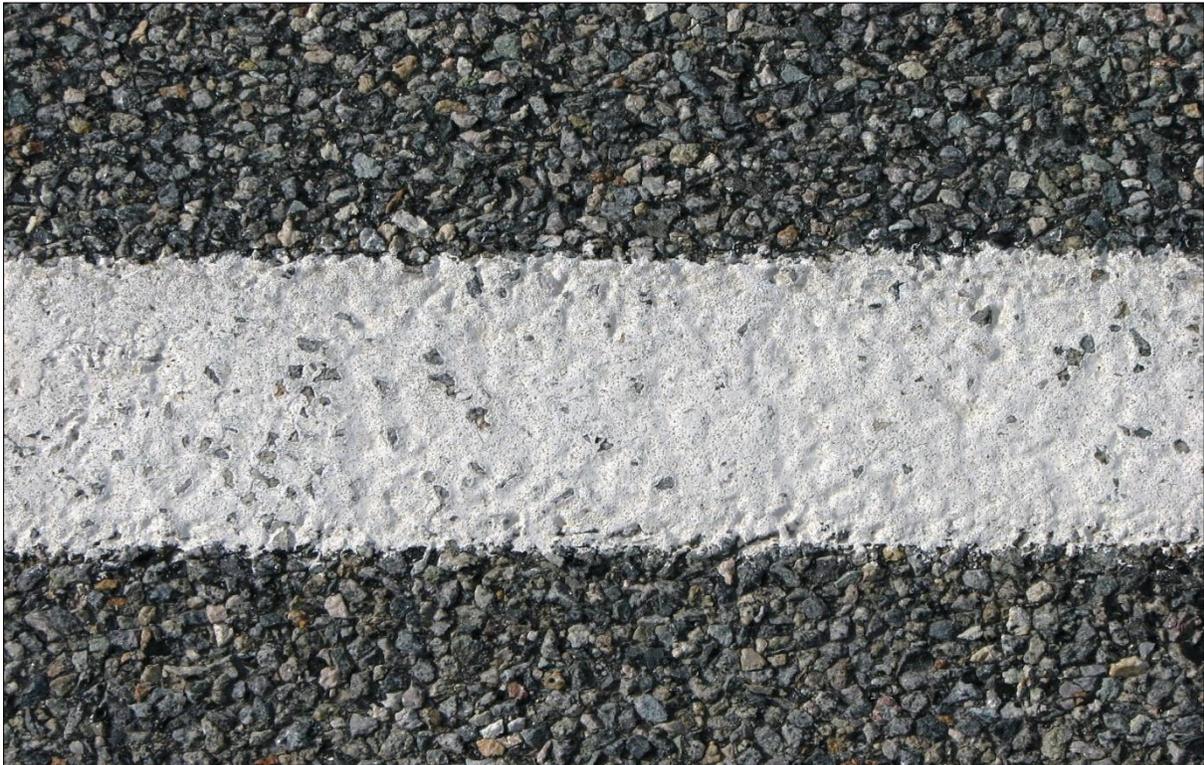
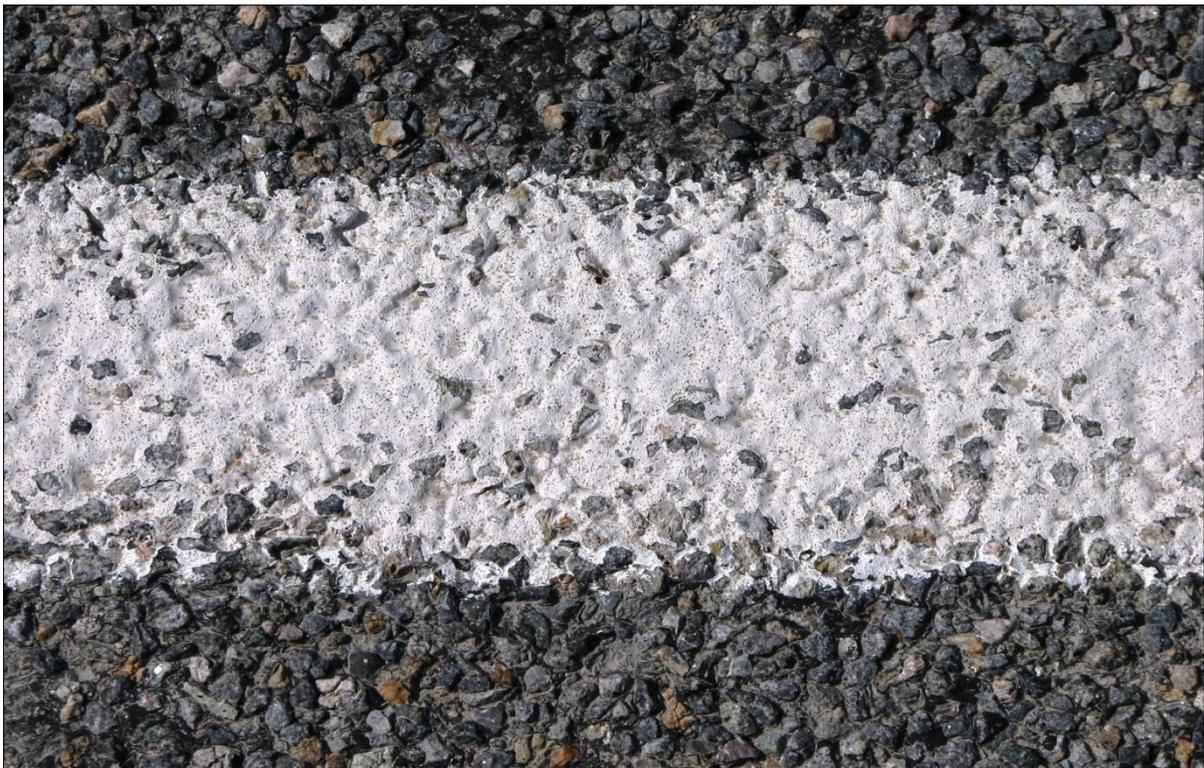
**Control Section: Poly-Carb Epoxy – Light Grind South Bound (SB) Lanes MP143-153**

↑↓ Representative images of the Poly-Carb SB control section prior to the new markings application.

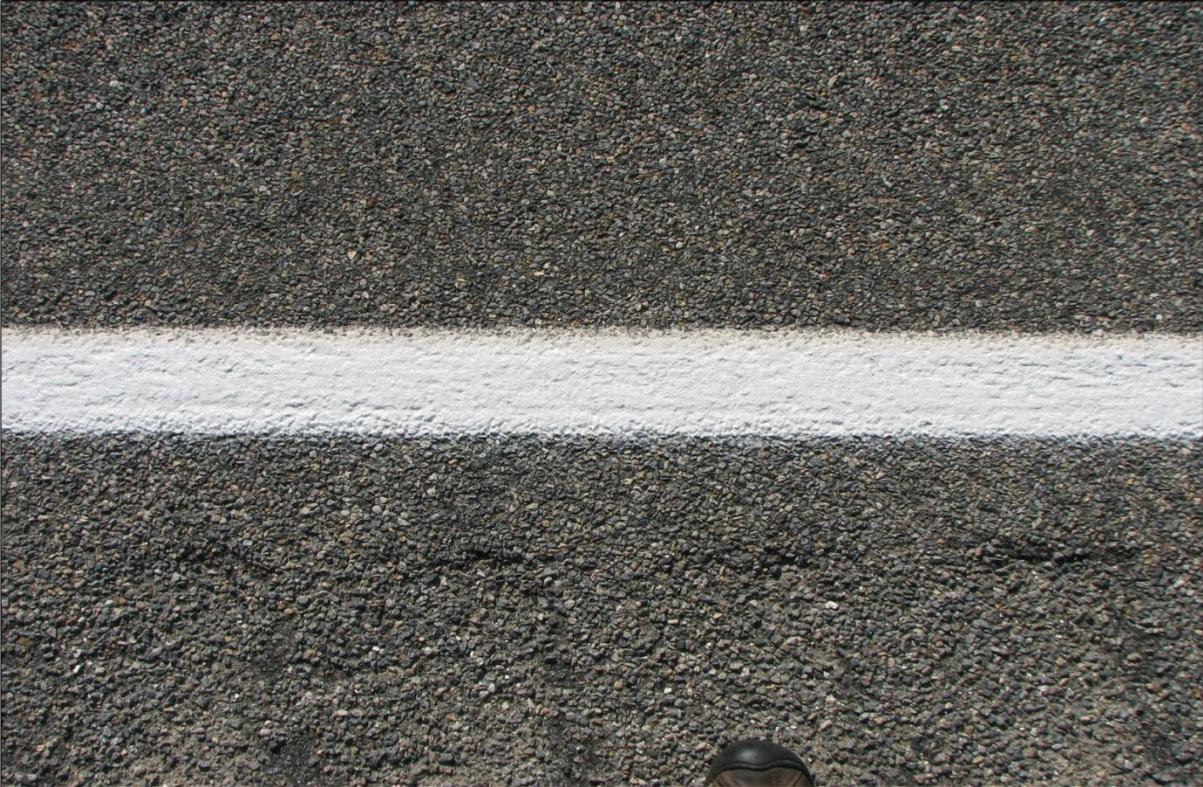
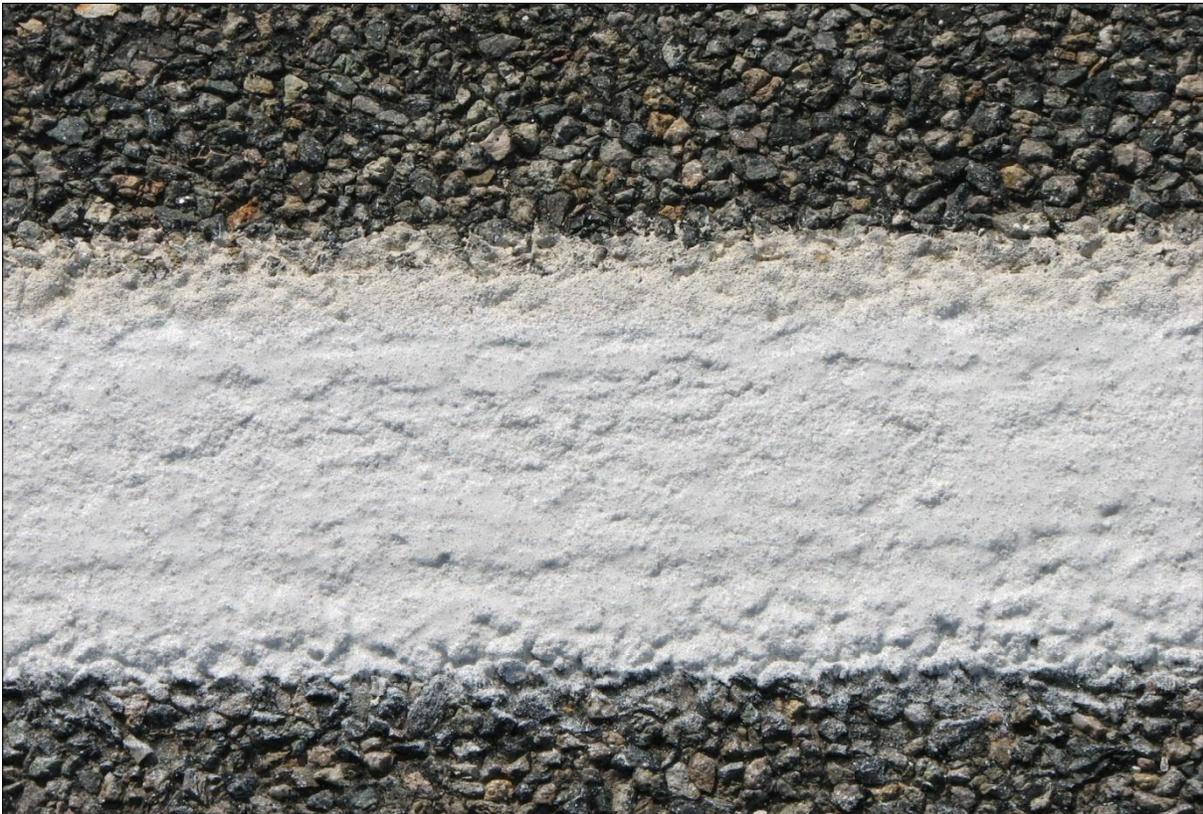
↑↓ Representative images of the Poly-Carb SB control section after the pavement marking application.

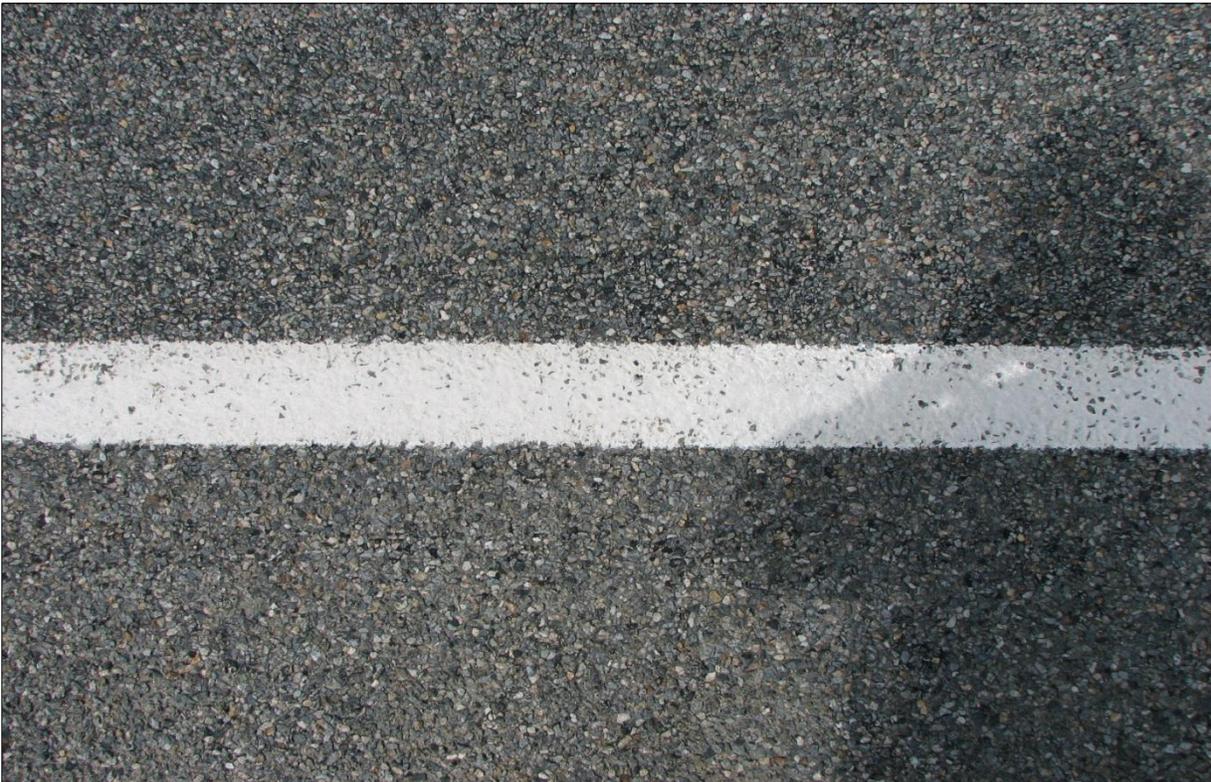
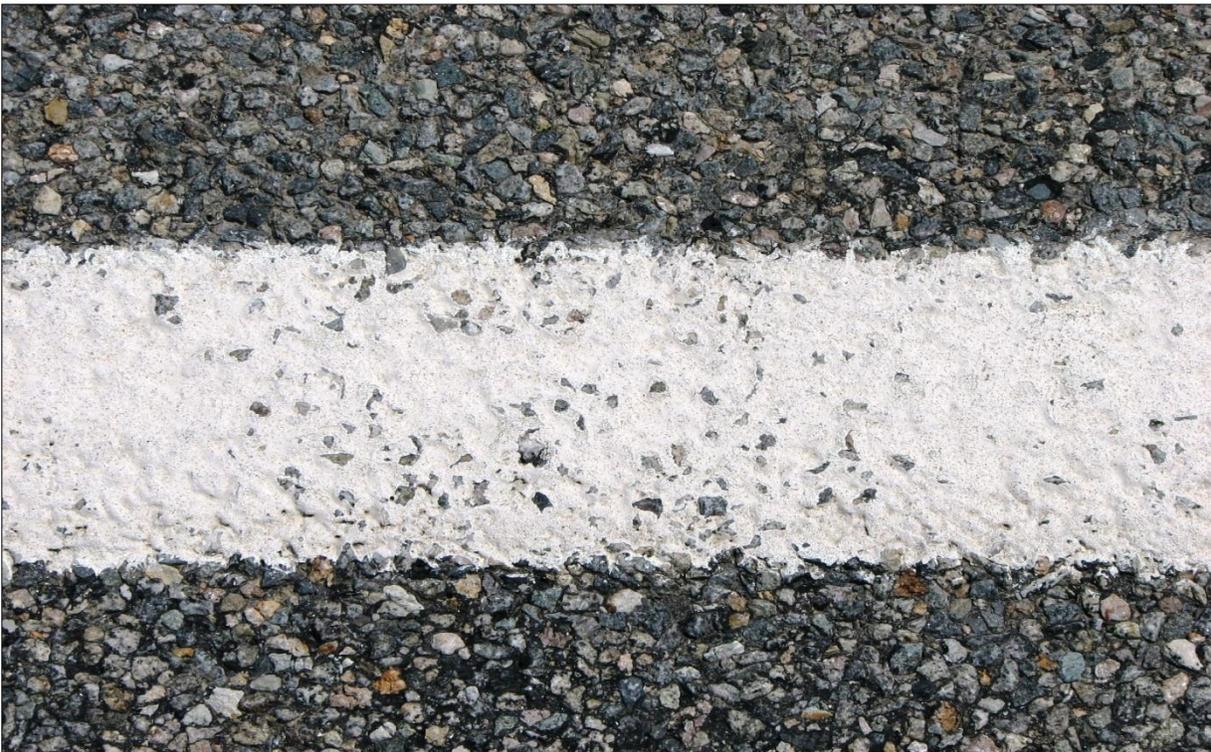
**Control Section: Poly-Carb Epoxy – Heavy Grind North Bound (NB) Lanes MP143-153**

↑↓ Representative images of the Poly-Carb NB control section prior to the new markings application.

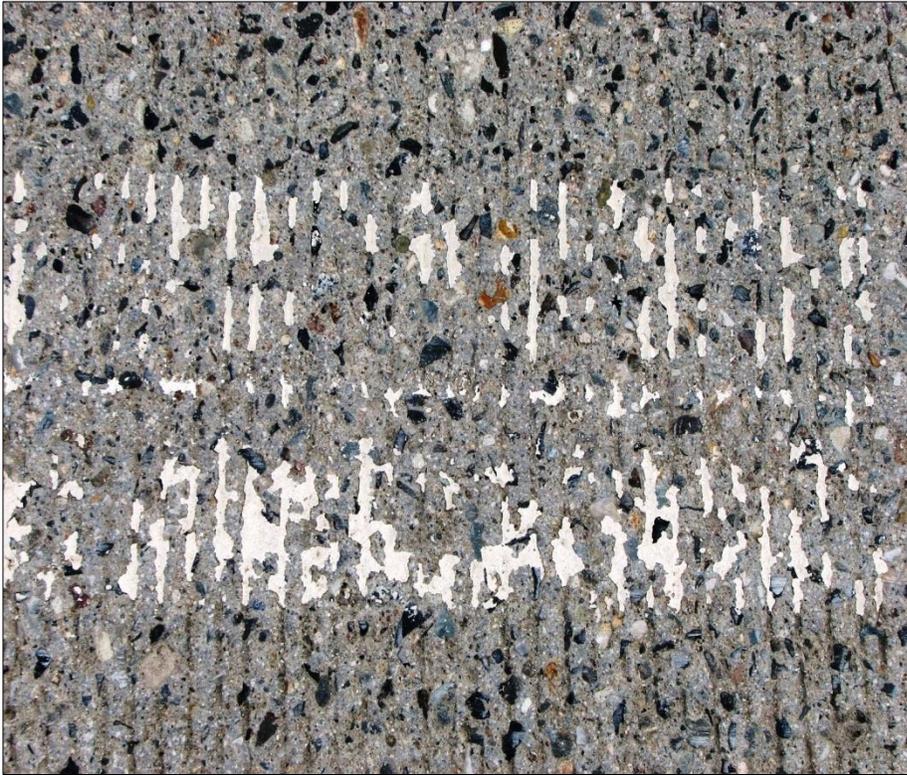
← Example of marking stripe on one of the areas PCCP bridges prior to new marking application.

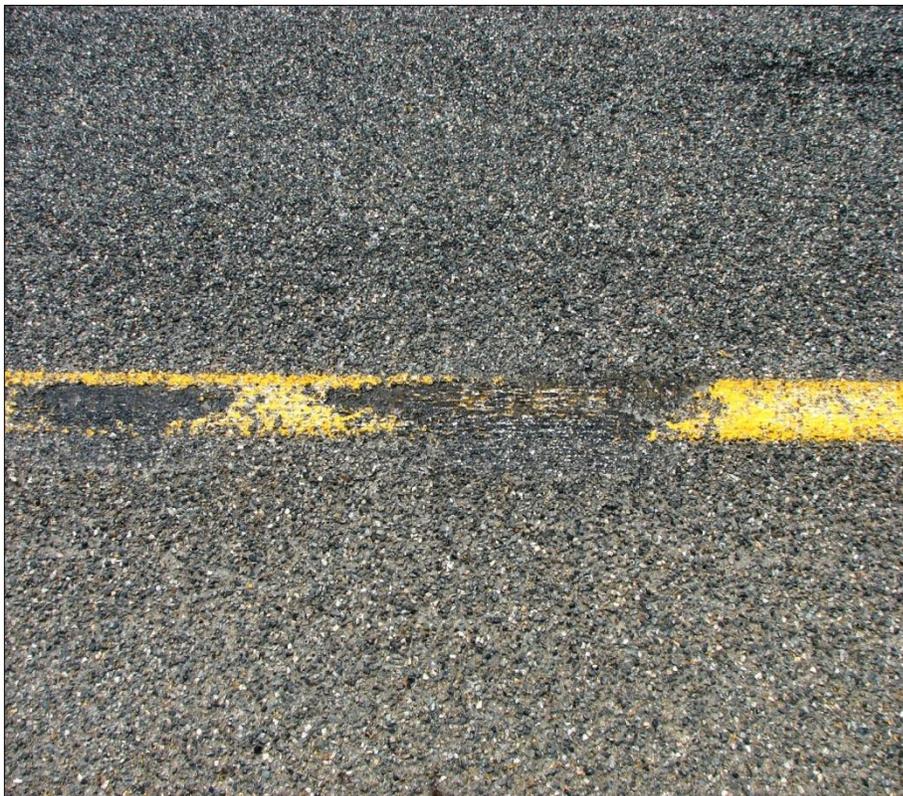
← Example of snow plows damage to pavement markings which was prevalent on all sections of the project.

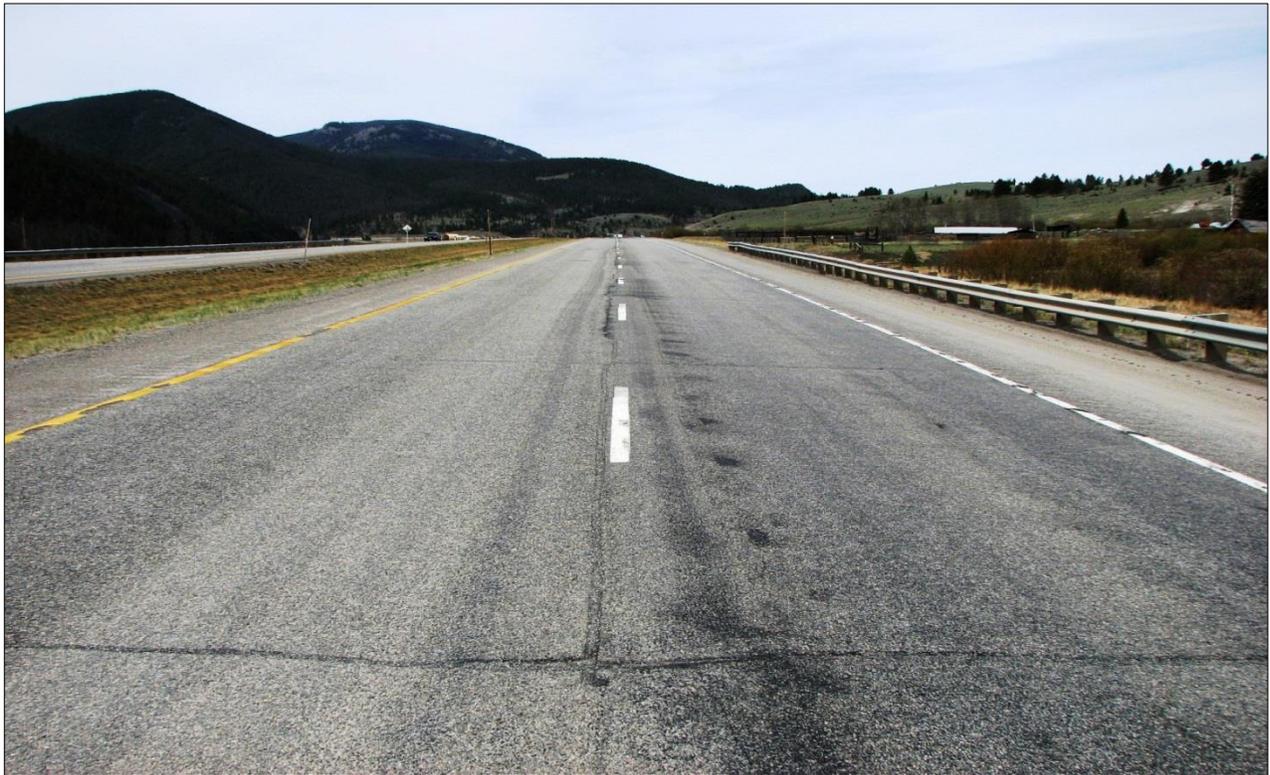
**Site Inspection April 2013 – Poly-Carb Light-Grind MP 143-153 Southbound**

↑ Representative image of Southbound Poly-Carb control section; view south.

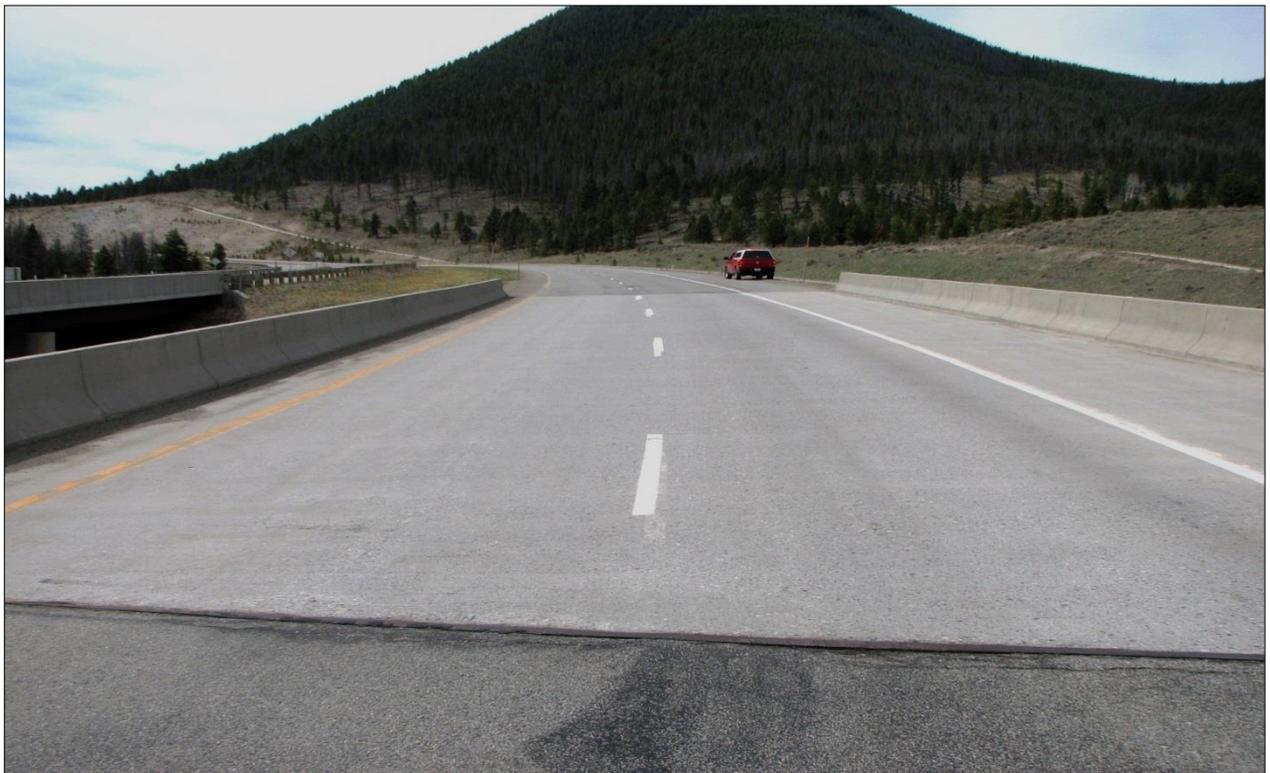
↓ Representative image of Southbound Poly-Carb control section - PCCP deck; view south.

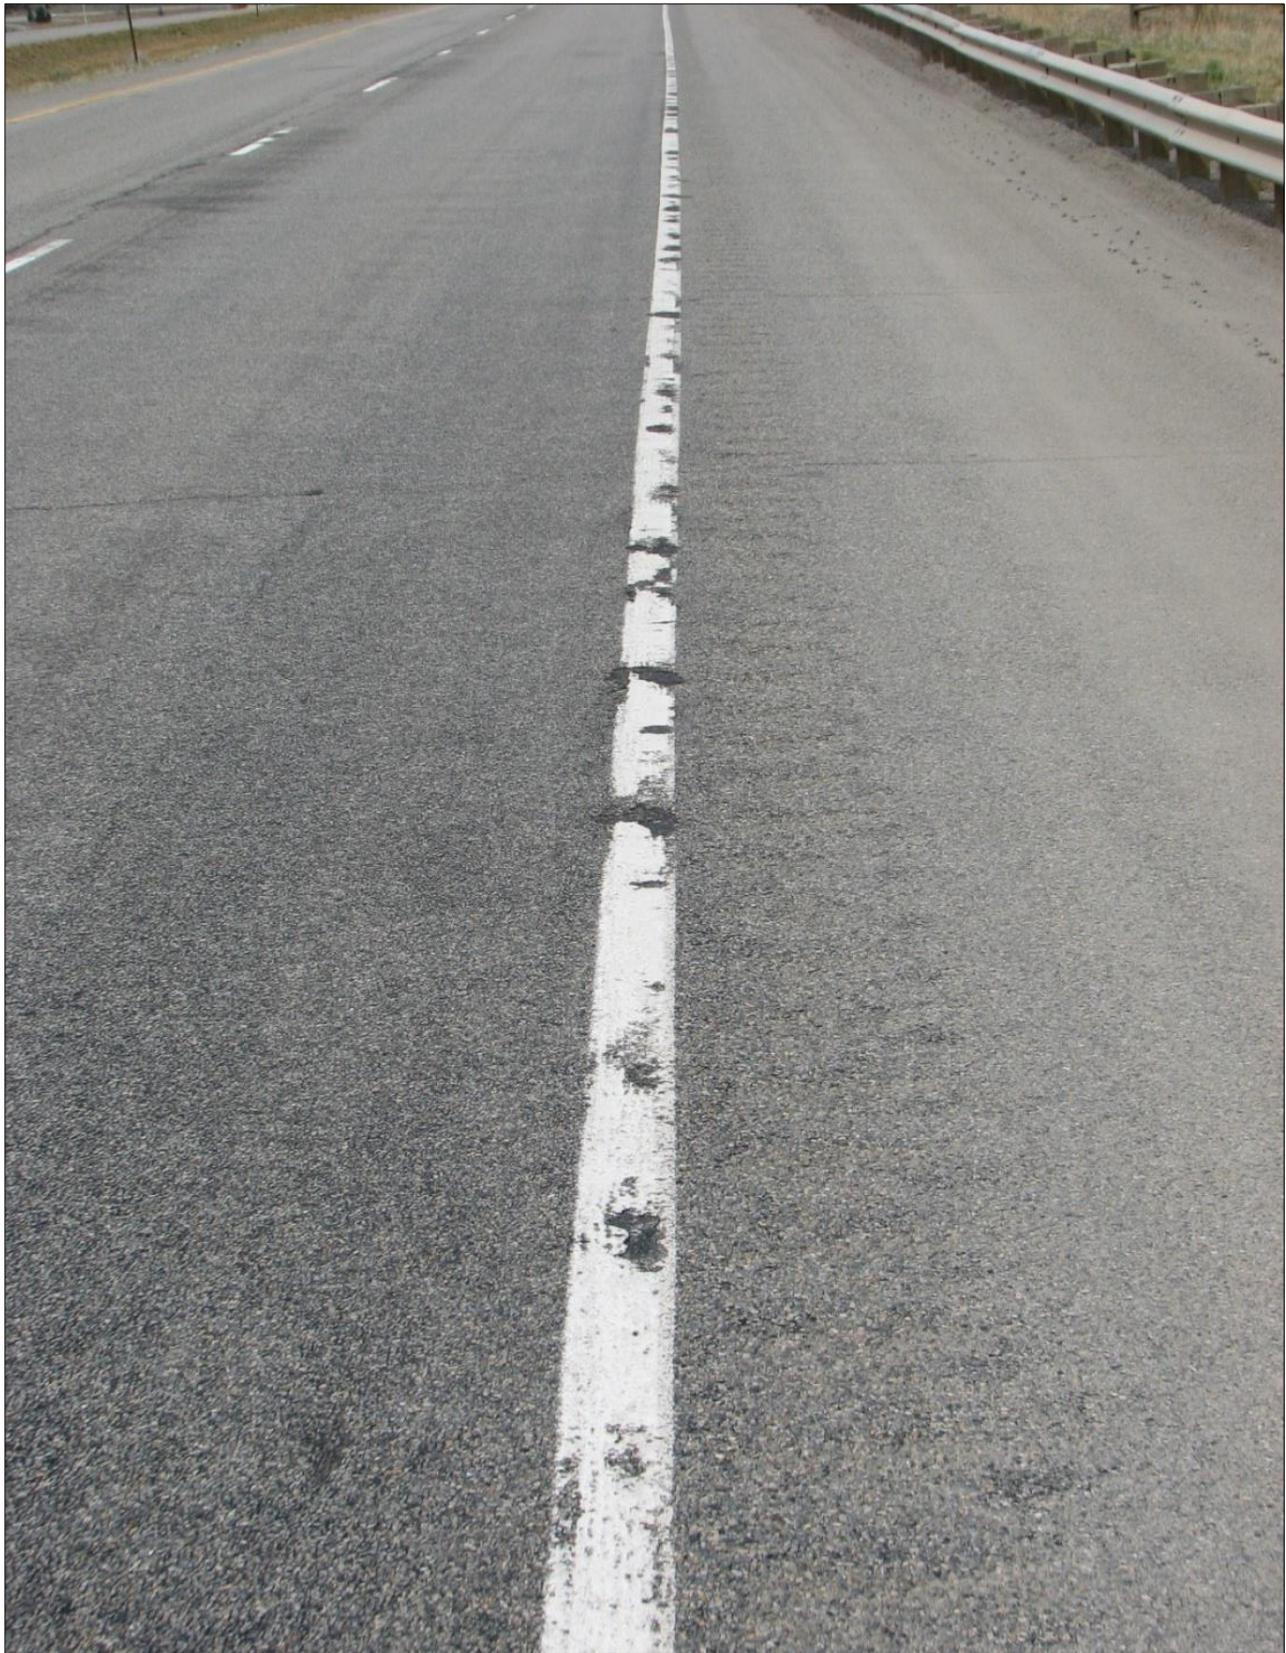
↑ Representative image of Southbound Poly-Carb control section, white stripe application (fog line); view south.

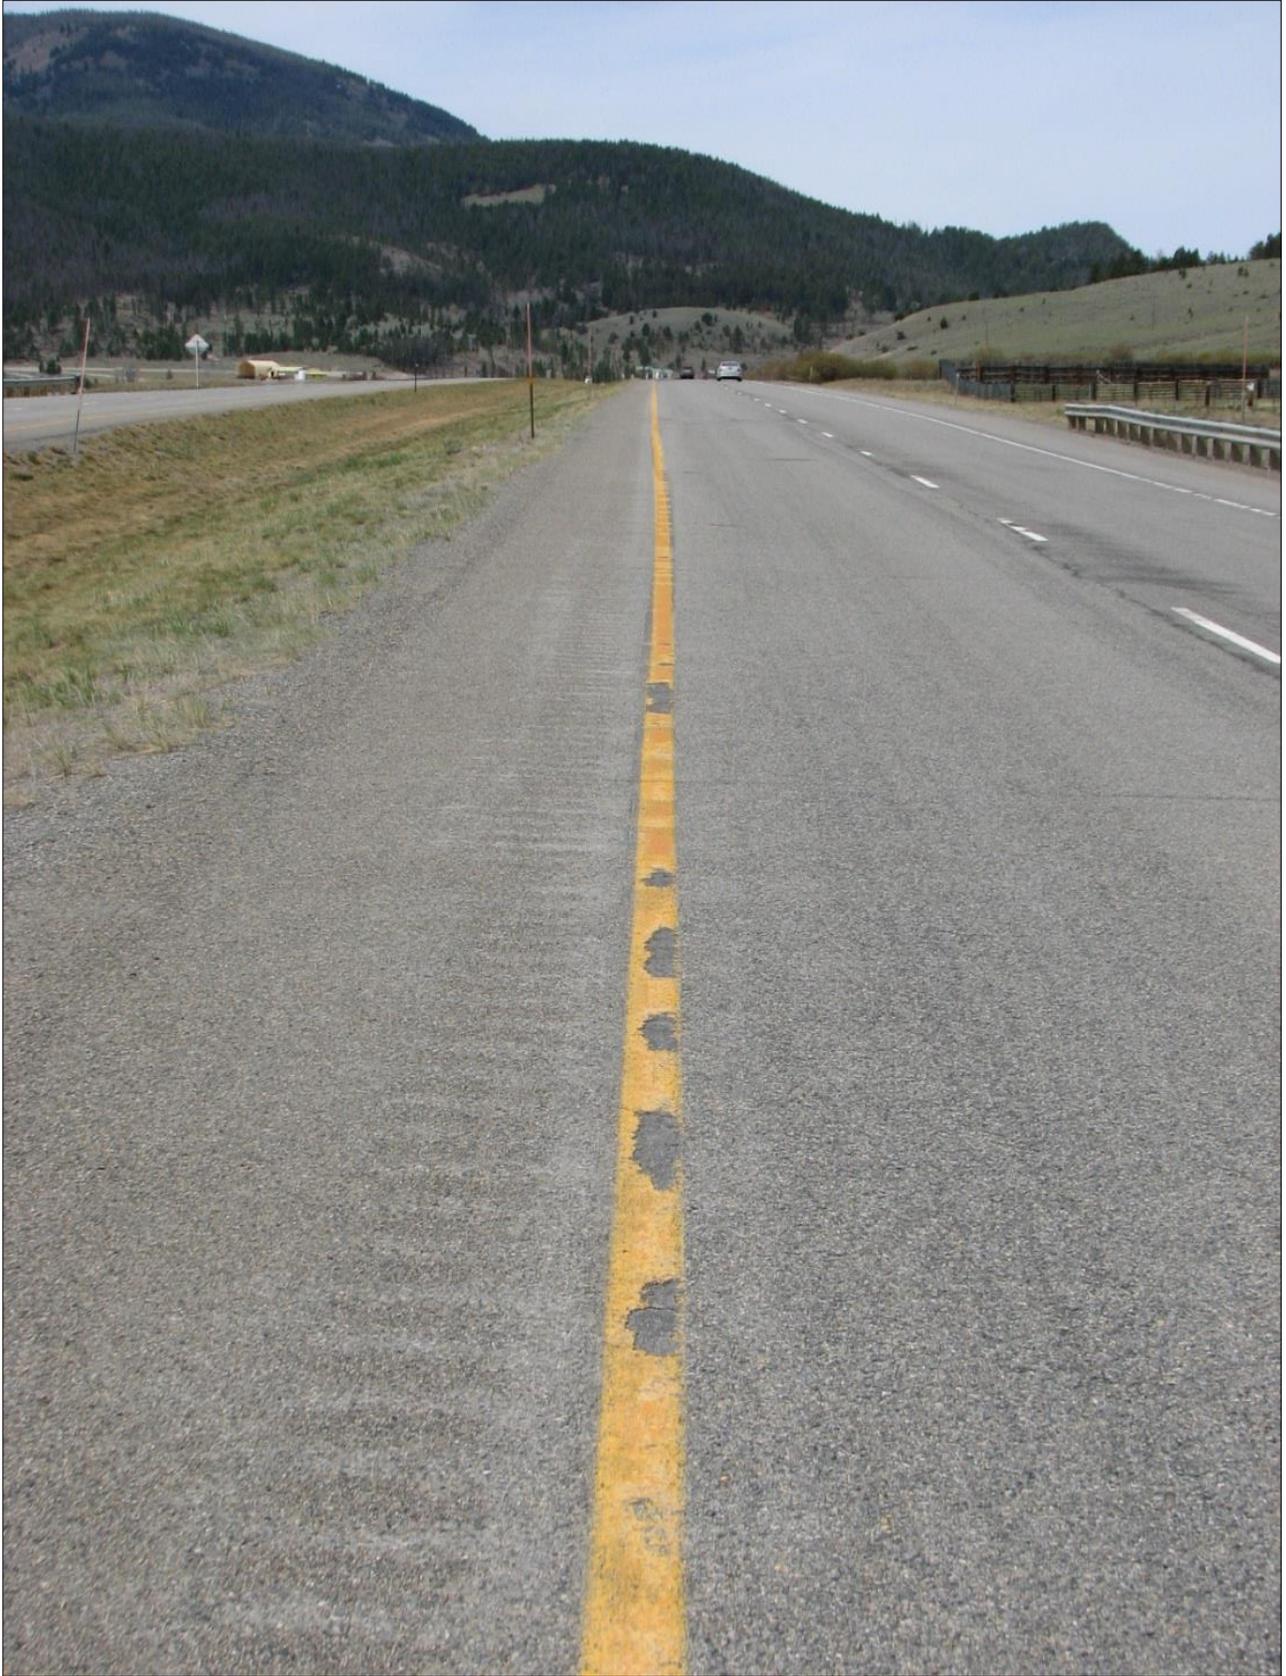
↑ Representative image of Southbound Poly-Carb control section, yellow stripe application; view south.

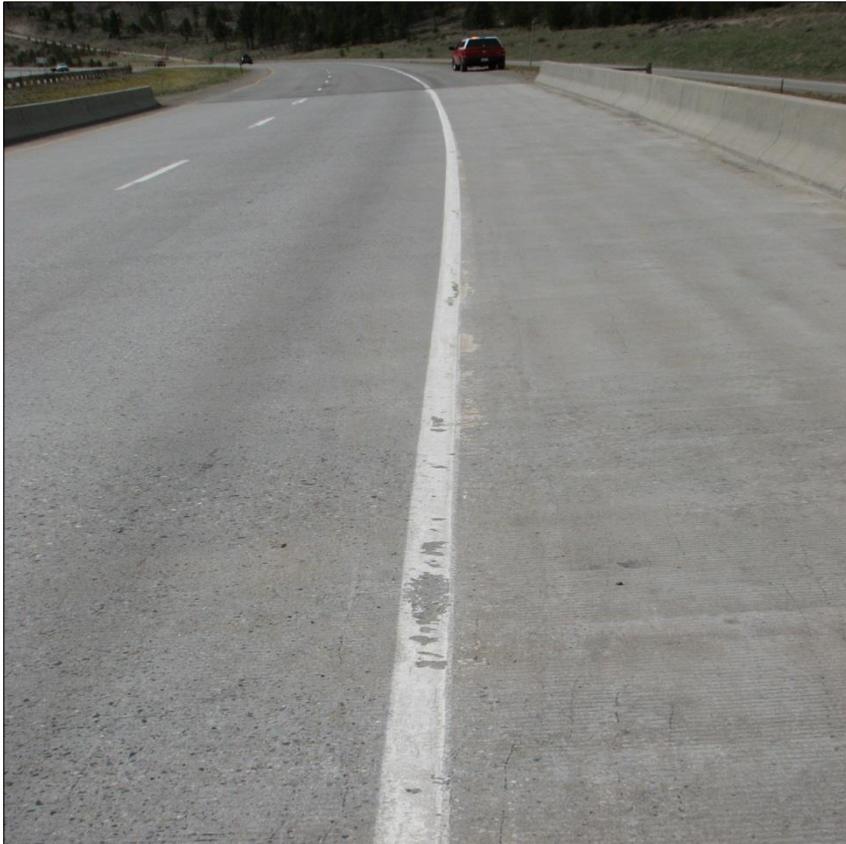
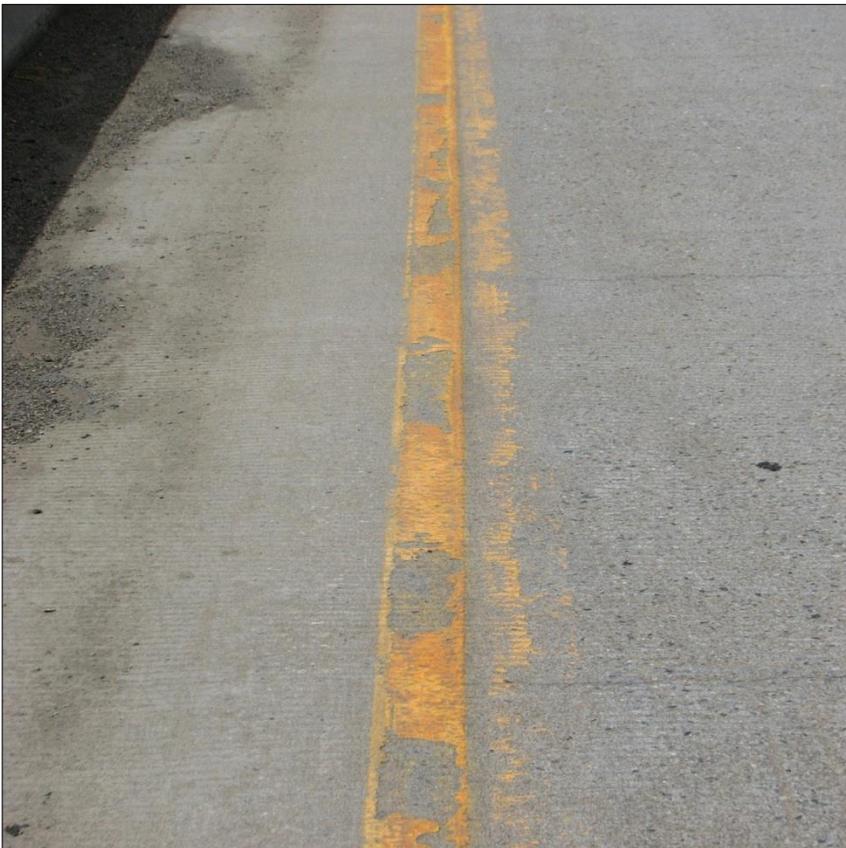
↙ PCCP deck: sample images of white and yellow striping; view south.

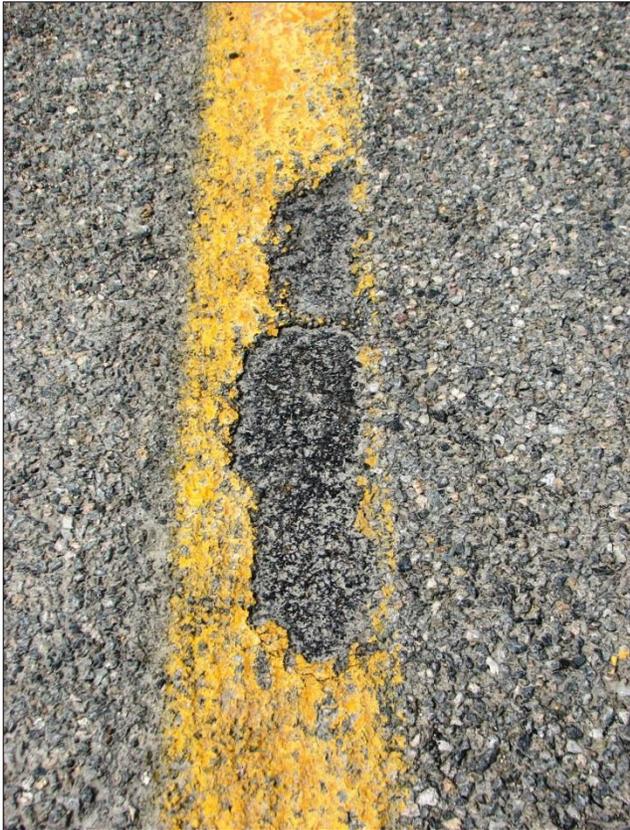
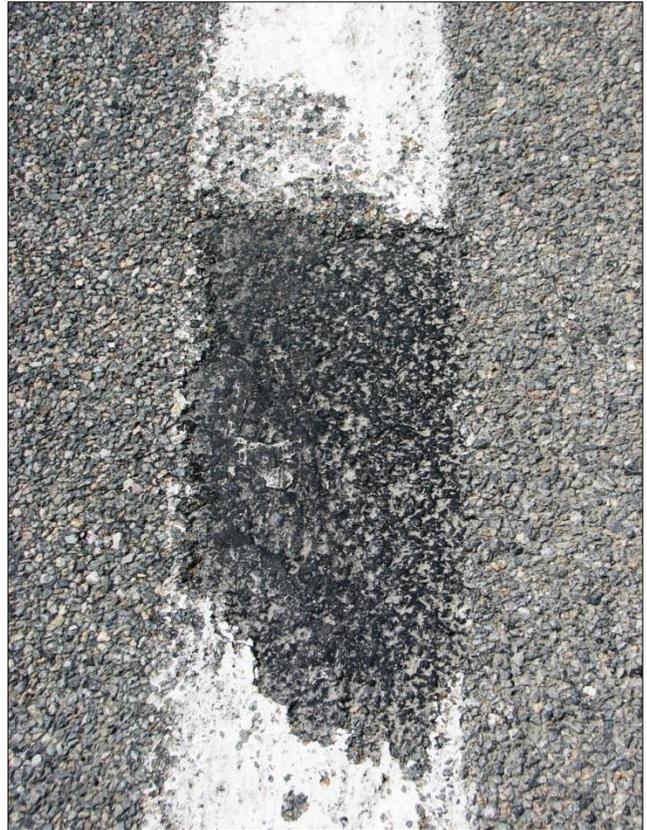
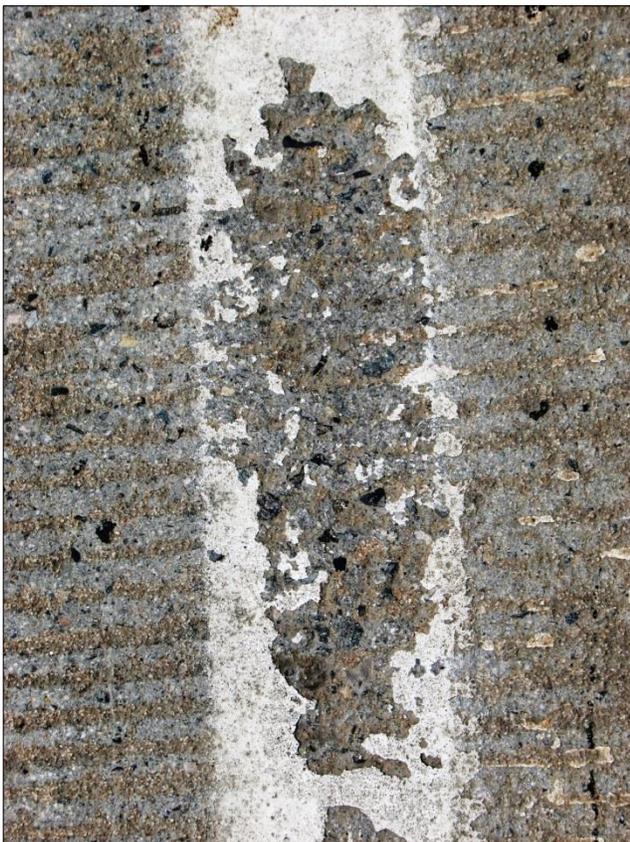
AC and PCCP striping applications; close-up of plow damage.

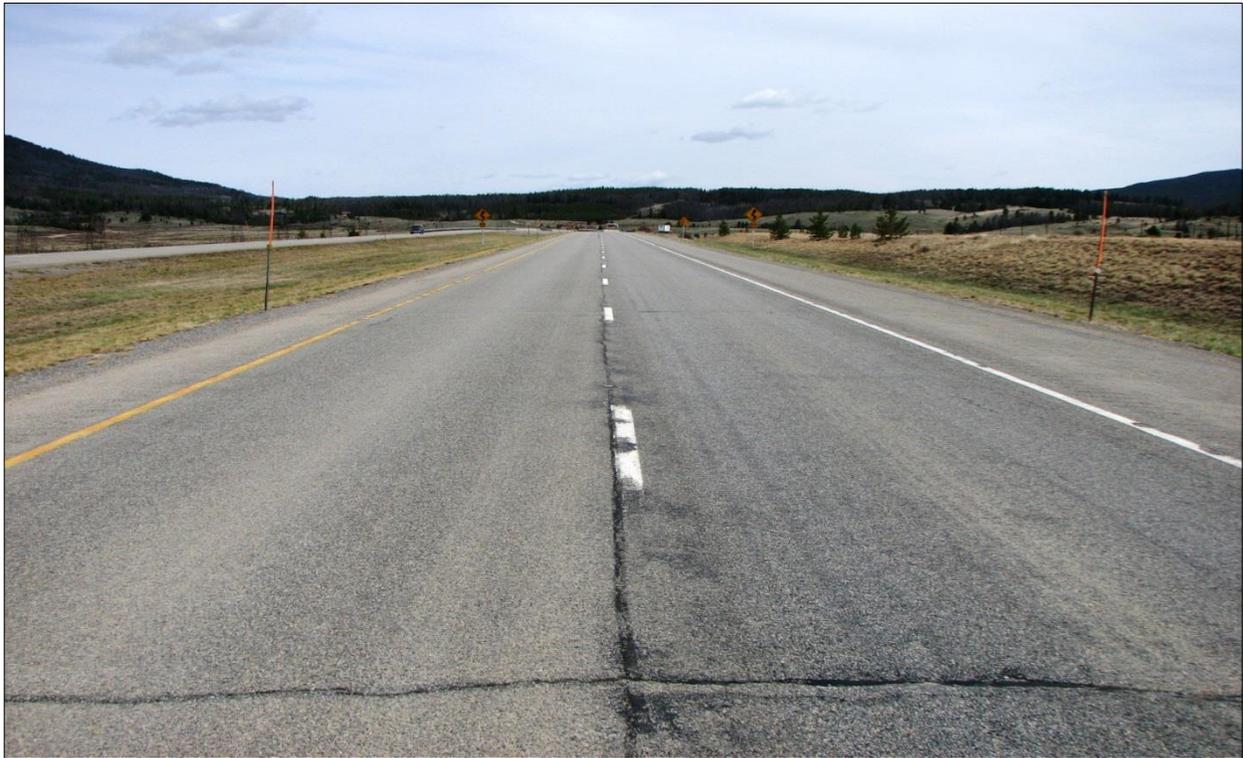
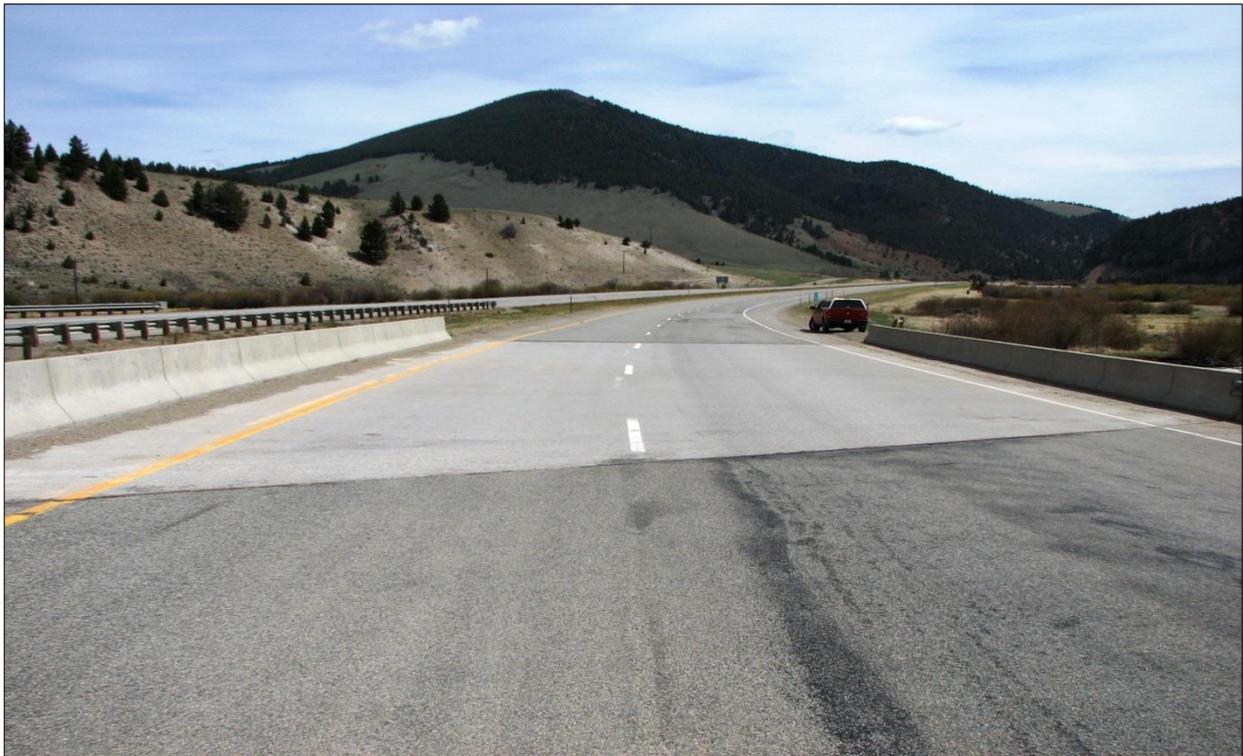
**Site Inspection April 2013 – Poly-Carb Heavy-Grind MP 143-153 Northbound**

- ↑ Representative image of northbound Poly-Carb control section; view north.
- ↓ Representative image of northbound Poly-Carb control section - PCCP deck; view north.

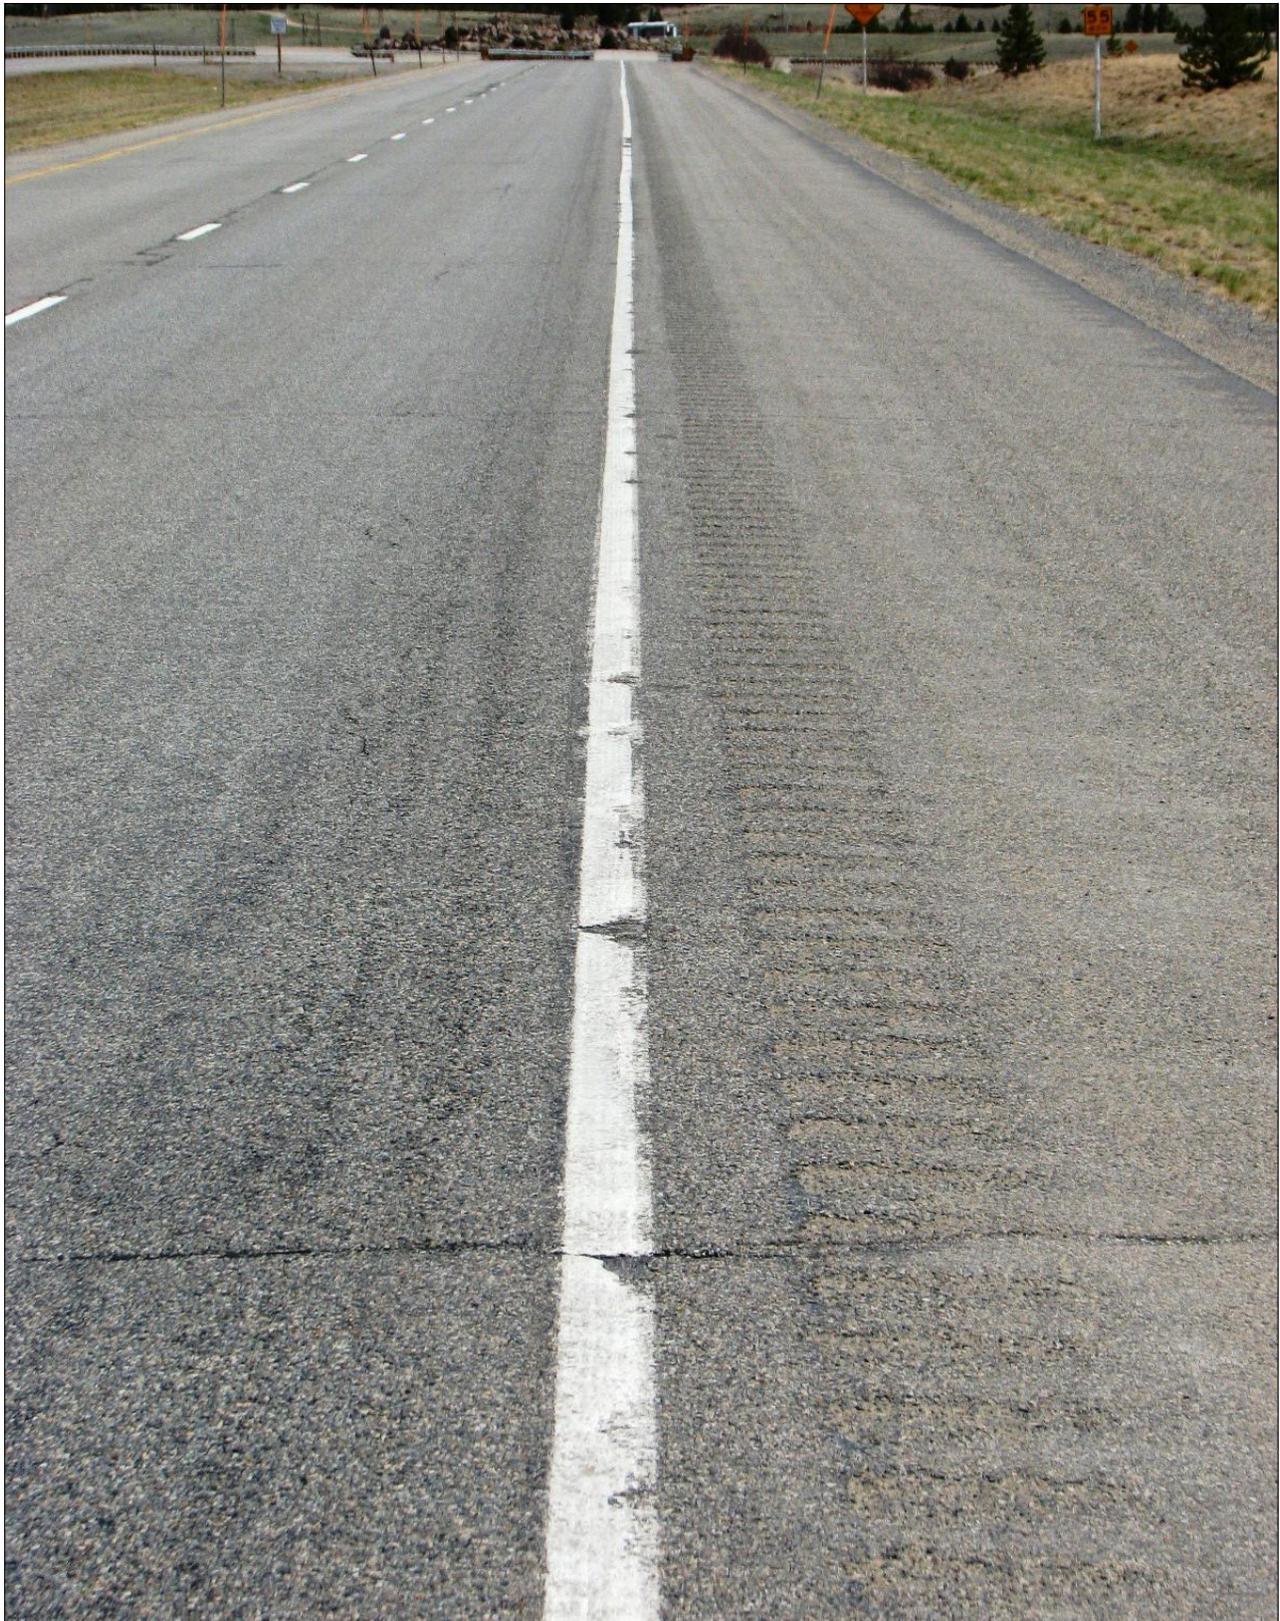
↑ Representative image of northbound Poly-Carb control section, white stripe application; view north.

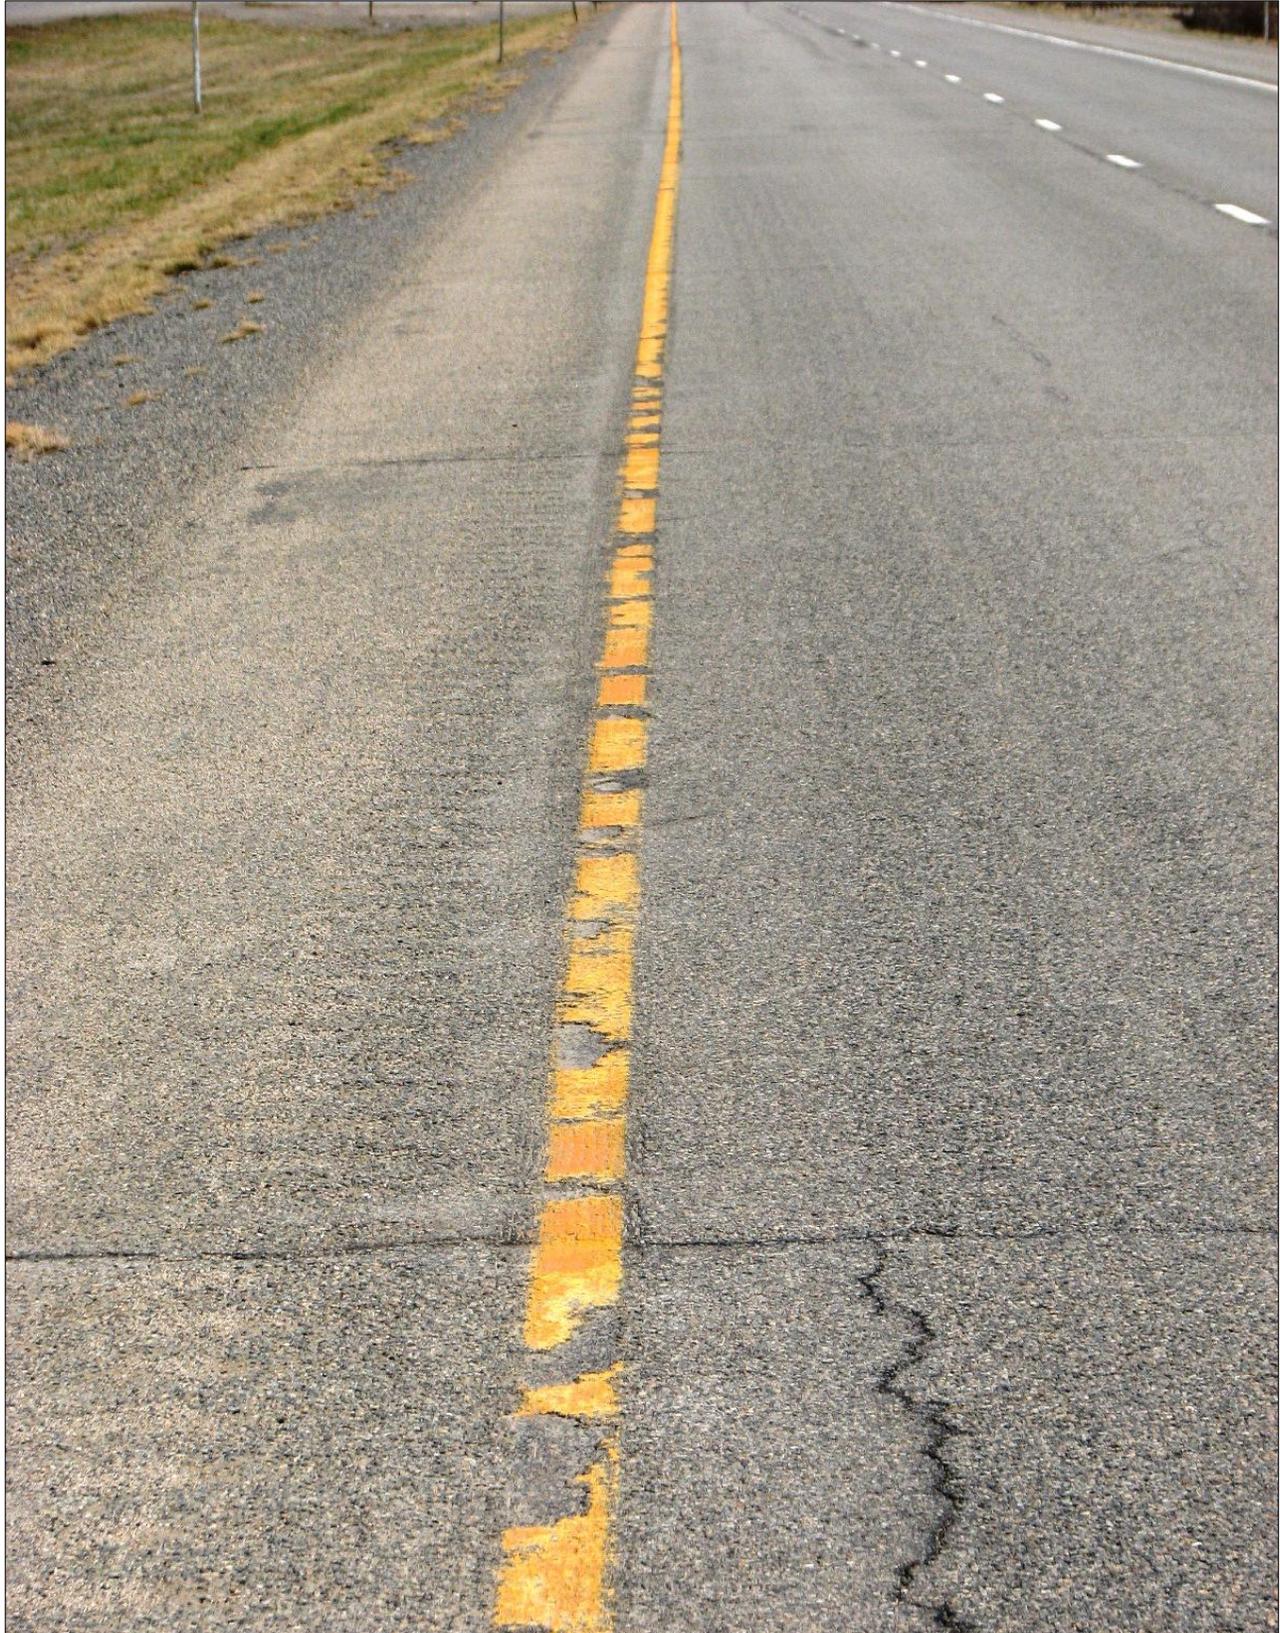
↑ Representative image of northbound Poly-Carb control section, yellow stripe application; view north.
