**EXPERIMENTAL PROJECTS FINAL REPORT**  
**URETHANE EPOXY PAVEMENT MARKINGS**

**Project Name:** Elk Park

**Project Number:** HWY-310386-RP

**Experimental Project No.** MT-12-02

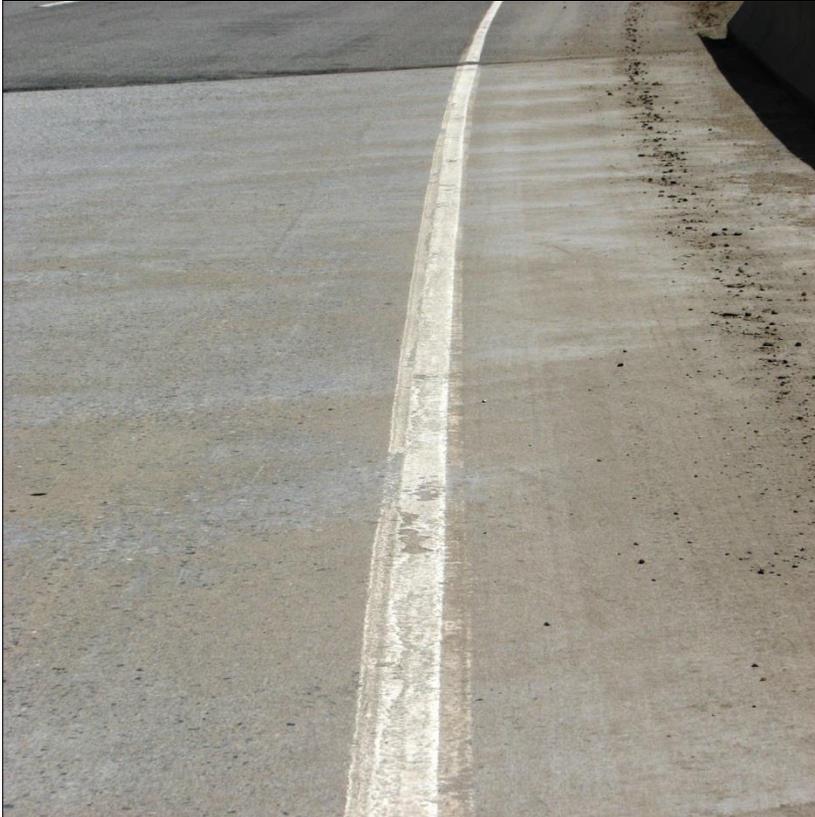
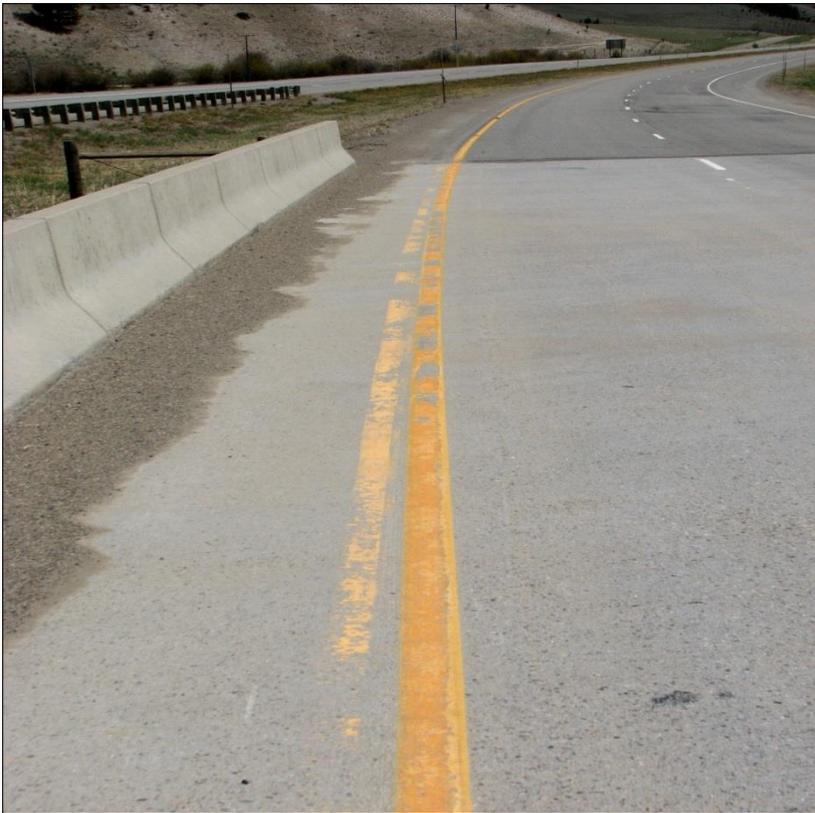
↙ PCCP deck: sample images of white and yellow striping; view north.

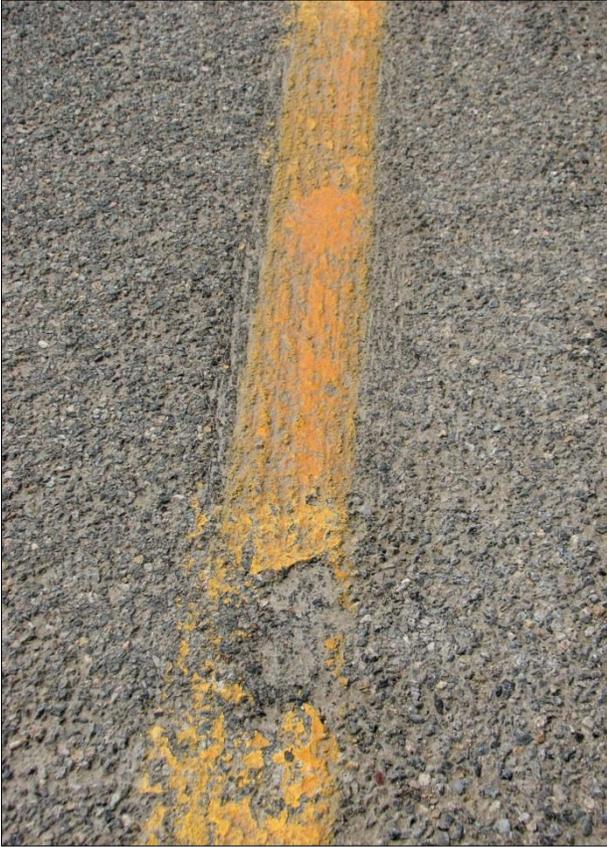
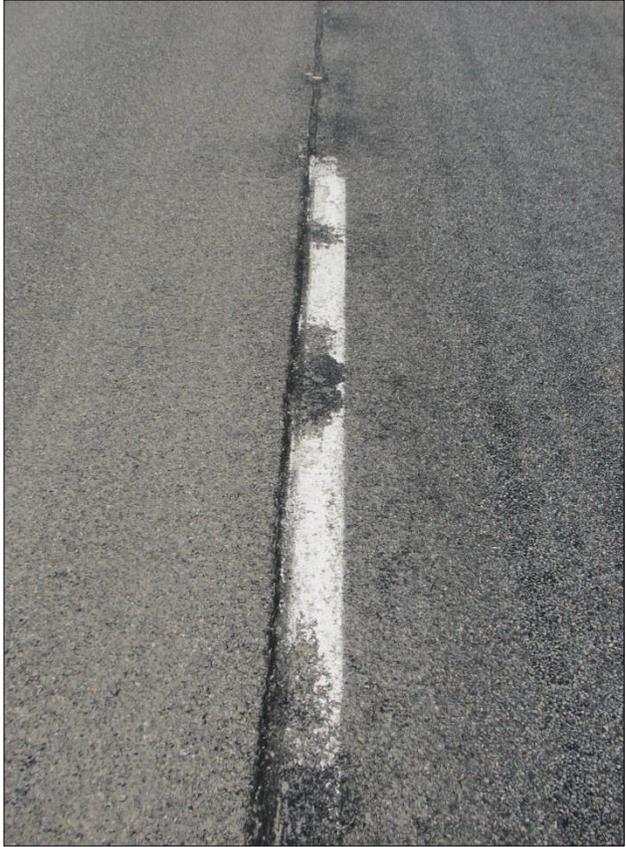
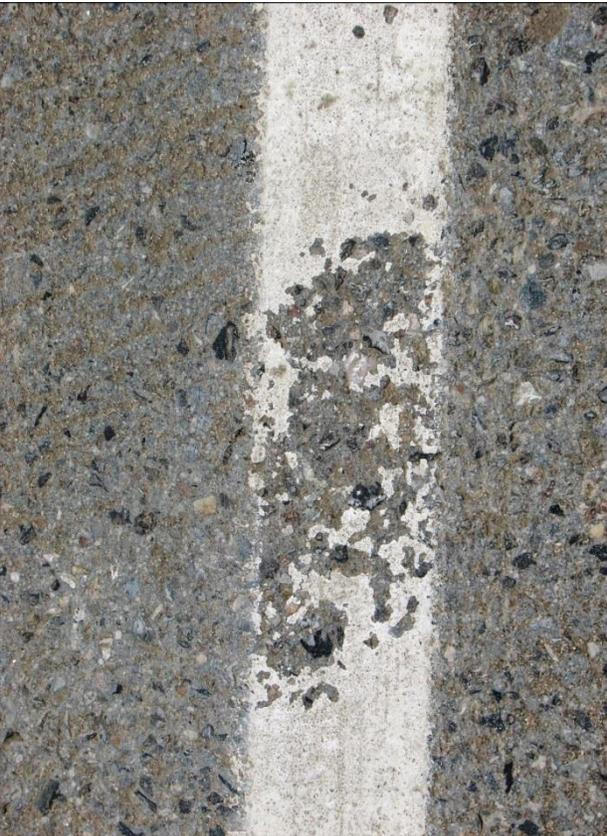
AC and PCCP striping applications; close-up of plow damage.

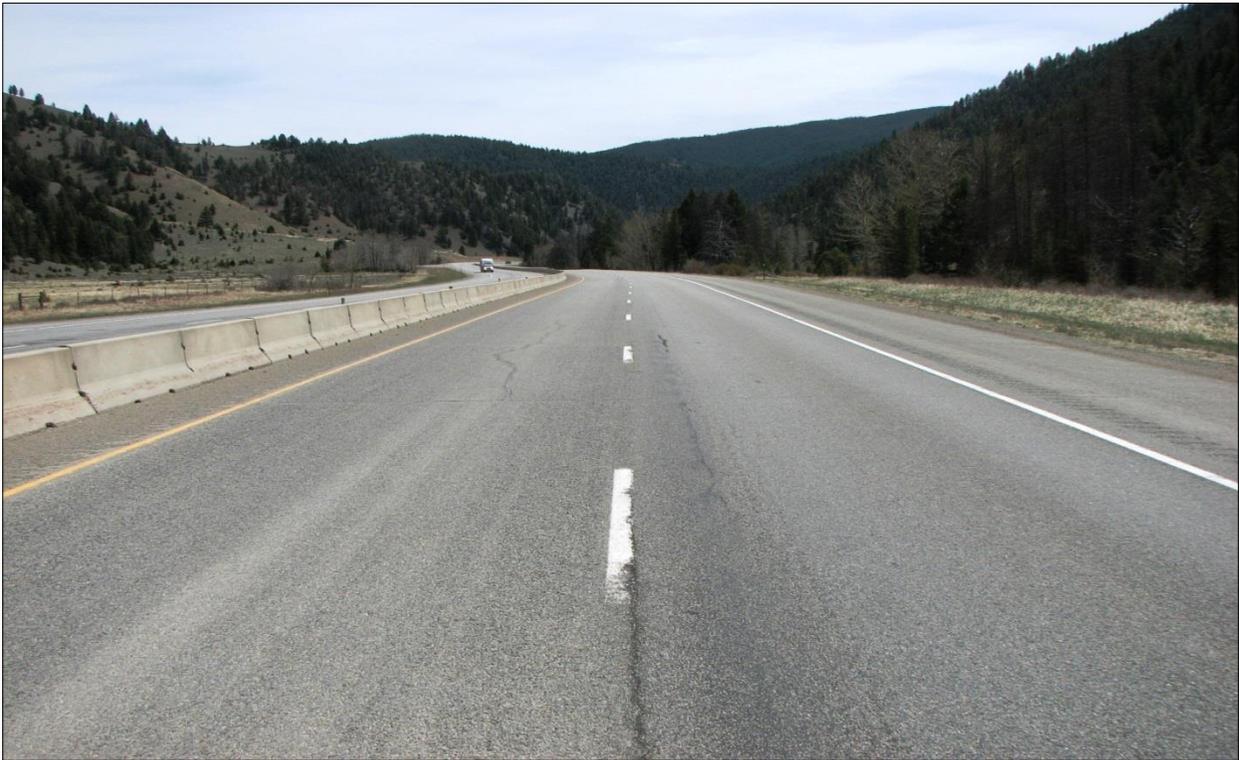
**Site Inspection April 2013 – Swarco MFUA-10 Heavy-Grind MP 153-163 Northbound**

↑ Representative image of northbound MFUA-10 test section; view north.

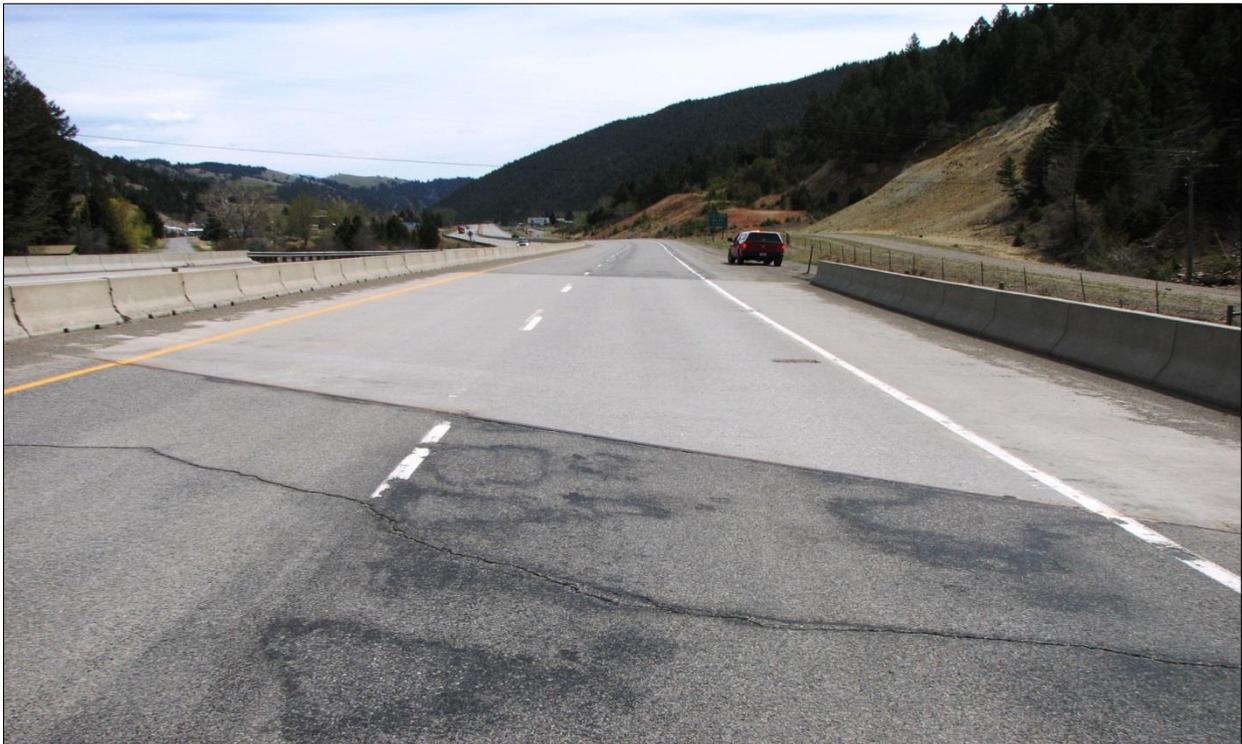
↓ Representative image of northbound MFUA-10 test section - PCCP deck; view north.

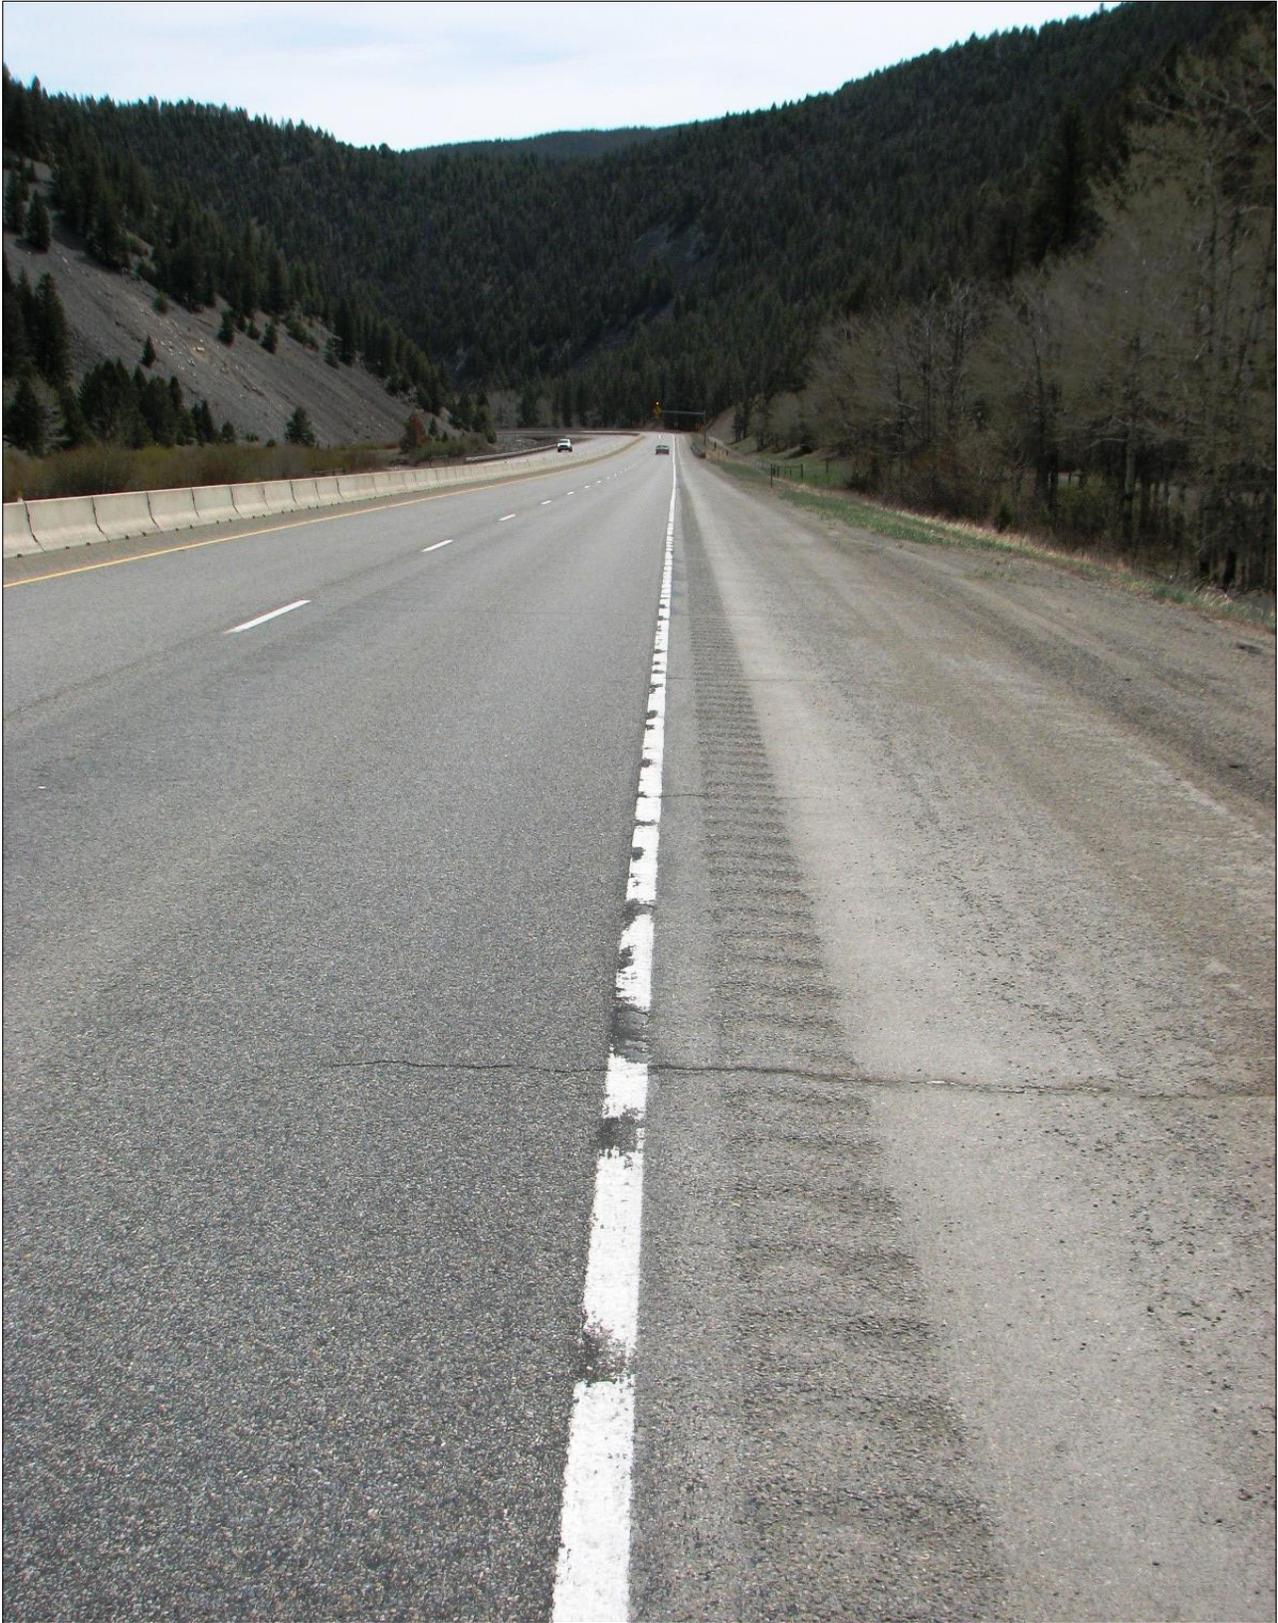
↑ Representative image of northbound MFUA-10 test section, white stripe application; view north.

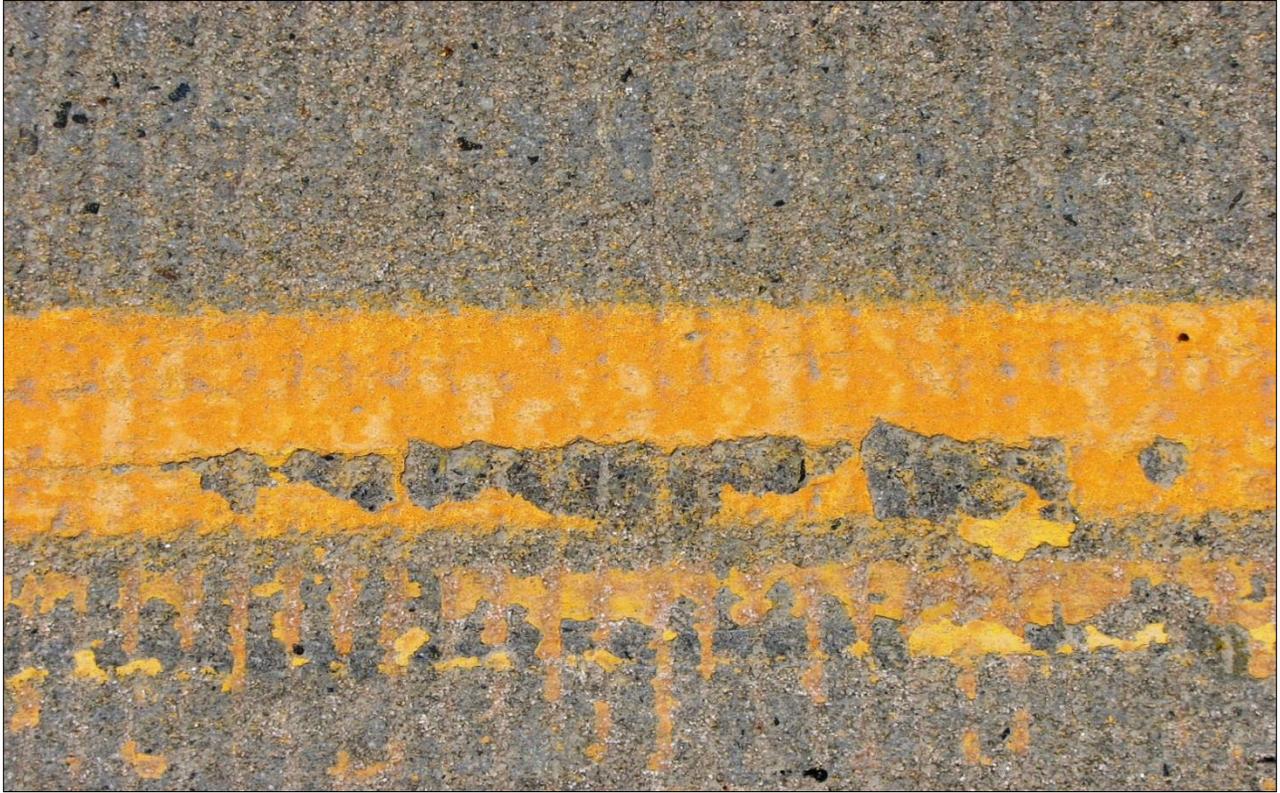
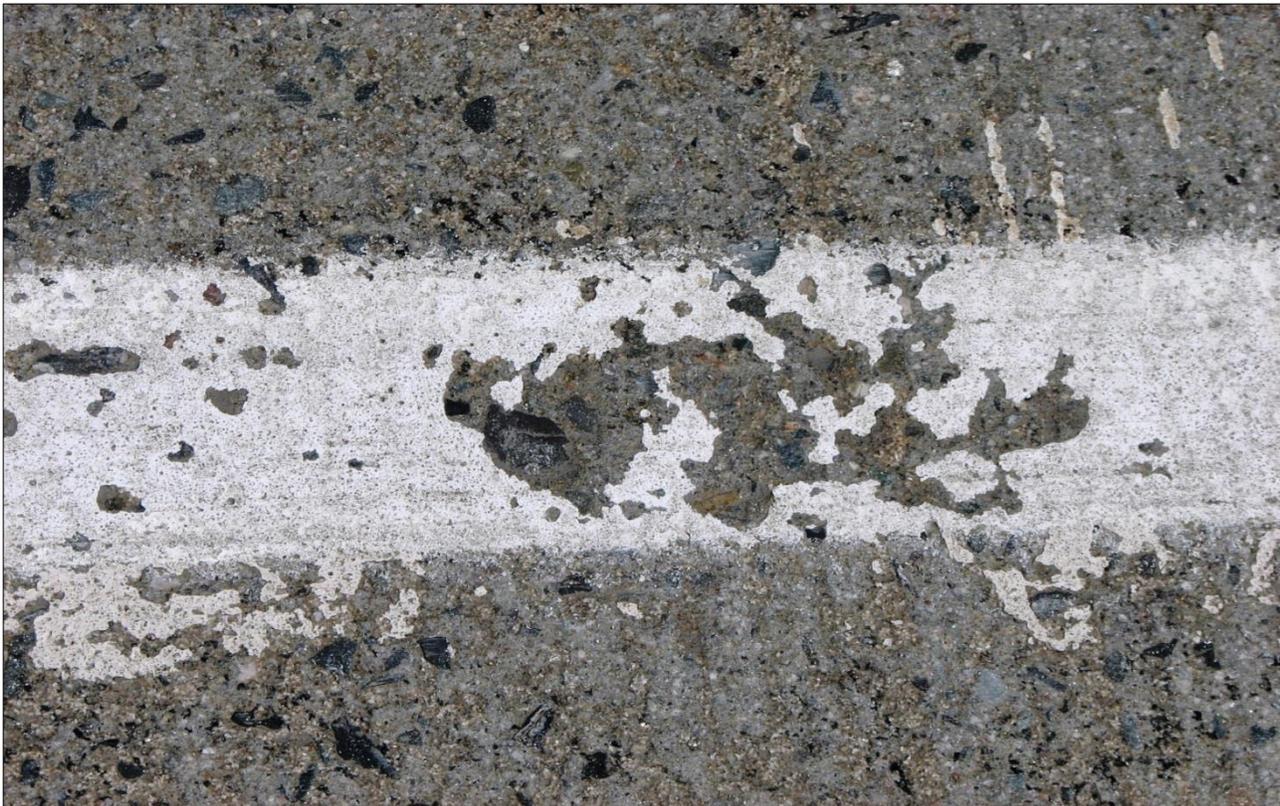
↑↓ PCCP deck: representative images of white and yellow striping.

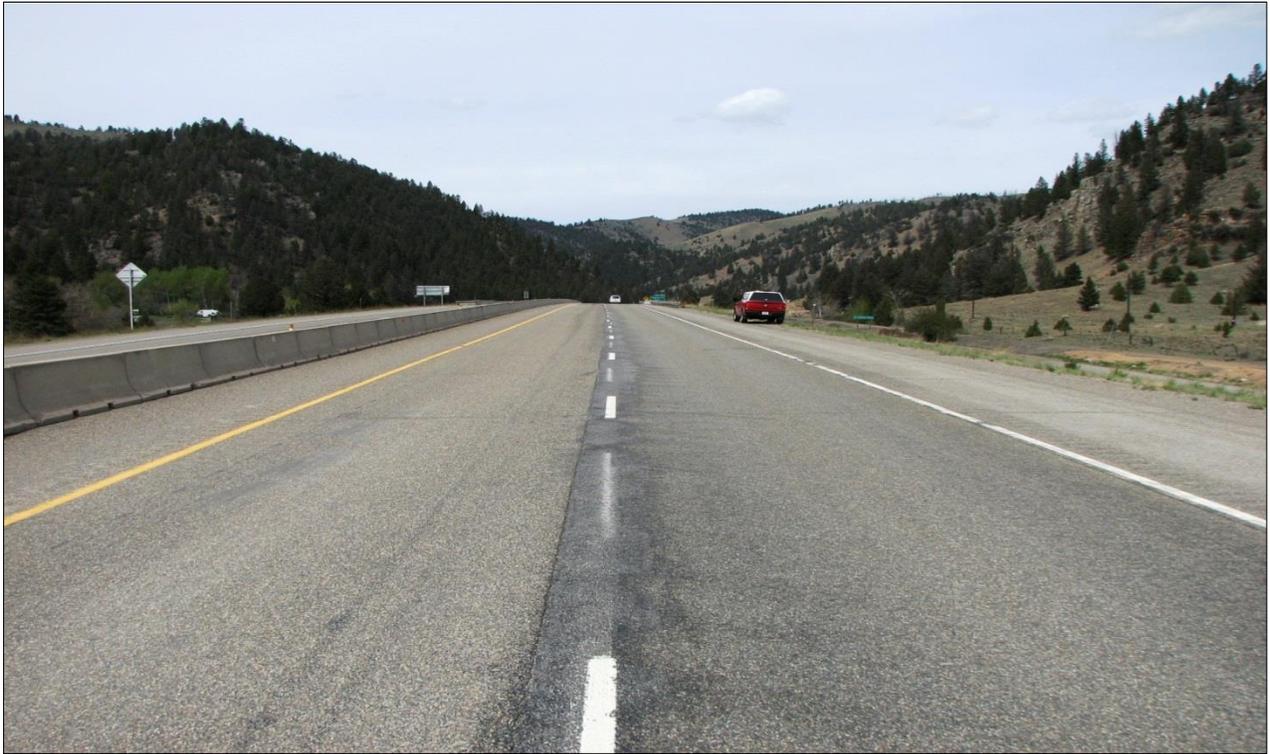
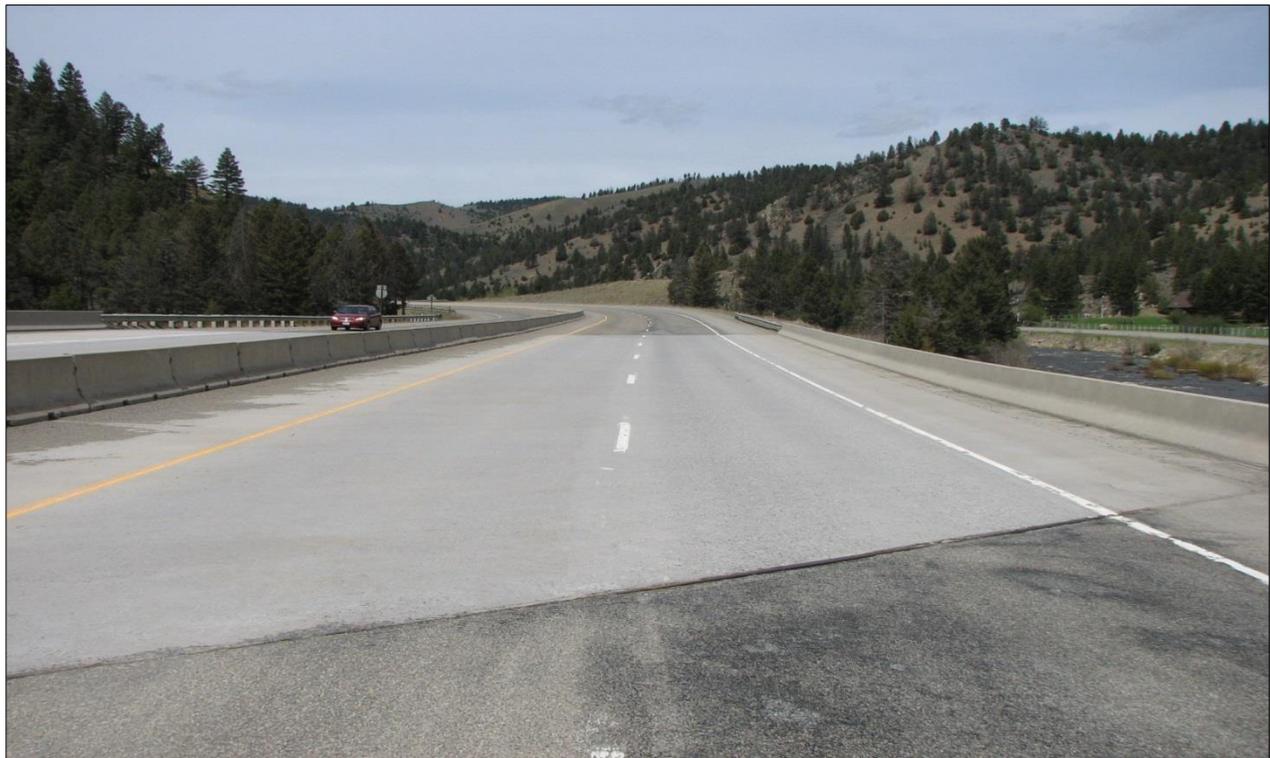
**Site Inspection April 2013 – Ennis HPS-4 Heavy-Grind MP 153-163 Southbound**

- ↑ Representative image of southbound Ennis HPS-4 test section; view south.
- ↓ Representative image of southbound Ennis HPS-4 test section - PCCP deck; view south.

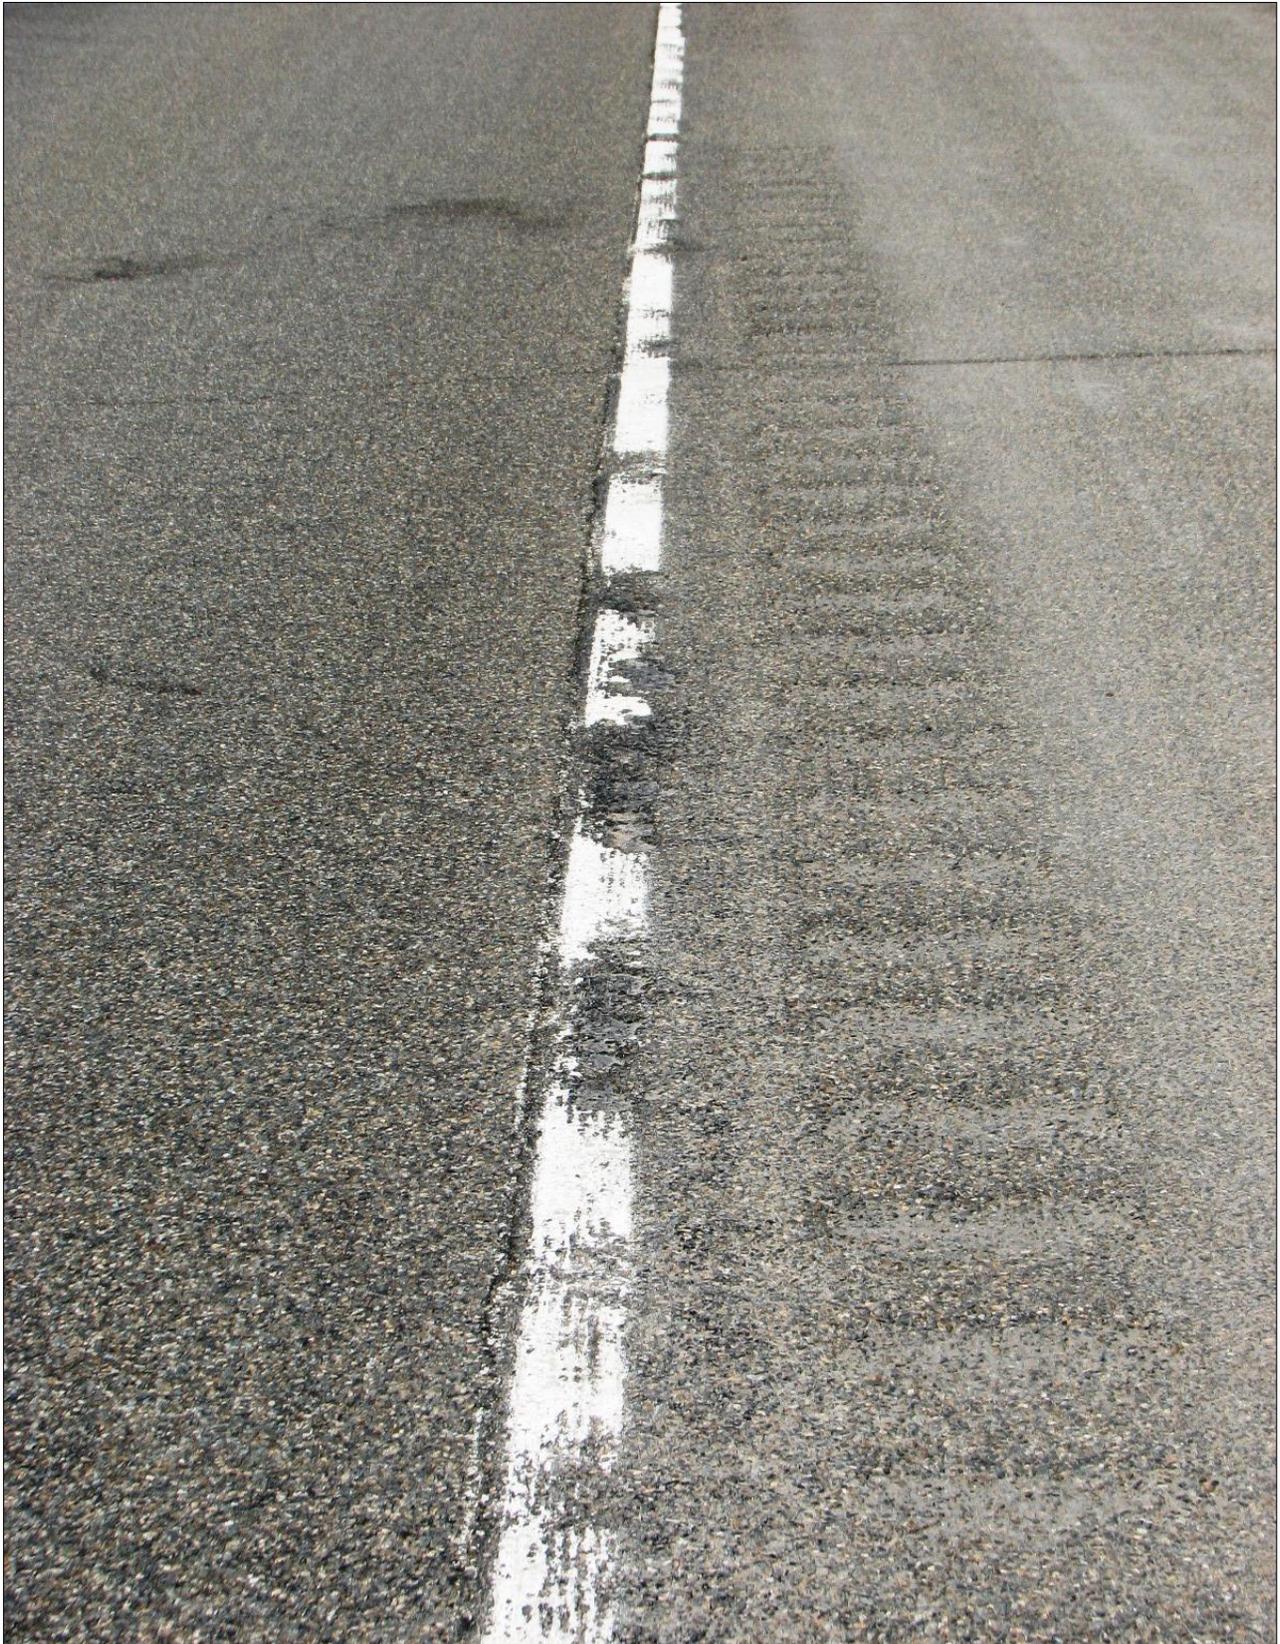
↑ Representative image of southbound Ennis HPS-4 test section, white stripe application; view south.

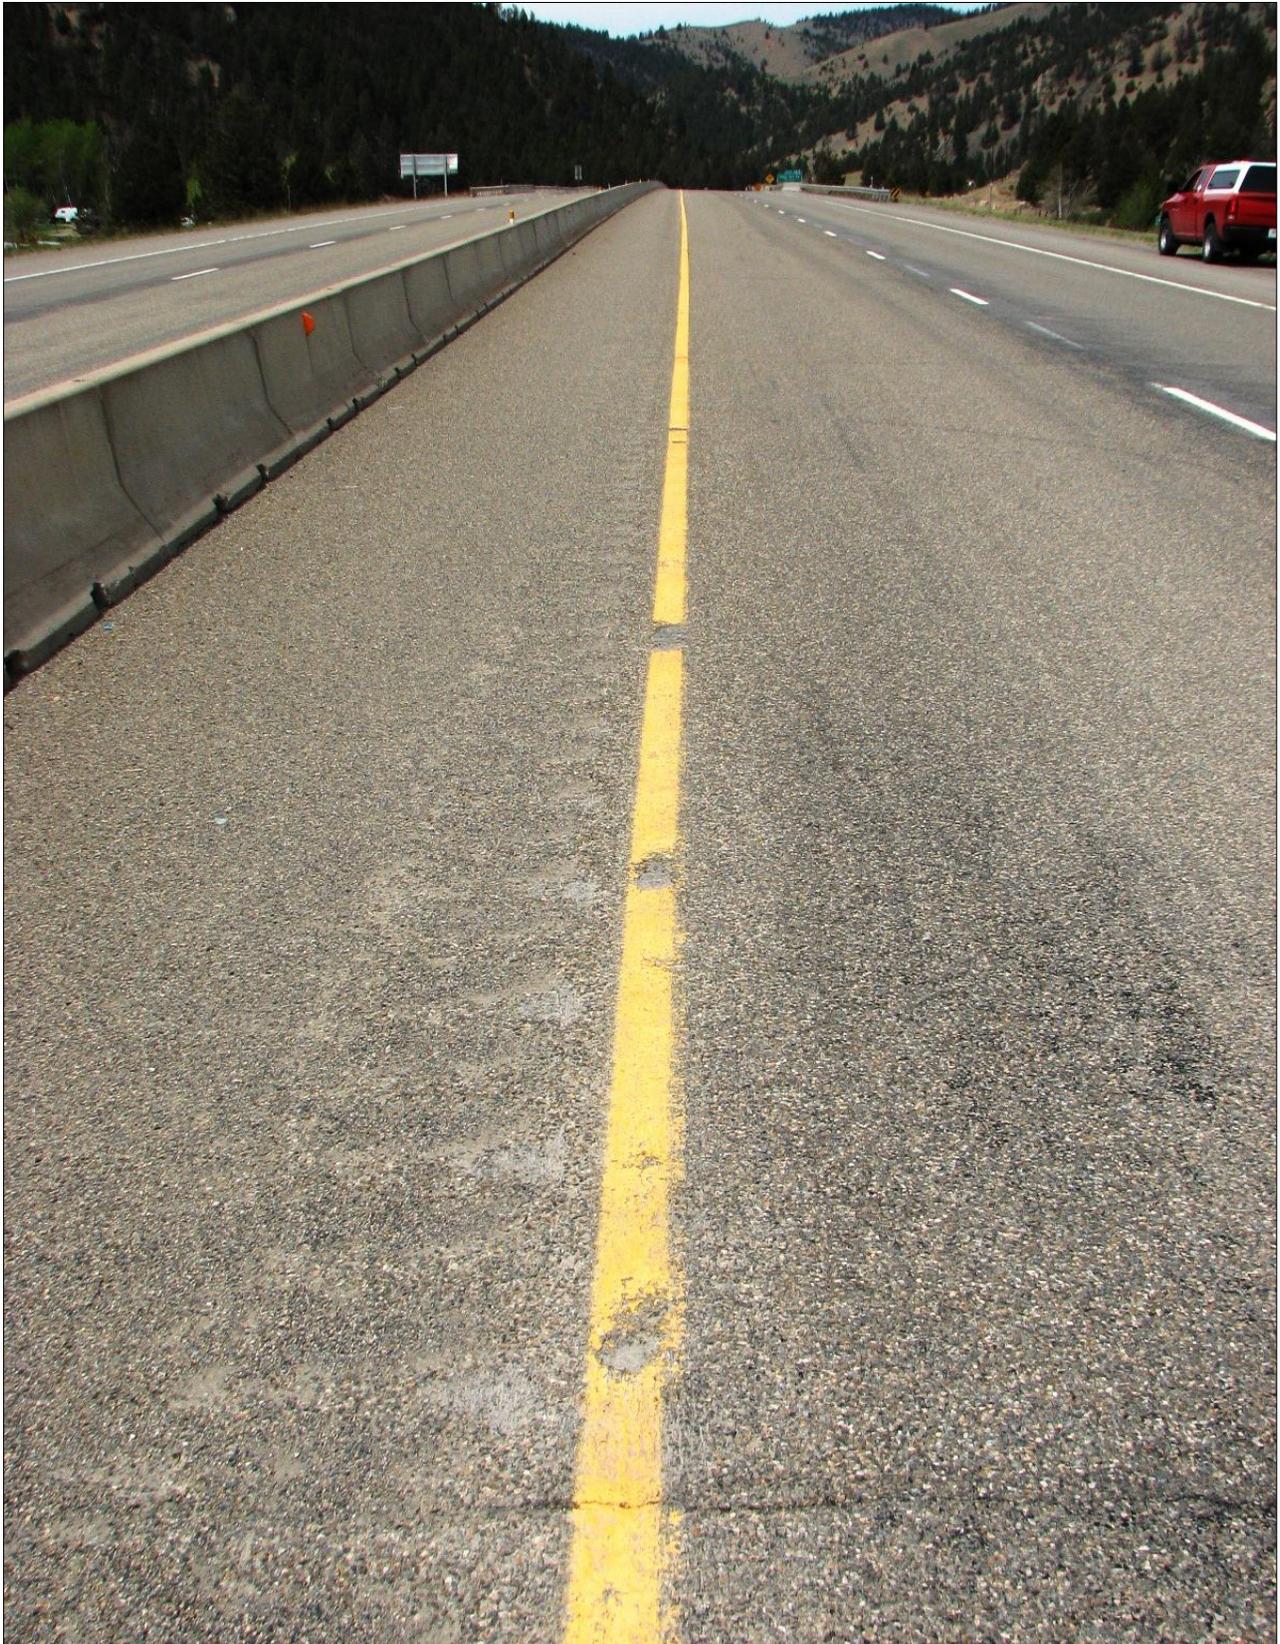
↑ Representative image of southbound Ennis HPS-4 test section, yellow stripe application; view south.

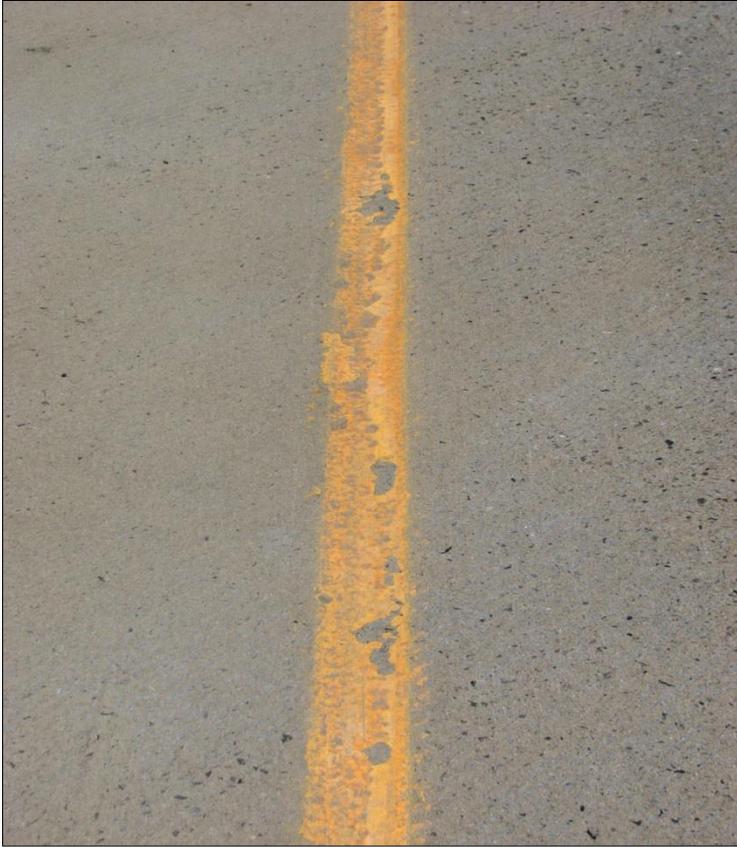
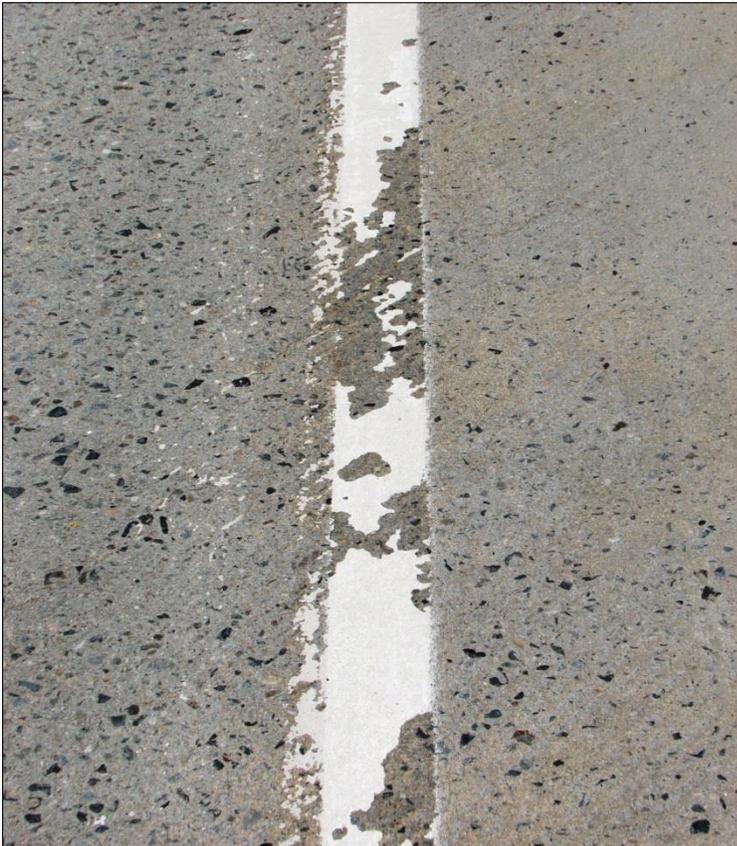
←↓ PCCP deck: sample images of white and yellow striping; view south.

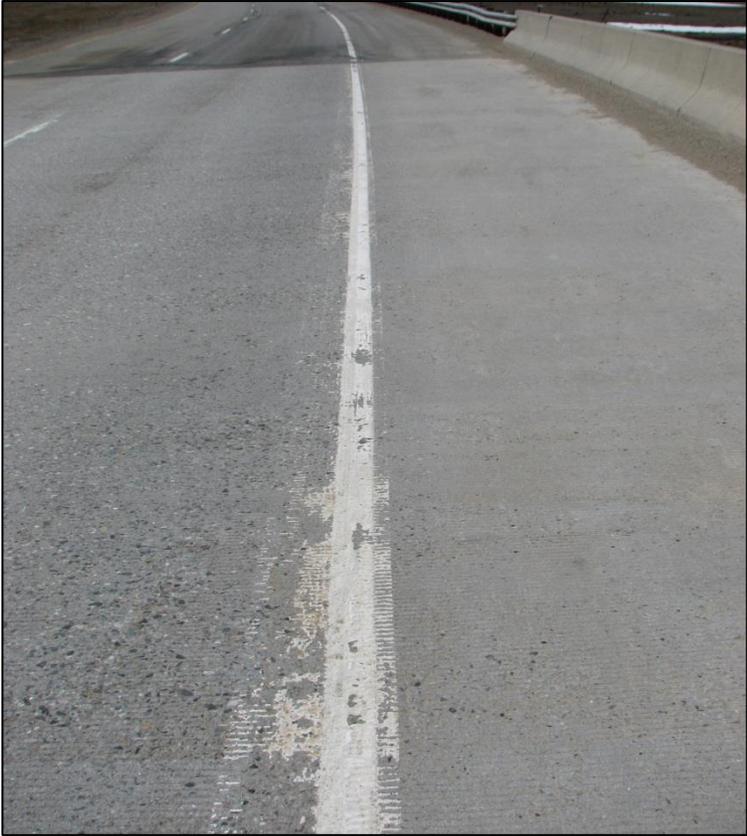
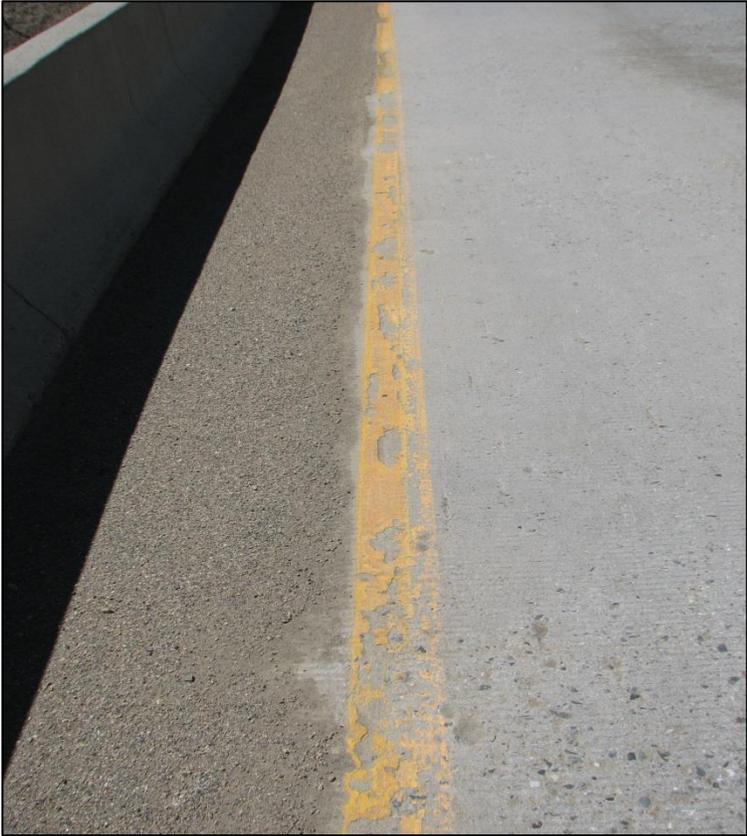
**Site Inspection April 2014 – Poly-Carb Light-Grind MP 143-153 Southbound**

↙↓ Representative images of the white and yellow striping on the project concrete deck surface.
