**EXPERIMENTAL FEATURES PROJECT  
CONSTRUCTION REPORT**

**EVALUATION OF WARM MIX ASPHALT (WMA) PAVEMENT**

<u>Project Name</u>	<u>Project Number</u>	<u>Project Location</u>	<u>Project Length</u>
Monida-Lima (SB)	IM 15-1(109)0	Interstate 15, Beaverhead County, Butte District- approximate RP 0.0 to RP 17.1	17.1 miles

**FHWA Project Number:** MT 10-02

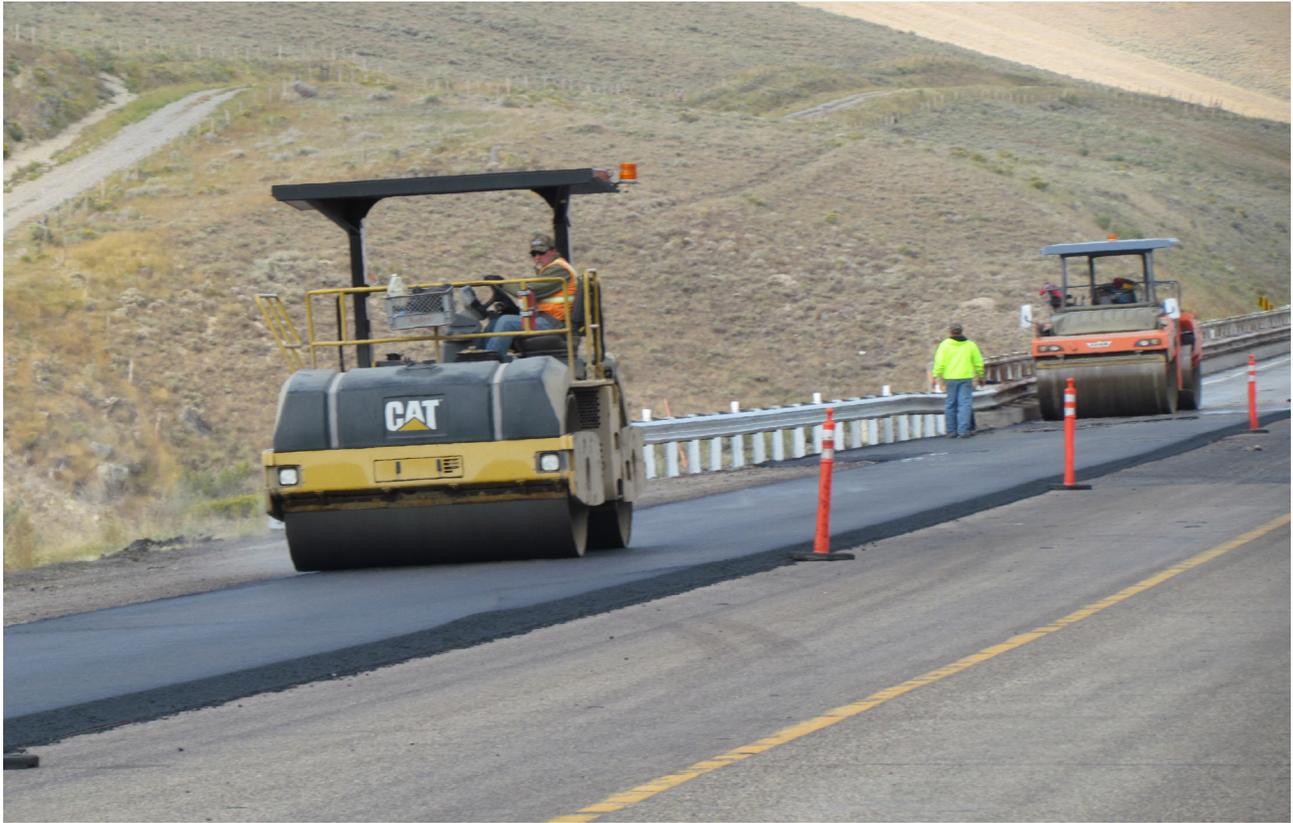
Figure 4- Beginning of Sasobit paving section, note the “wave” of plant mix in front of rollers

The Sasobit WMA application appeared to have issues with compaction when placed at high temperatures. Observed were excessive mat rollout to 15 feet instead of normal 12 feet, moisture on the plant mix, and a “wave” of

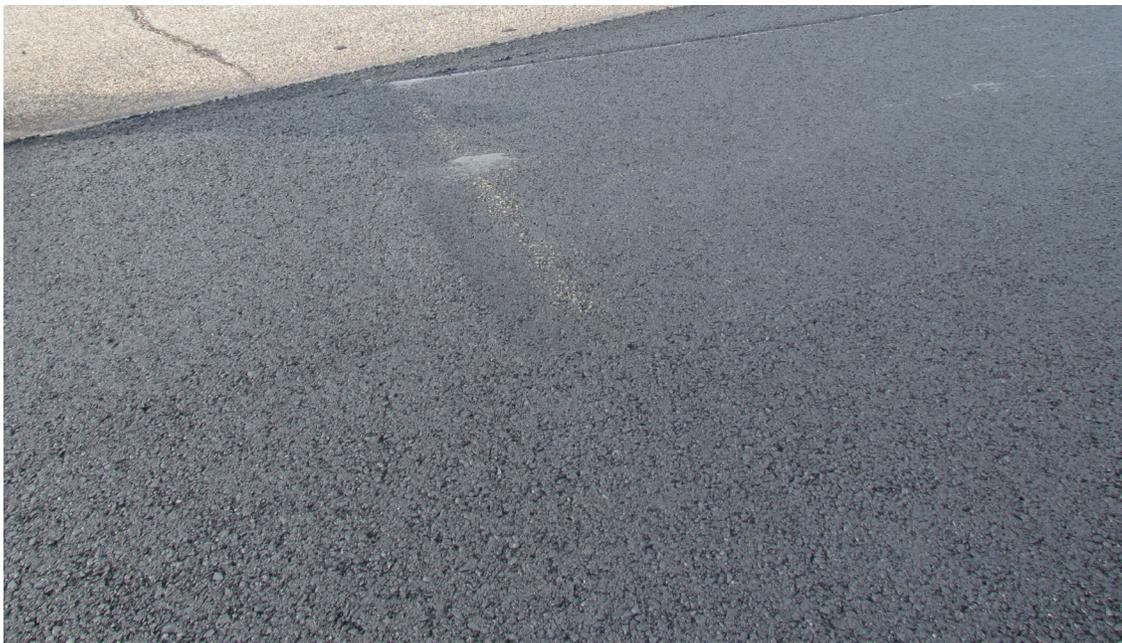
Figure 5- Beginning of Sasobit paving section when plant and placement temperatures were high

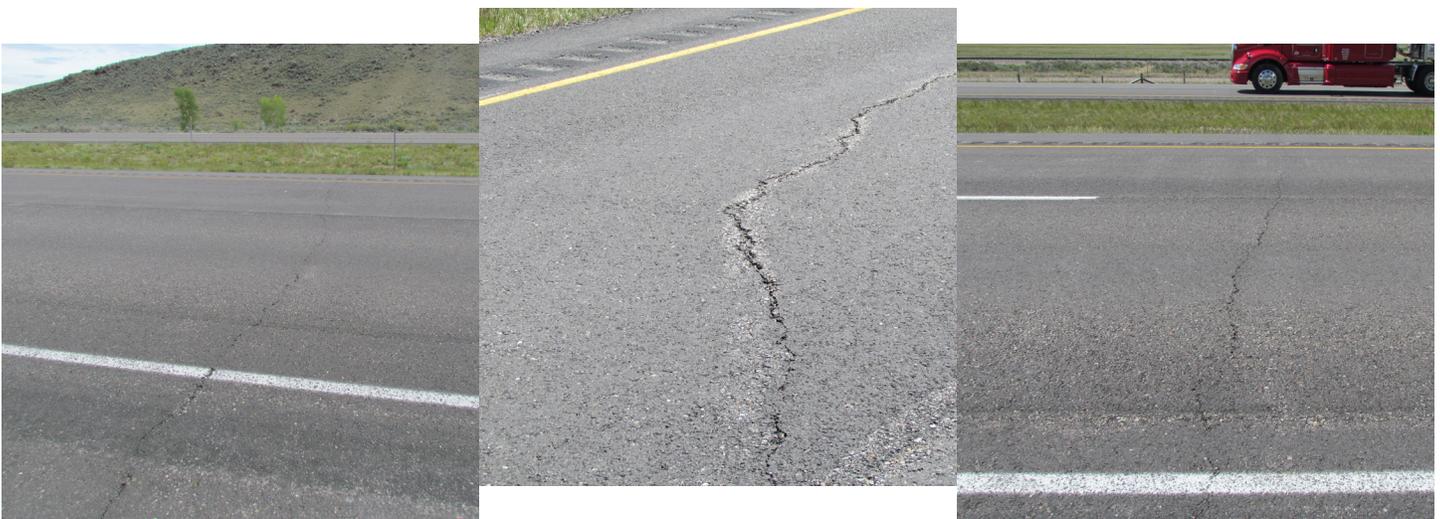
Research staff visited the the Monida-Lima site along with Butte District Construction and contractor staff to view reported cracking in the pavement. This visit was May 31, 2012 and the entire project had not received a seal coat application. Reflective cracking in the pavement was seen and documented throughout the whole project including each section of WMA technology and HMA in both northbound and southbound lanes (see Figure 11). After this review, the Butte District decided to perform crack seal work after the seal coat application. The entire project was sealed and covered July 2012.

Figure 11- Examples of surface cracking in hot mix asphalt pavement in southbound lanes (left), warm mix asphalt pavement (center), and hot mix asphalt pavement in northbound lanes (right)

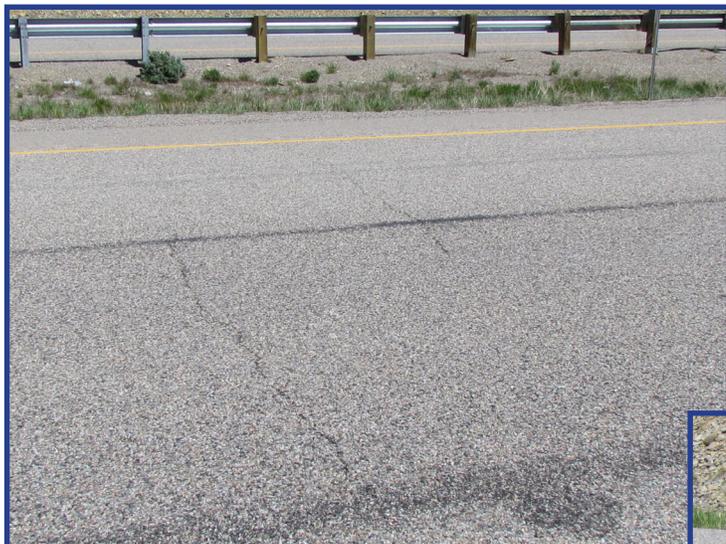
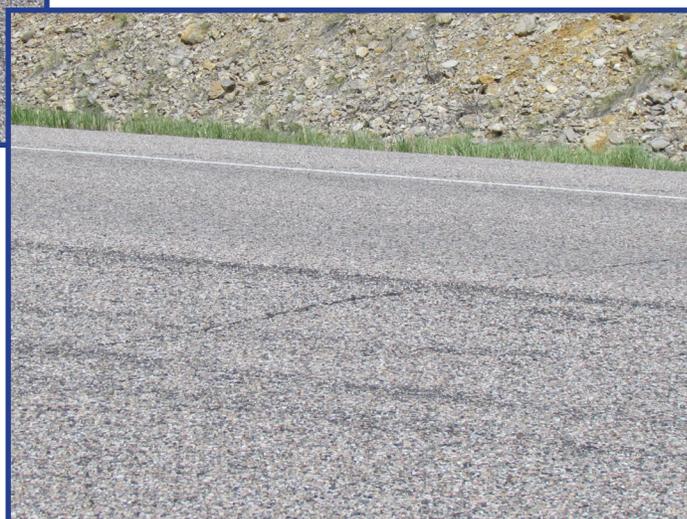
Research staff visited the project site May 2013. There was no visible difference between all sections of each WMA technology or the HMA pavement in either the southbound or northbound lanes. Reflective cracking was present and cover material from the seal and cover (done July 2012) was missing from the roadway throughout whole project. The figures below represent the visual condition of the pavement in the southbound and northbound lanes.

Figure 12- Examples of reflective cracking in warm mix asphalt pavement (top) and hot mix asphalt pavement in northbound lane (right)

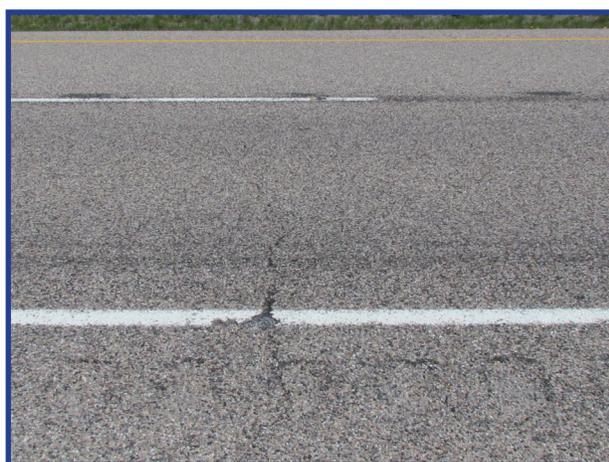
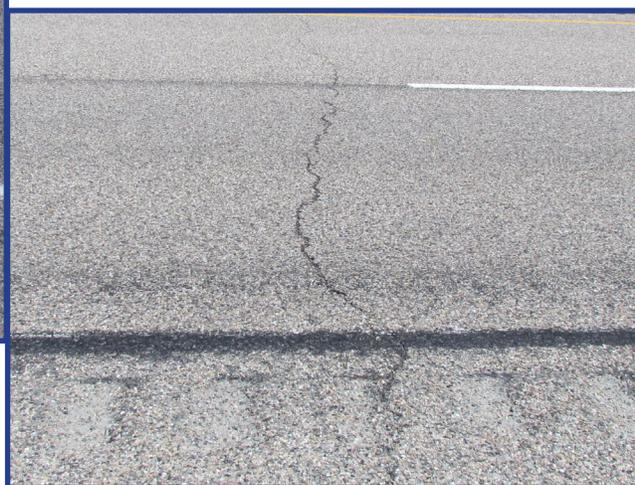
Figure 13- Examples of cover material loss along the roadway shoulder and center line in southbound lanes

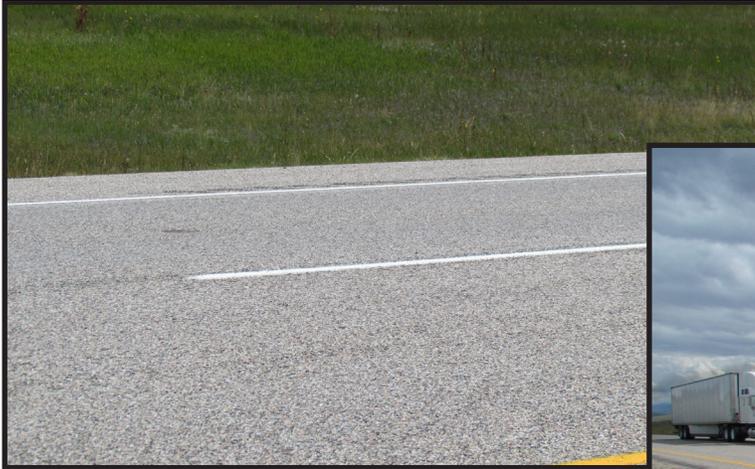
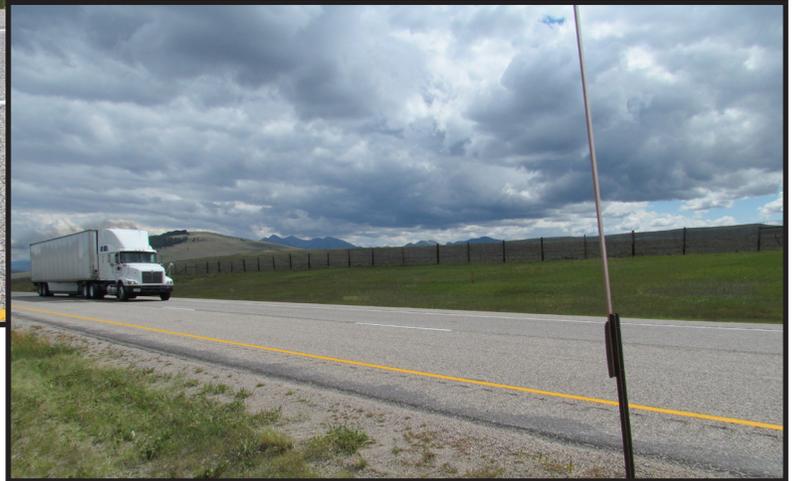
Research staff visited the project site late August 2014. Similar to 2013's visit, there were no visible differences between all sections of the WMA technology or the HMA pavement in either the southbound or northbound lanes. Reflective cracking was present and cover material from the seal and cover was missing from the roadway throughout whole project. The figures below represent the visual condition of the pavement in the southbound and northbound lanes.

Figure 14- I 15 southbound (top) and northbound (right) approximately RP 16

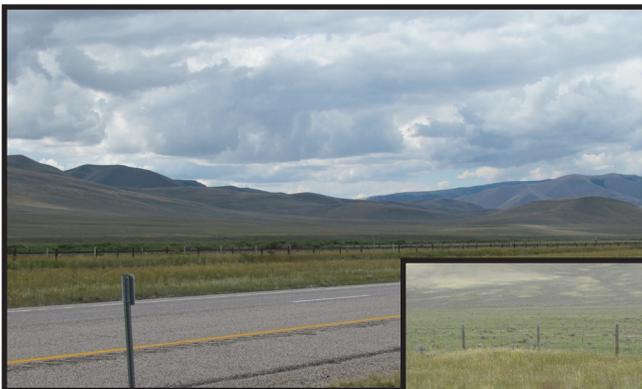
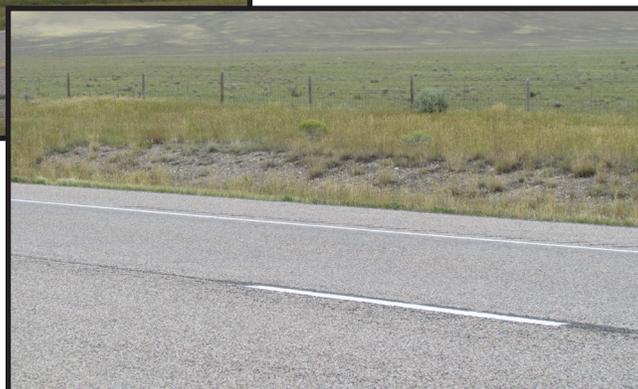
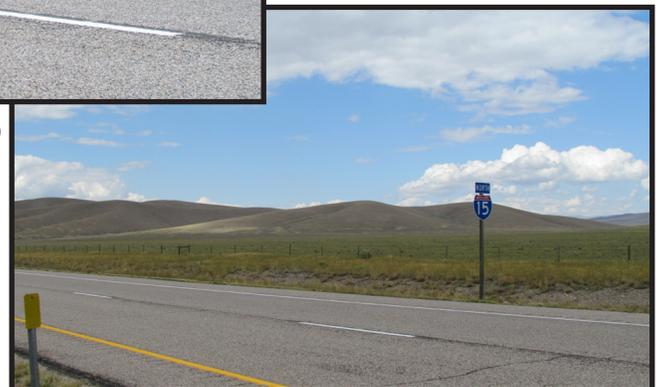
Figure 15- I 15 southbound (top), northbound close-up (middle) and northbound (right) approximately RP 6

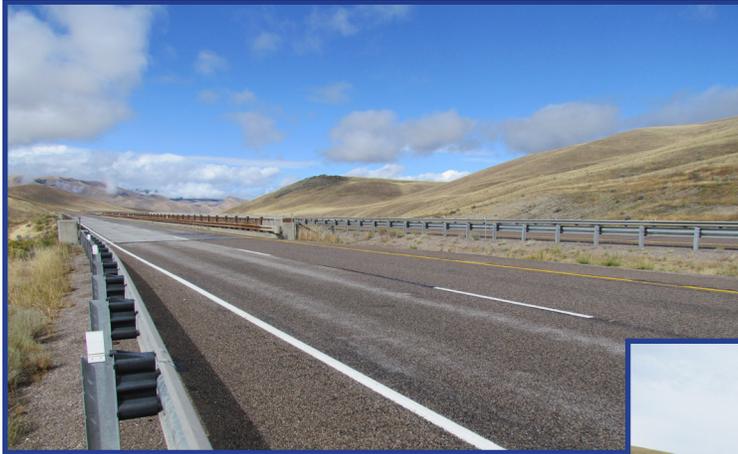
Research staff visited the project site mid-September 2015. Similar to previous visits, there were no visible differences between all sections of the WMA technology or the HMA pavement in either the southbound or northbound lanes. Reflective cracking was present and cover material from the seal and cover was missing from the roadway throughout whole project. The figures below represent the visual condition of the pavement in the southbound and northbound lanes.

Figure 16- Sasobit treatment southbound (left) and HMA northbound (below) approximately RP 17

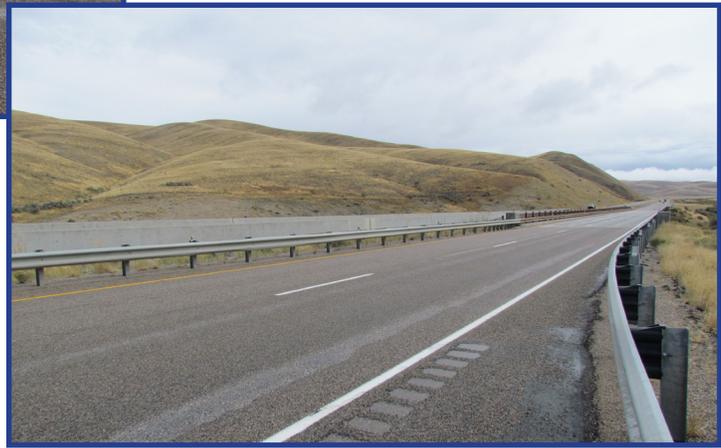
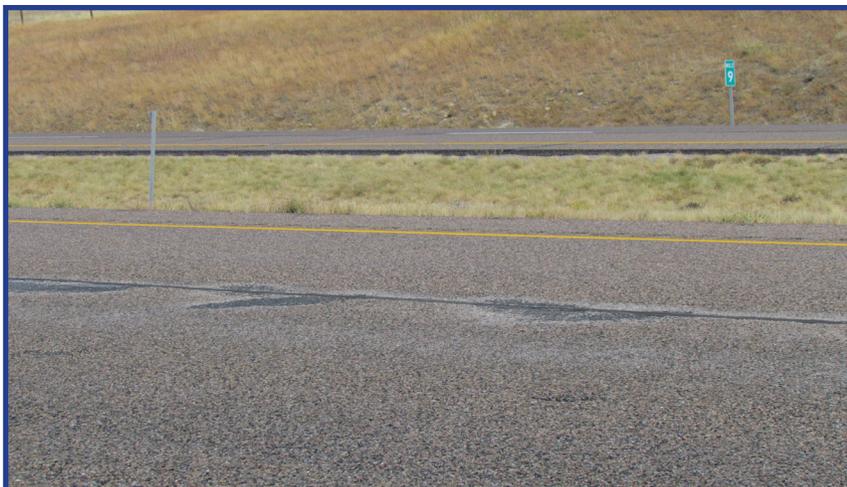
Figure 17- Evotherm treatment southbound shows cracking near the centerline and missing seal and cover material near RP 9

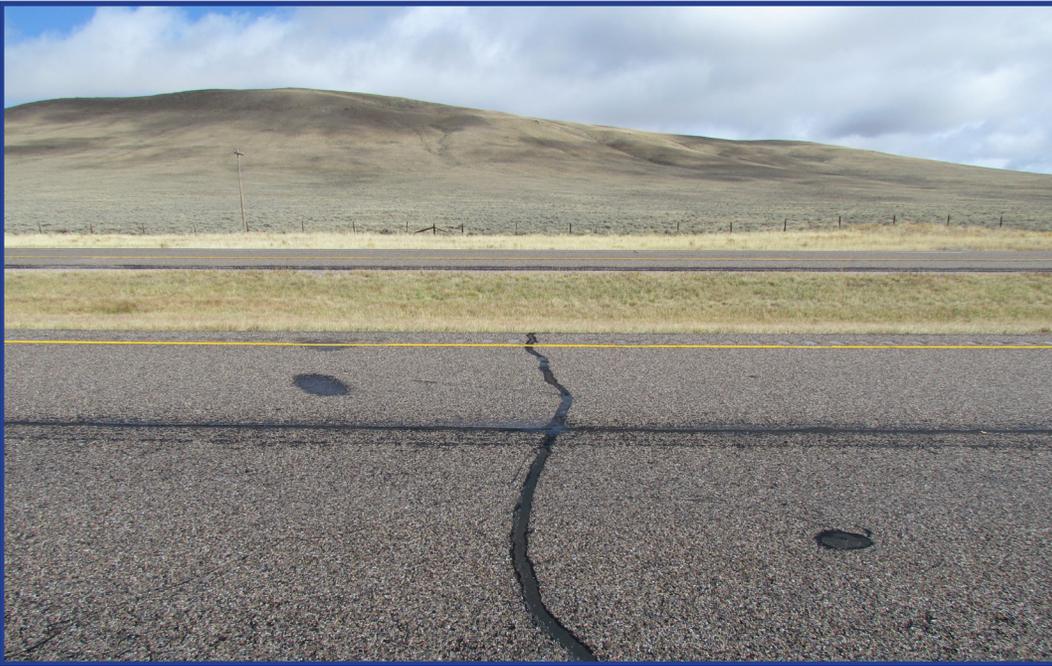
Figure 18- Reflective cracking and missing seal and cover material in southbound lane near RP 4.5

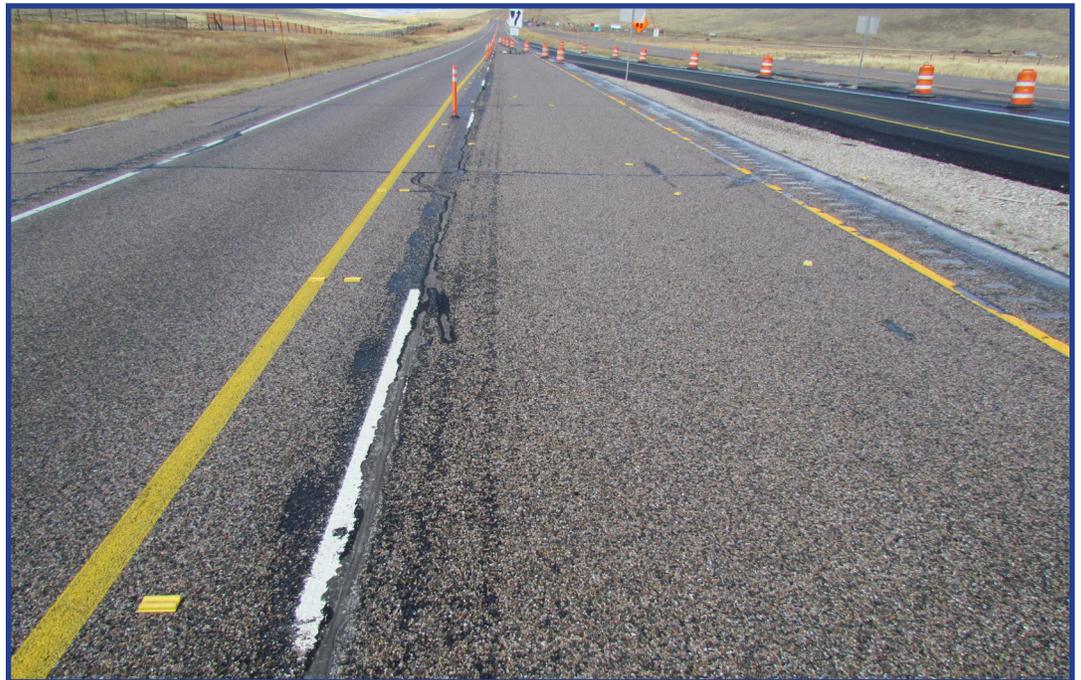
Figure 19- Foaming treatment southbound shows cracking near the centerline and missing seal and cover material near RP 1

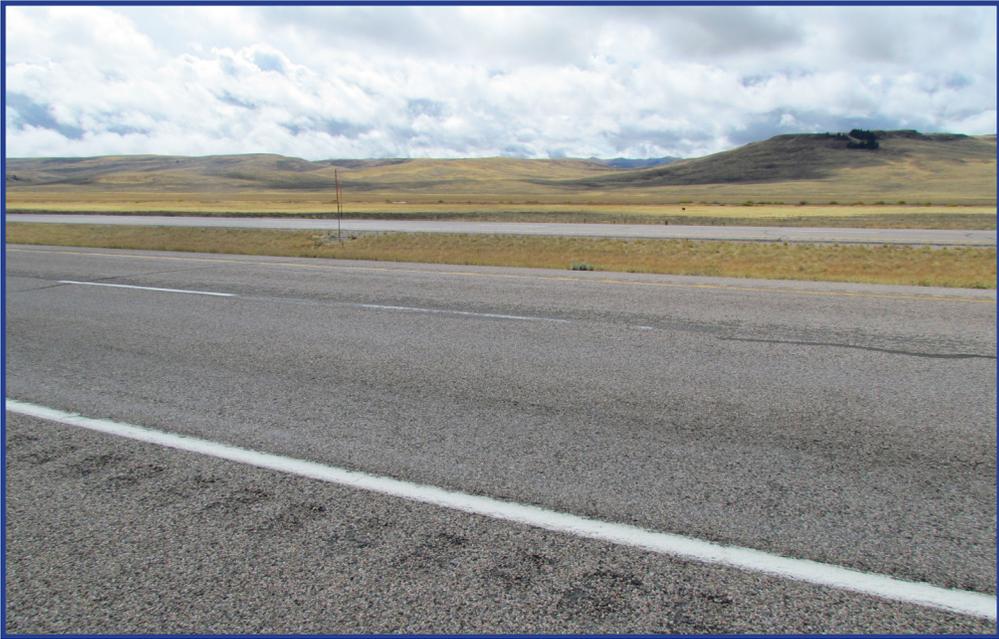
Figure 20- HMA northbound shows cracking near the centerline and missing seal and cover material near RP 5

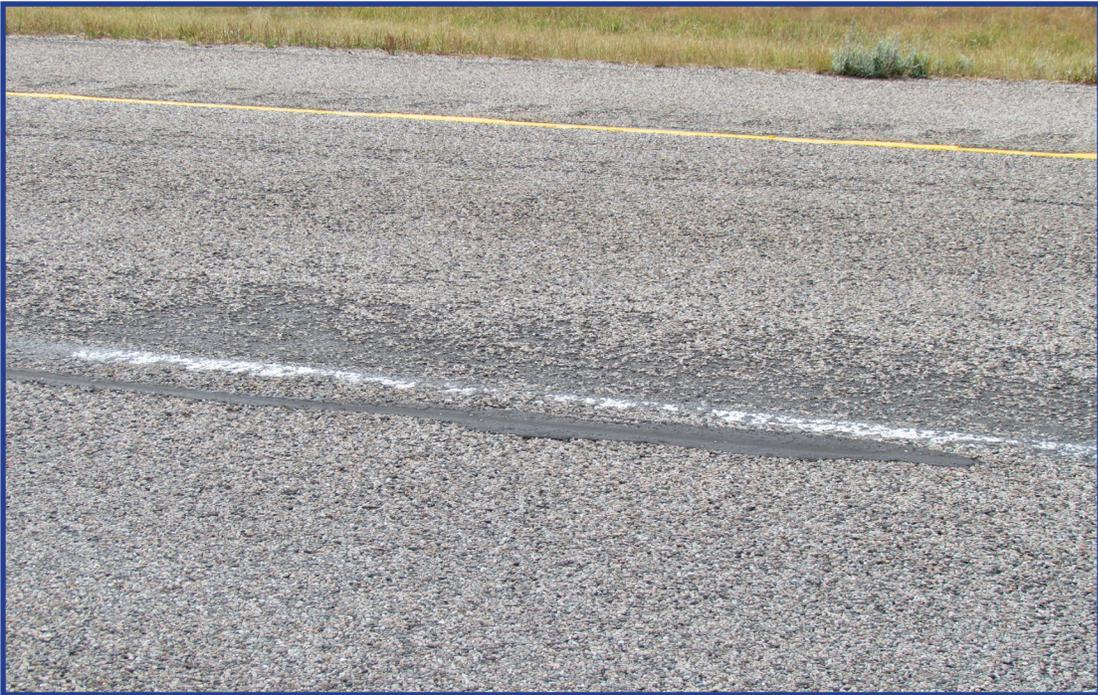
Figure 21- HMA northbound close-up shows cracking near the centerline and missing seal and cover material near RP 5
