Montana Department of Transportation

Structure Name: Timberlane  
 Route & MP: 68-07.4

Inspection Date: 8/12/05

**USDA, FOREST SERVICE  
 ROUTINE ROAD BRIDGE INSPECTION REPORT**

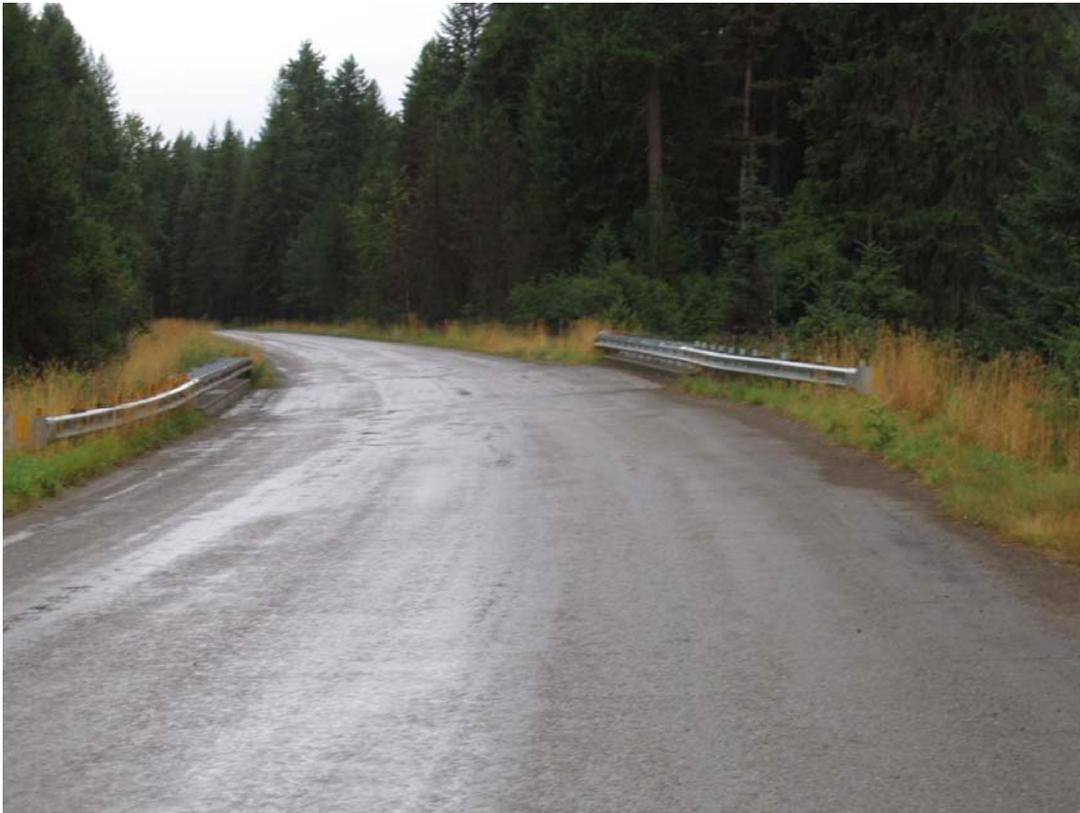
Photo #1 – View of the approach looking back.

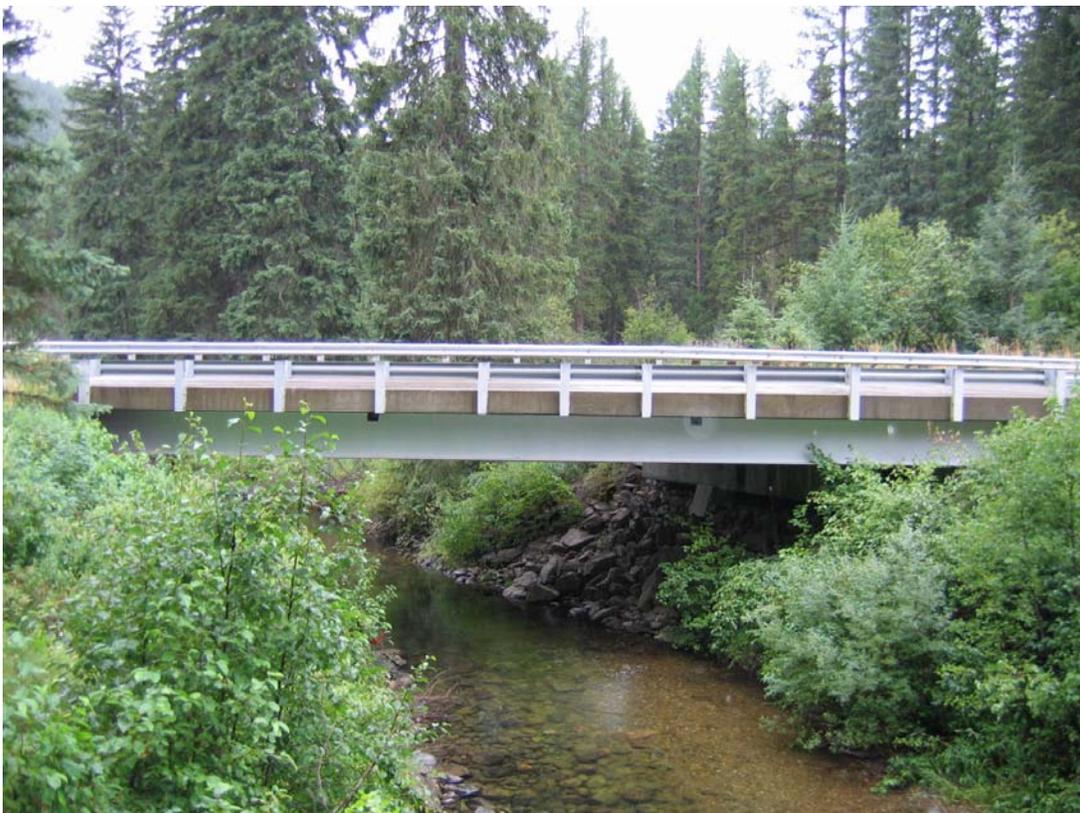
Photo #2 – Profile view looking downstream.

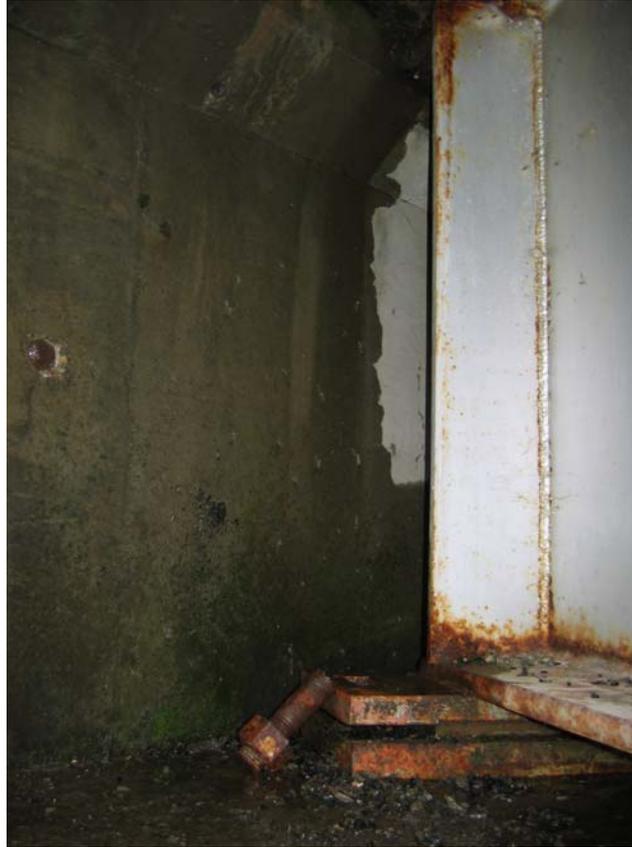
A. DIAPHRAGMS	G		
	B. BRACING	NA		
*2.	FLOOR BEAMS	NA		
*3.	STRINGERS	NA		
*4.	TRUSSES	NA		
	A. CHORDS	NA		
	B. PORTALS	NA		
	C. VERTICALS/DIAGONAL	NA		
	D. BRACING	NA		
C1.	BEARING DEVICES	P	Two anchor bolts sheared off at abutment #1, upstream girder.	
C2.	PAINT	F	No noticeable progression in flaking paint on 2 <sup>nd</sup> girder from downstream.	
C3.	DEFLECTION UNDER LOAD	NOB		
C4.	VIBRATION UNDERLOAD	NOB		
<b>60. SUBSTRUCTURE:</b>			<b>7</b>	
A	*1. ALIGNMENT (TIPPING, TILTING,...)	G		
B	*2. EROSION OR SCOUR	F	Loss of material under abutments and end wing walls.	
U	*3. SETTLEMENT	G		
T	<b>TIMBER ABUTMENTS (INCL. WW)</b>			
M	*4. CAPS	NA		
E	*5. POSTS/PILES	NA		
N	*6. BACKING PLANKS	NA		
T	*7. SILLS/FOOTINGS	NA		
S	*8. CRIB WALLS	NA		
	<b>OTHER ABUTMENTS</b>			
	*9. CAPS	G	Random cracking.	
	*10. FOOTINGS	NOB		
	*11. BACKWALLS	G	Leaking joint between backwall and deck causing wet conditions at bearings.	
	*12. PILES	NA	Several tight vertical cracks.

Photo #3 – View of the broken anchor bolt at abutment #1.

REASON* /PRIORITY**	REFERENCE CODE	DESCRIPTION	COST
H/N		Technical Bridge Inspection	\$500
H/N	36.C	Repair bridge rail post anchorage	\$2,000
H/N	59.C1	Repair bearing devices at abutment #1	\$5,000
H,R/N	59.C2	Paint Steel girders	\$20,000
H/N	60.15	Place riprap along downstream north bank	\$500
H,R,N	61.1	Remove leaning tree	\$500
H/N	Wearing Surface	Asphalt seal and patch on areas above backwalls to stop water from penetrating onto caps	\$400

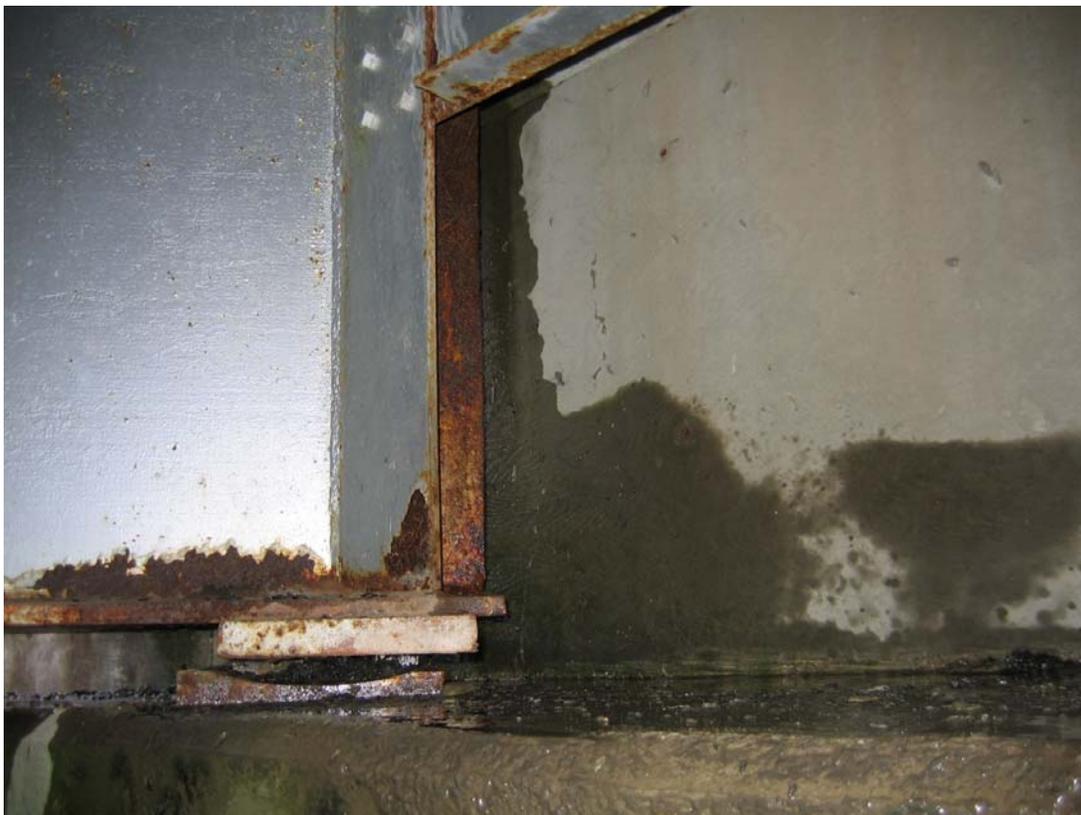
Photo #4 – View of the expanded bearing at abutment #1. Also note the leaking backwall/deck connection.

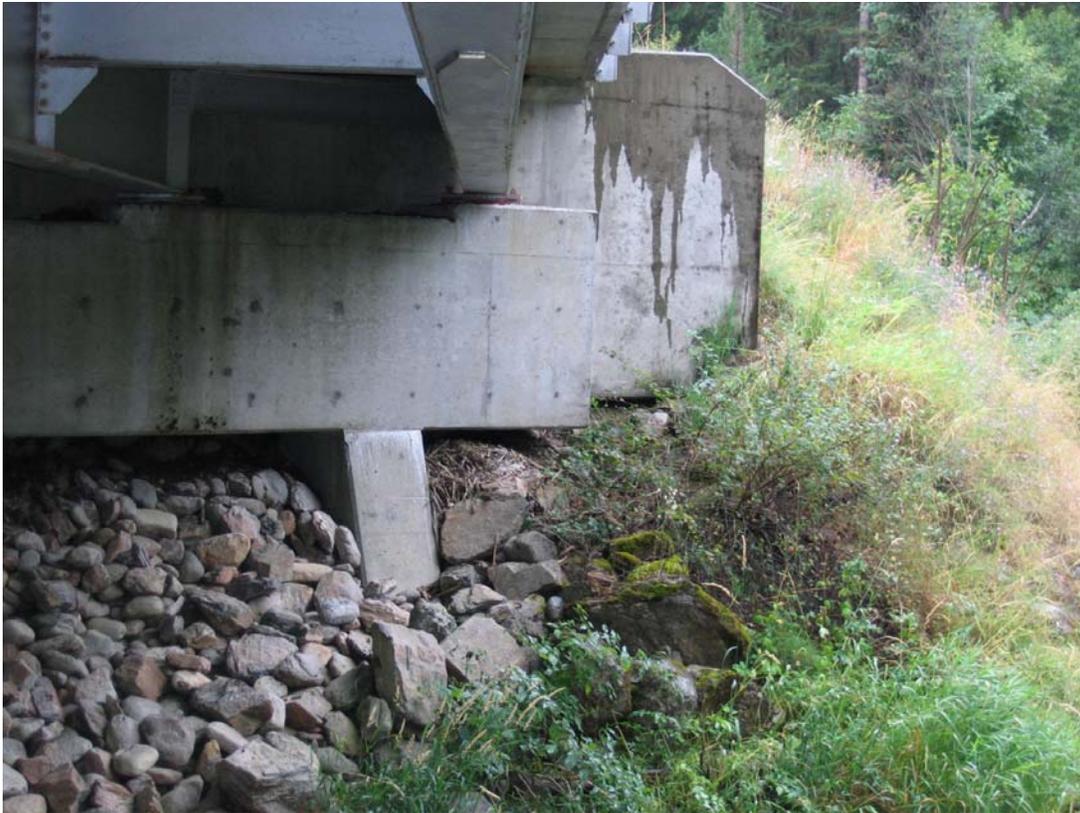
Photo #5 – View of material loss typical under both abutments and wing walls.

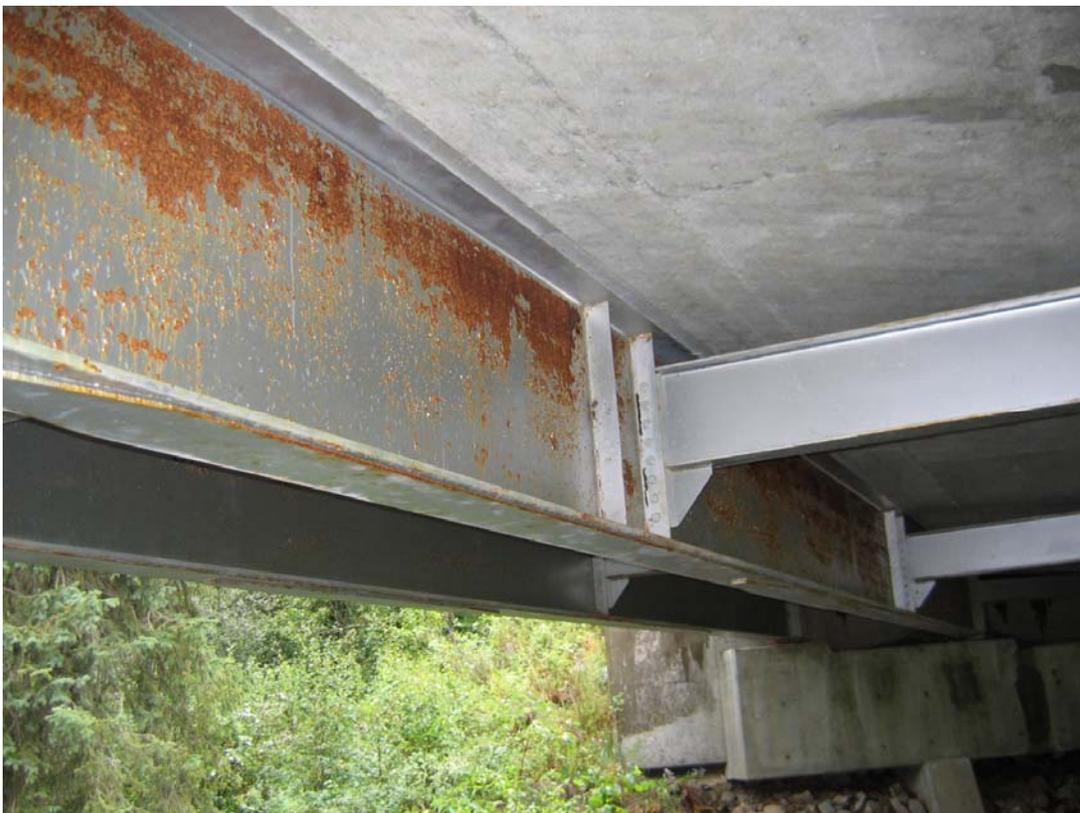
Photo #6 – View of failing paint on the 2<sup>nd</sup> girder from downstream.

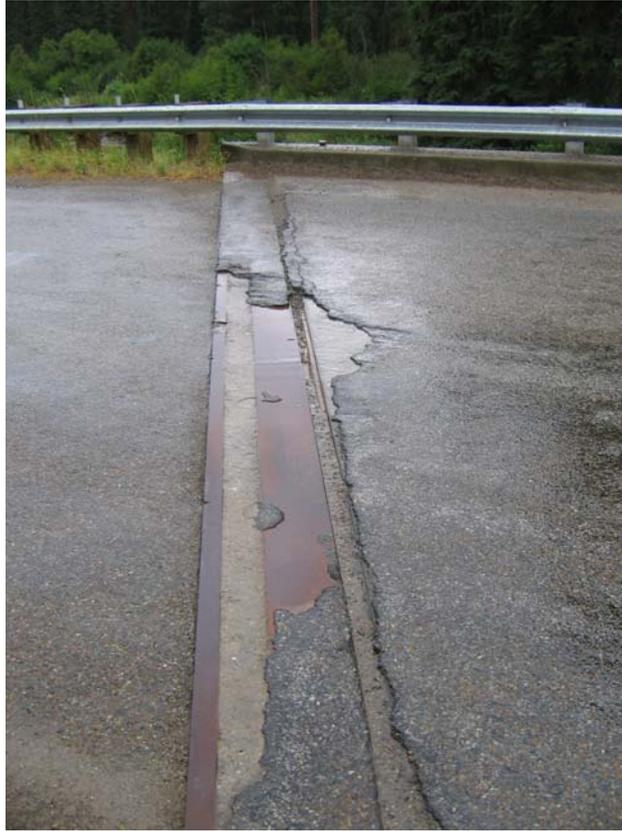
Photo #7 – View of failing approach asphalt at abutment #1 which creates an abrupt transition on to the deck.

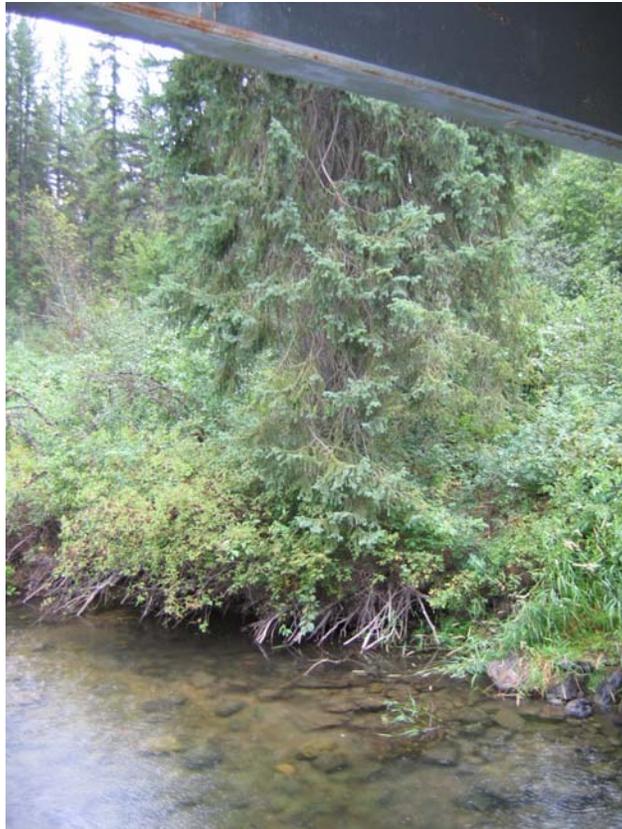
CONDITION RATING			REMARKS
<b>61. CHANNEL AND CHANNEL PROTECTION</b>			<b>7</b>
*1.	CHANNEL SCOUR/EROSION	F	As previously noted downstream bank erosion has resulted in undermining of a large tree with exposed roots. Tree is currently leaning towards bridge.
*2.	CHANNEL PROTECTION	G	
*3.	VEGETATION	G	
*4.	WATERWAY OBSTR./DRAFT	G	Log upstream 50'.
*5.	ADEQUACY OF OPENINGS	G	
C1.	CLEAR HEIGHT	G	
<b>APPROACH CONDITION:</b>			<b>G</b>
*1.	SURFACING	G	Loss of surfacing above backwalls.
*2.	SHOULDER EMBANKMENT	G	
*3.	ROADWAY EMBANKMENT	G	
*4.	APPROACH SETTLEMENT	G	Transverse crack at approaches with 1/2" of settlement at abutment #1 (south).
<b>APPRAISAL CODES and REMARKS</b>			
<b>36. TRAFFIC SAFETY FEATURES:</b>		<b>1 1 1 1</b>	
*A.	BRIDGE RAILING	G	Collision impact damage at abutment #2, upstream post at deck connection.
*B.	RAIL TRANSITIONS	G	New 2001.
*C.	APPROACH GUARDRAILS	G	New 2001.
*D.	APPROACH RAIL ENDS	G	New 2001.

Photo #8 – View of the downstream streambank and undermining of a large tree which is leaning towards the bridge.
