EXPERIMENTAL PROJECTS CONSTRUCTION REPORT AND EVALUATION

KWIK BOND 1121 POLYESTER POLYMER CONCRETE (PPC) OVERLAY

Project Name: Br Deck Rehab/Repair 11

Experimental Project: MT-13-05

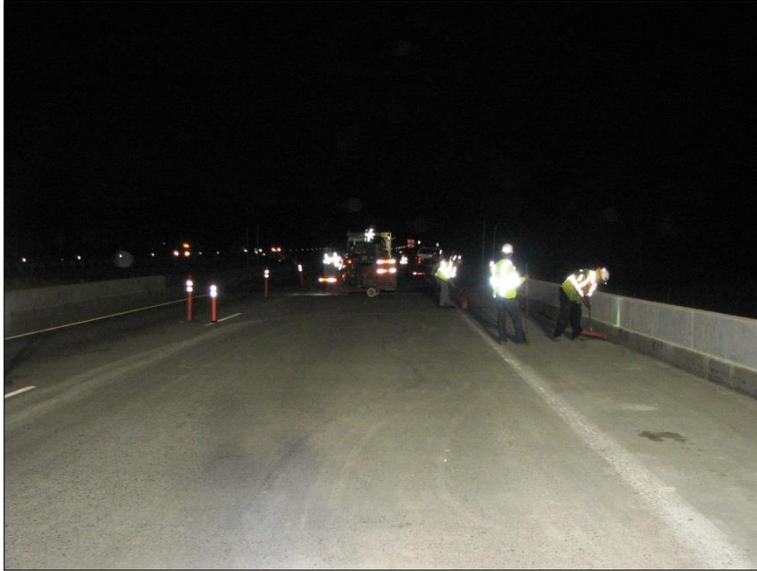
← Although difficult to see in this image, deck preparations consist of sand and metal shot blasting, hand grinding of pavement markers, air blasting, deck sweeping, and solvent spot cleaning of oil and stains.

Proper deck preparation is a critical element in the PPC process.

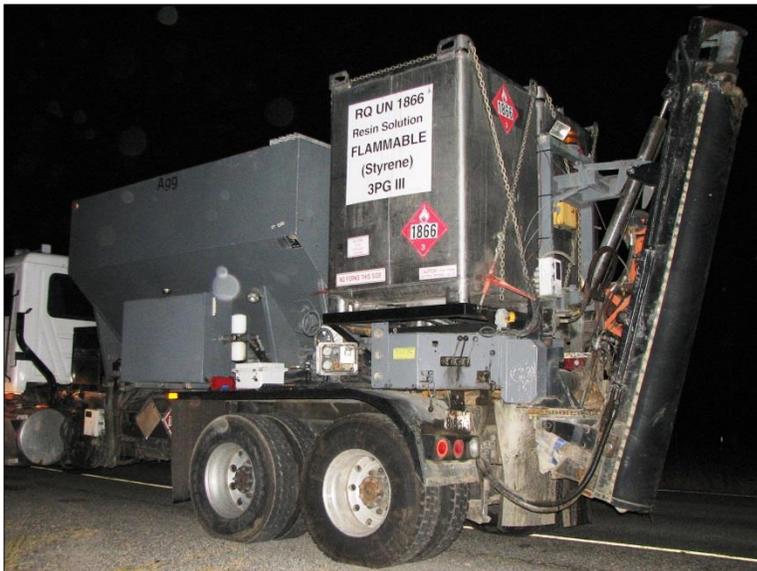
← A specialized mobile mixing unit is used for the PPC overlays.

The mobile unit contains the storage bins for the blend of aggregates to be used, the polyester polymer storage tank (unsaturated polyester resin in styrene), and the PPC screw mixing auger.

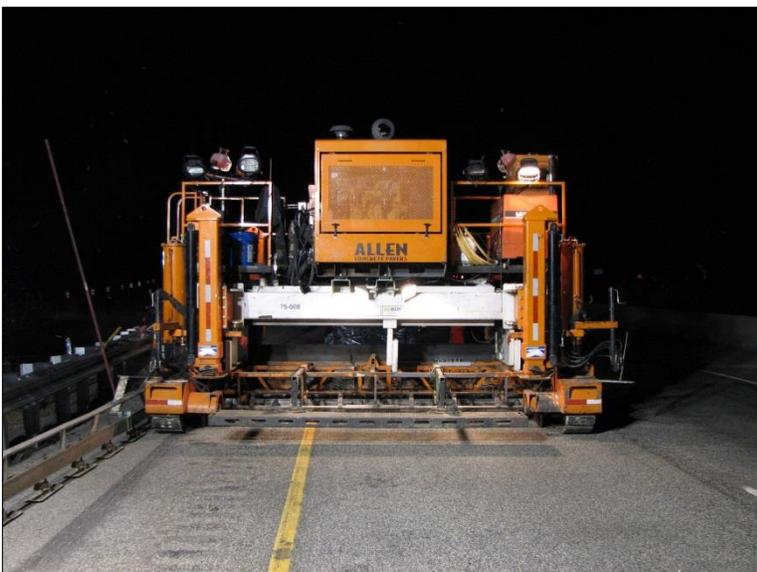
← The paving unit is an Allen High Profile Two Track Polyester Slip Form specifically modified for PPC paving applications.

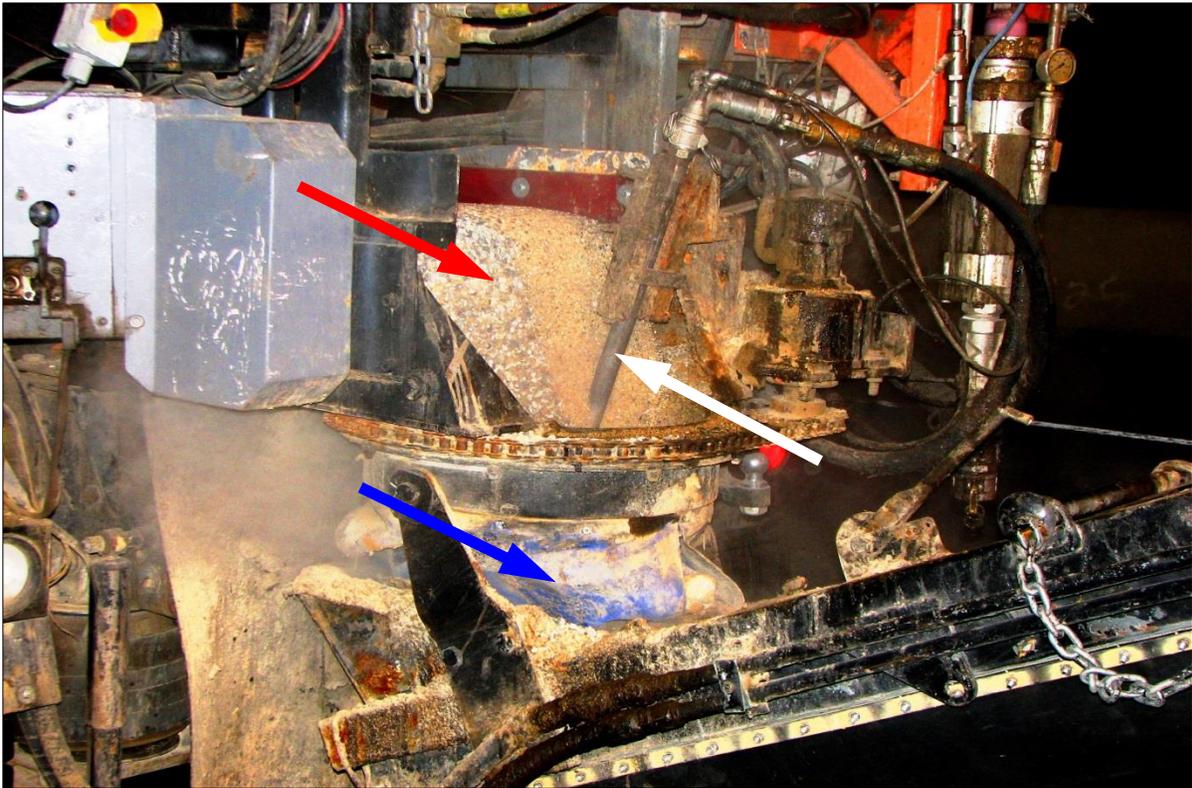
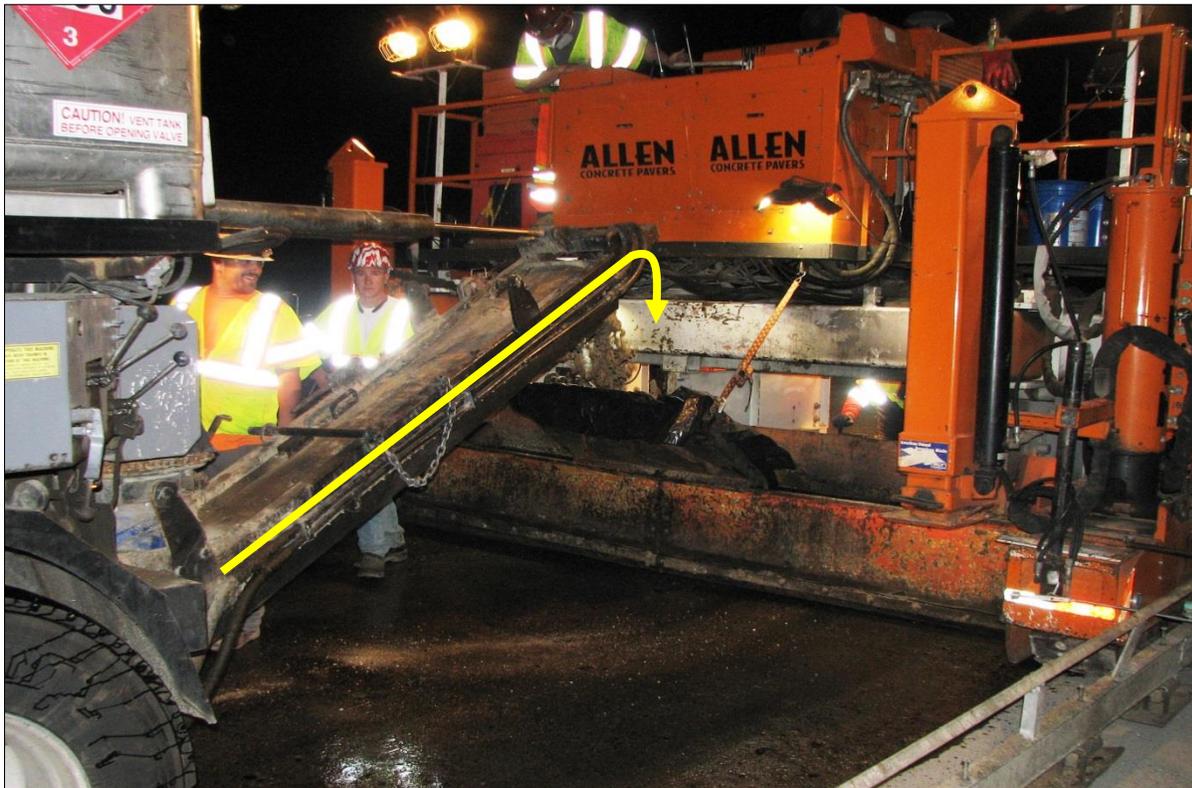
- ↑ During active operation, the aggregates (red arrow), are conveyed to the mixing chute (blue arrow); the styrene is injected into the aggregate blend by a fixed nozzle (white arrow).
- ↓ The styrene infused aggregates are then transported through a mixing auger screw/chute (yellow arrow) to be deposited into the paver hopper.

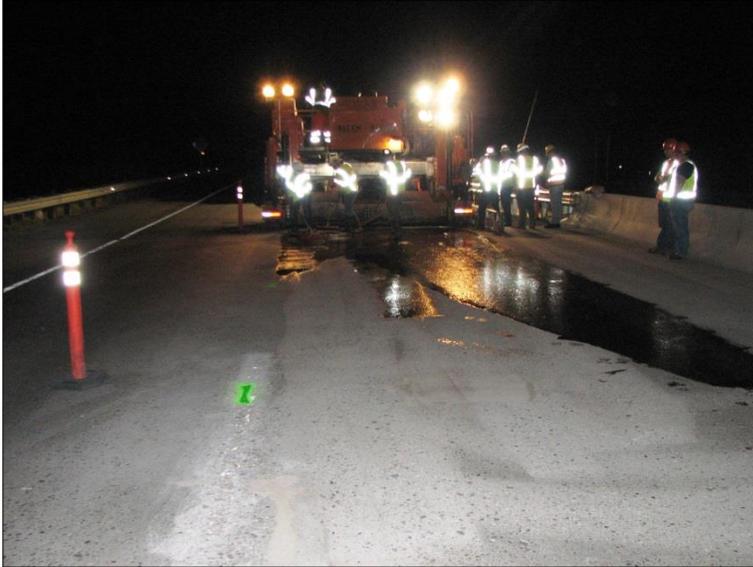
← Prior to the paving of the overlay, high molecular weight methacrylate (HMWM) is added to the prepared surface as a prime sealing coat.

Paving begins immediately after the HMWM is applied.

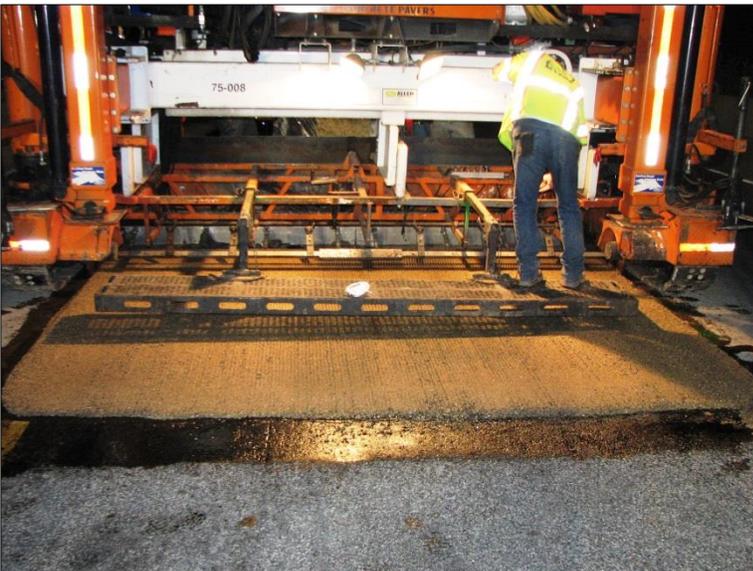
← At the beginning of the paving runs.

Note the paver initially tines the PPC as it exits out the rear of the slip form.

Based on a projects requirement, a PPC overlay may vary from 3/4" to 12" in thickness.

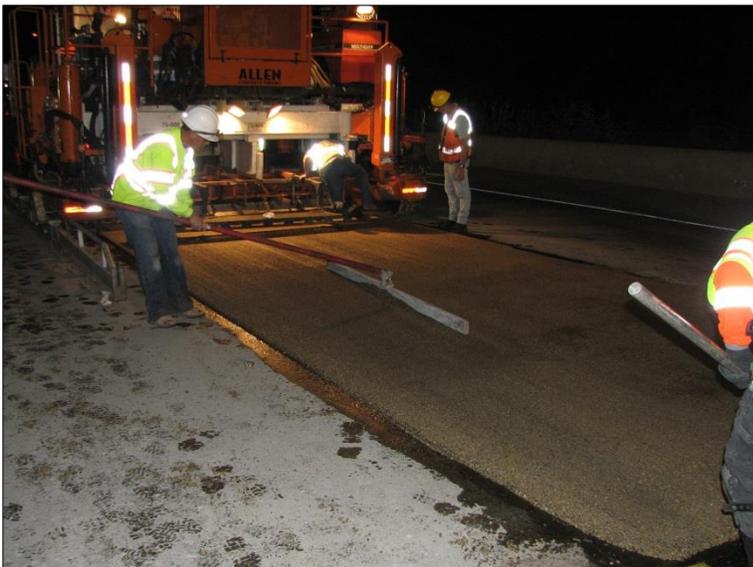
← The PPC is screed and floated to the desired density and texture.

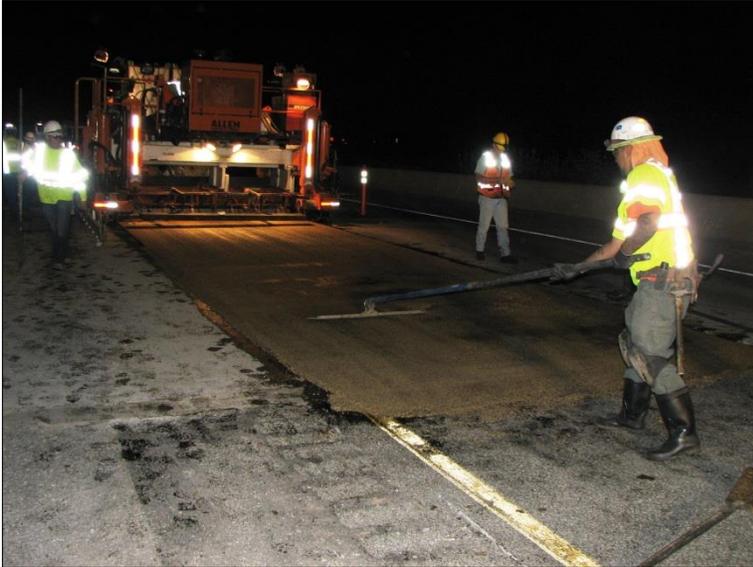
← Another image showing the workman applying a float to the PPC.

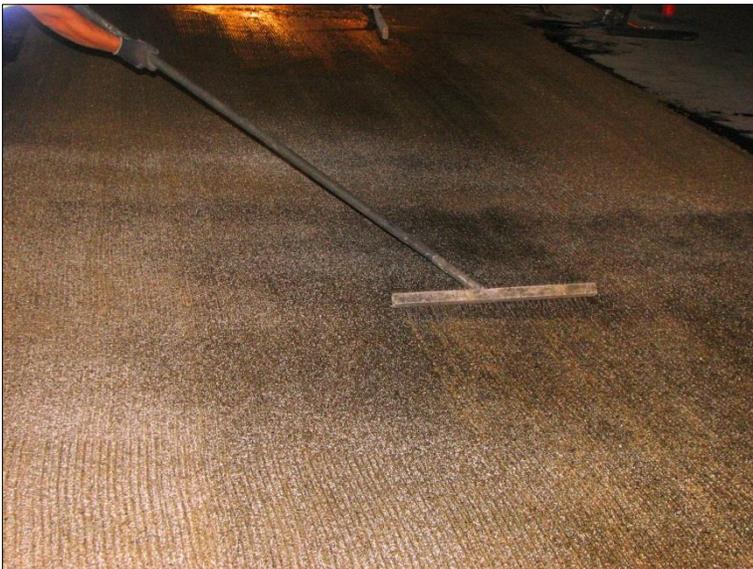
← Longitudinal tining is reapplied for mechanical texture as one of the last steps in completing the PPC run.

However, prior to tining; a layer of top sand (quartzite) is hand applied to the surface of the overlay to provide added mechanical skid resistance.

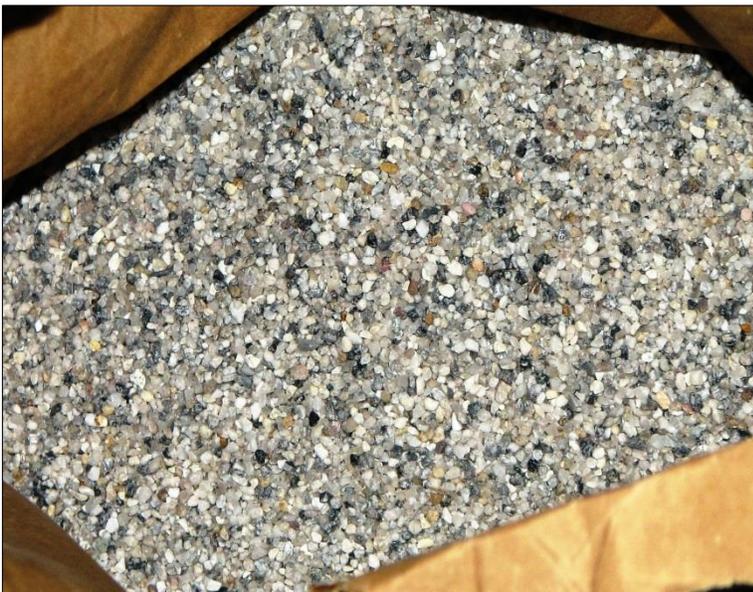
← Close-up of the Kwik Bond top sand.

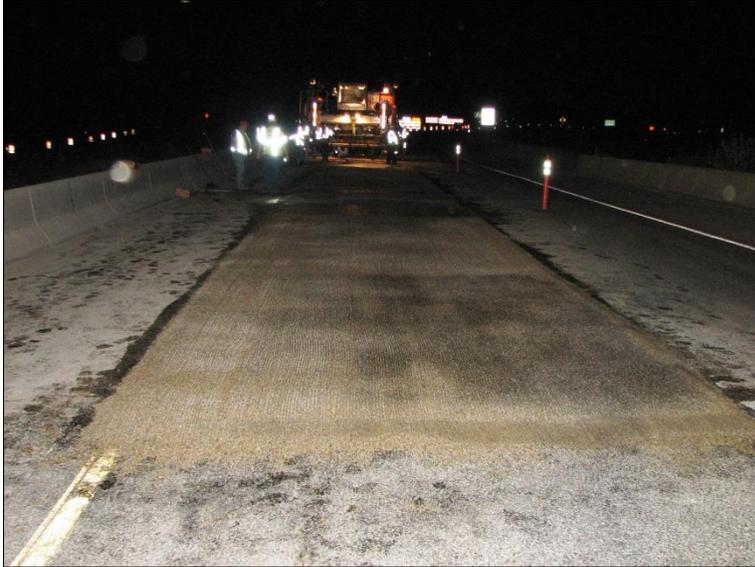
← Completed PPC run with approach and edges feathered.

The edges were initially feathered for a smooth traffic transition from pavement to deck surface.

The approaches were rebuilt to insure a jointed connection with the deck overlay and pavement, (see pages 9 & 10).

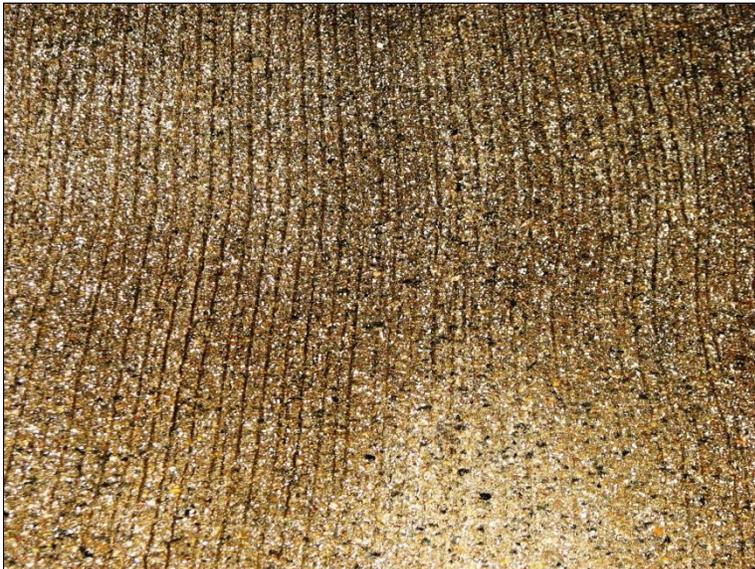
← Close-up of tined surface with top sand application.

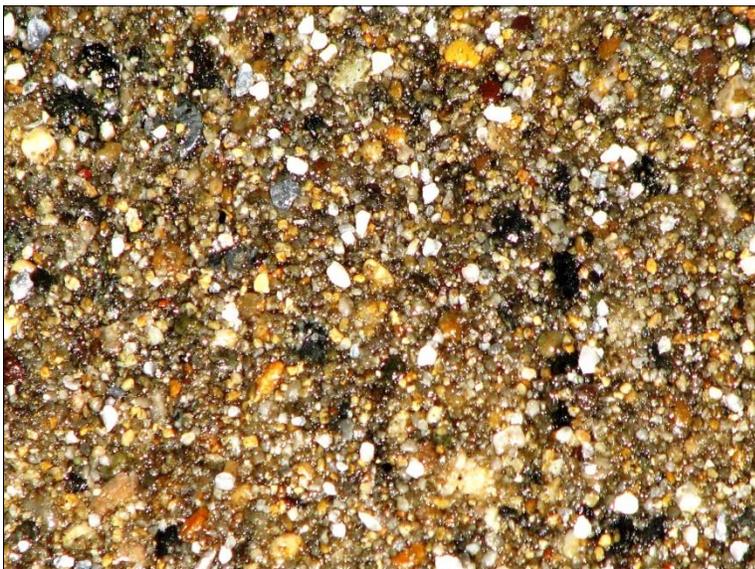
← Additional close-up of aggregate texture with added top sand prior to tining.

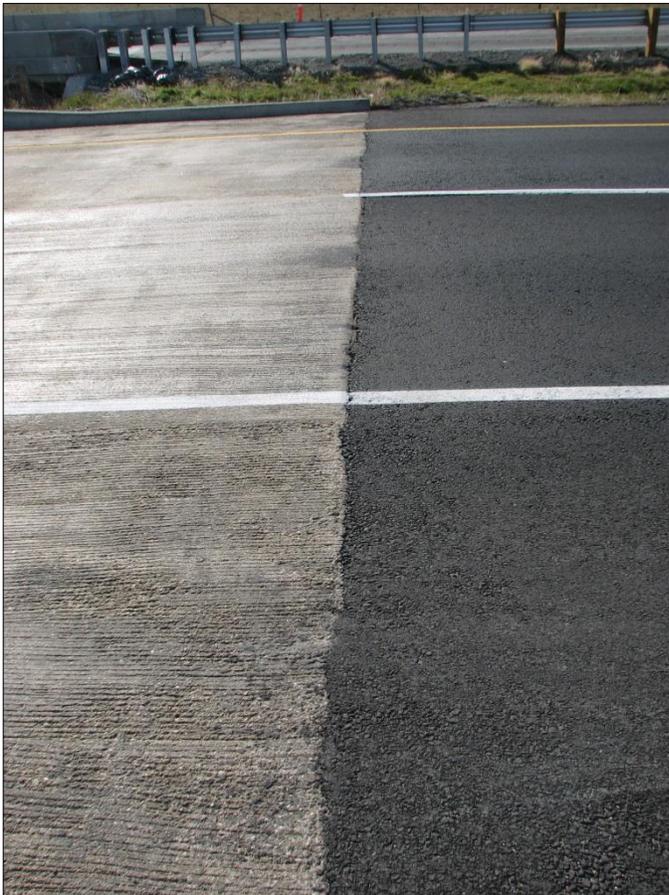
← A smooth transition was attained by rebuilding the approaches.

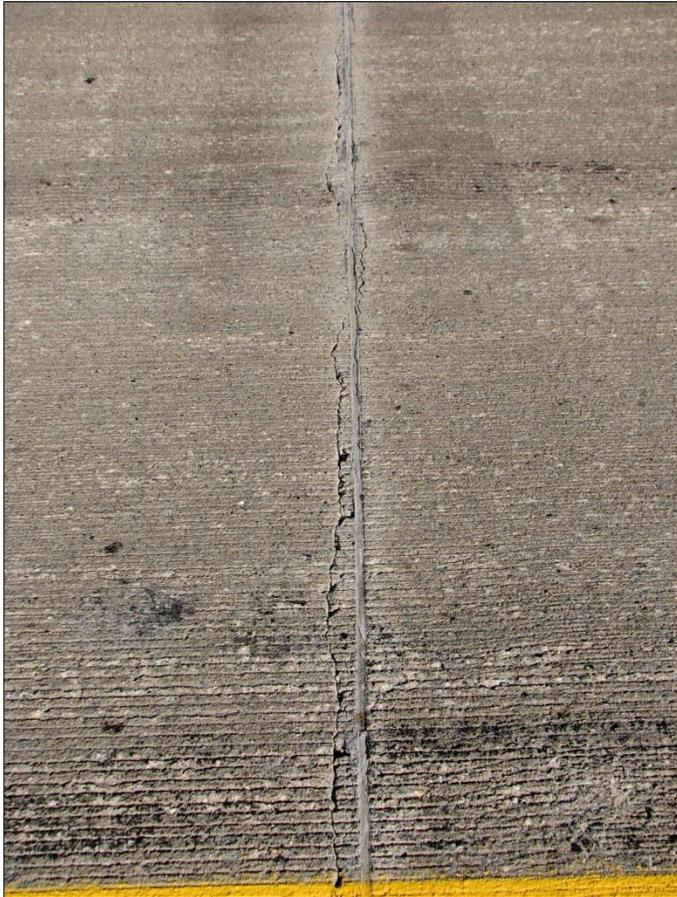
Transverse cracks have appeared at deck joints considered to be normal and several cracks have appeared at the transition joints at pavement to deck; all minor to date.

← Sep County Rd. structure: View of cracking along an expansion joint on the south side, east end of the westbound deck.

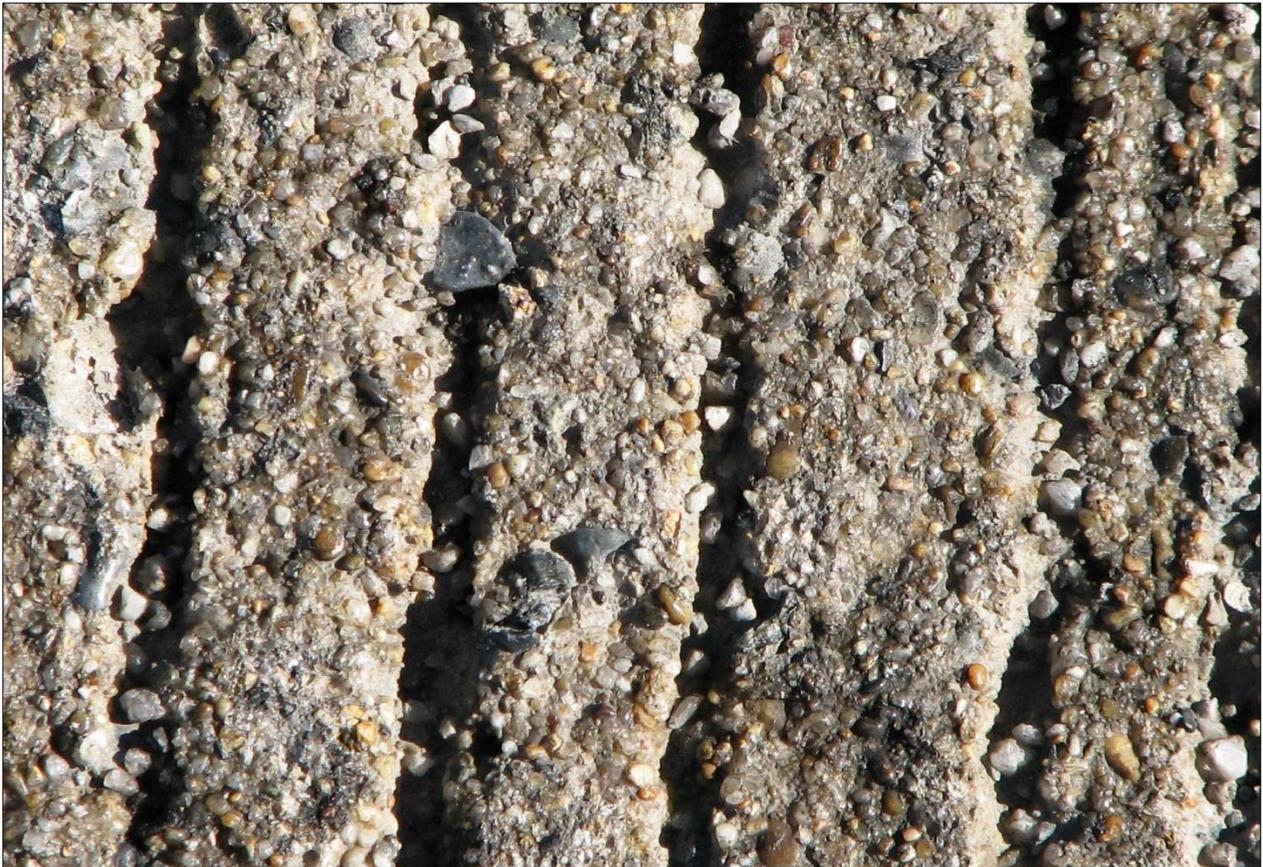
↓ Close-up of PPC texture in wheel path.

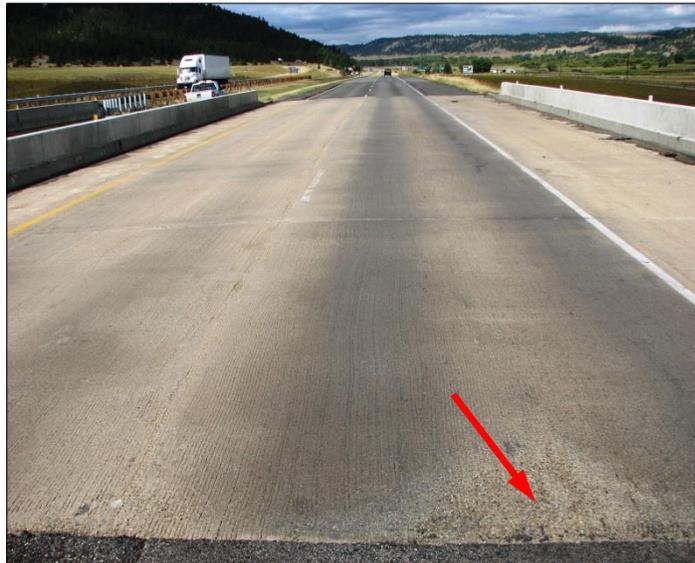
All three structures displayed good texture appearance since installation. No visible vehicle tire wear is apparent to date. No apparent snow plow activity has affected performance of the overlay with exception of the Sep County deck which has areas on the east end travel lane approach of assumed plow abrasion and more pronounced topical scraping of the overlay on the south side deck shoulder (see pages 12 & 13).

This abrasion or scraping of the PPC material is assume to be undulations of the polymer due to inconsistencies during the paving process (possibly due to the manual screed and floating of the material after paving) which created varying thicknesses susceptible to plow scrape.

← Surface textures in both lanes appeared to be in good condition after the first year since installation.

Some shearing, assuming plow scrape, of the PPC may be seen at the pavement to deck transition travel lane (Red arrow).

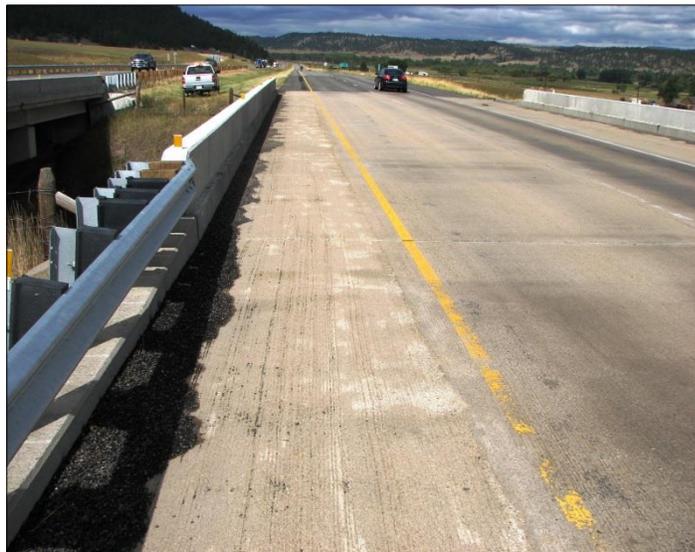
← Additional plow abrasion is apparent on the deck shoulder; predominately on the south side.

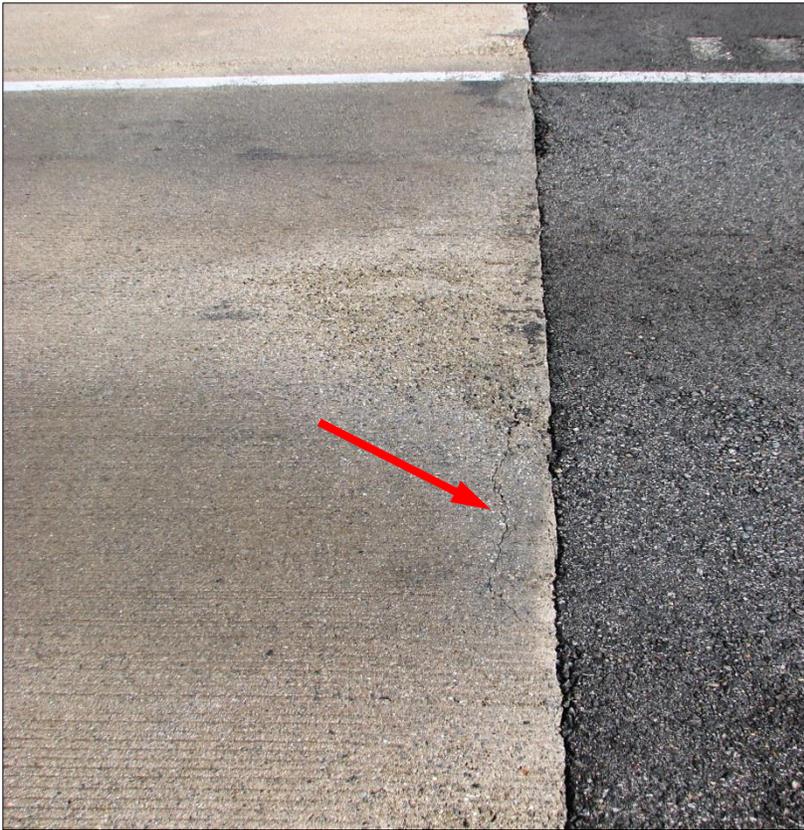
← Closer view of the plow scrapes on the PPC travel lane in addition to some localized cracking near the joint approach (red arrow).

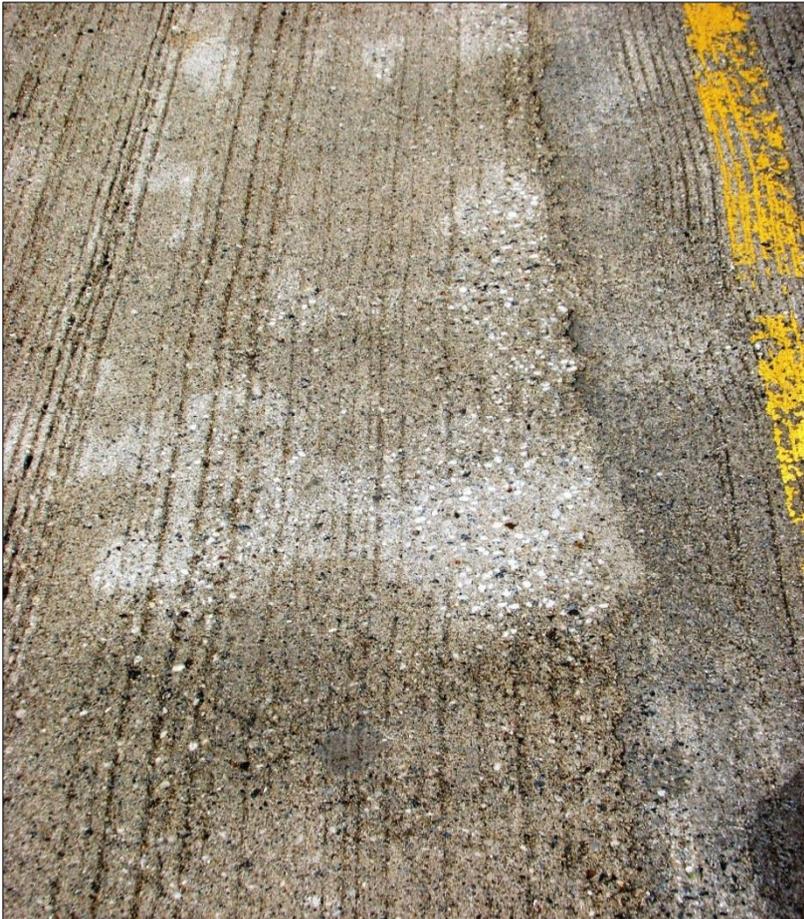
← Close-up of PPC abrasion by plow passes (south deck shoulder).

Future inspections will document if this trend continues.

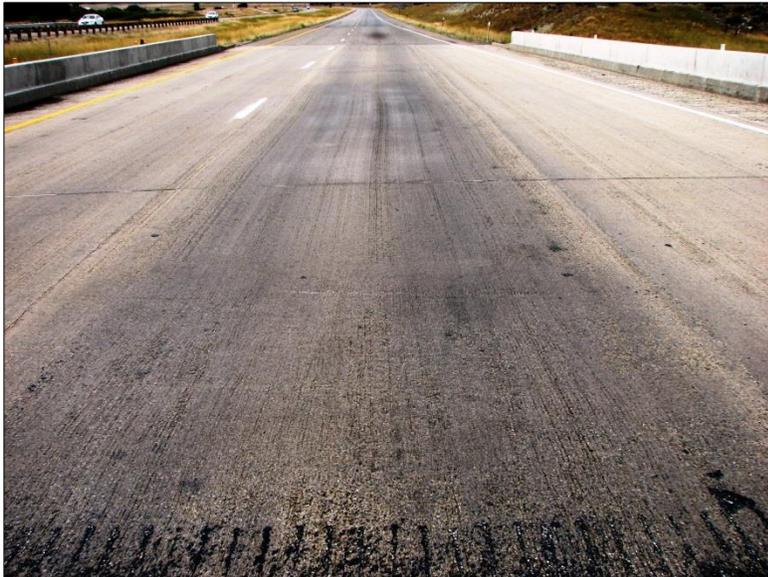
← Berry Creek Westbound:
Visually, Both structures
surface texture appear coarse
with tining well pronounced as
initially placed in 2014.

No evidence of plow abrasion
on any area of the two decks
as seen on the Sep County
structure.

The AC approaches have been
chipped sealed.

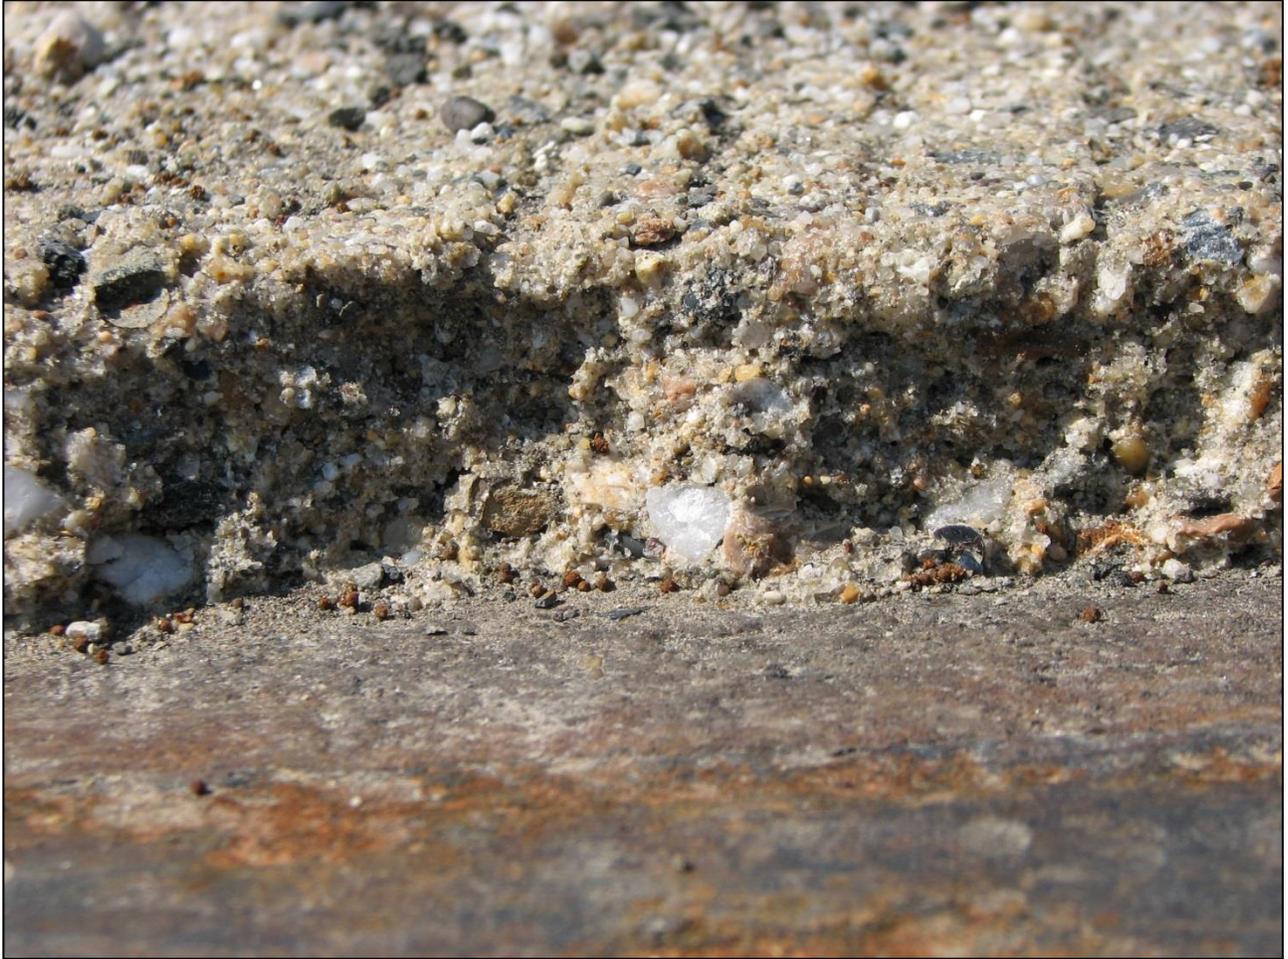
↑ Cross section close-up of the aggregate matrix in the fully cured polyester polymer overlay: Thickness represented in this image is approximately 1.25" (3.2cm).
