**FINAL REPORT**

**EVALUATION OF REDI-TORQUE MODEL 280 OMNI DIRECTIONAL SLIP BASE  
SQUARE SIGN SUPPORT**

**Project Name:** Redi-Torque Square Sign Support

**Project Number:** MT-11-03

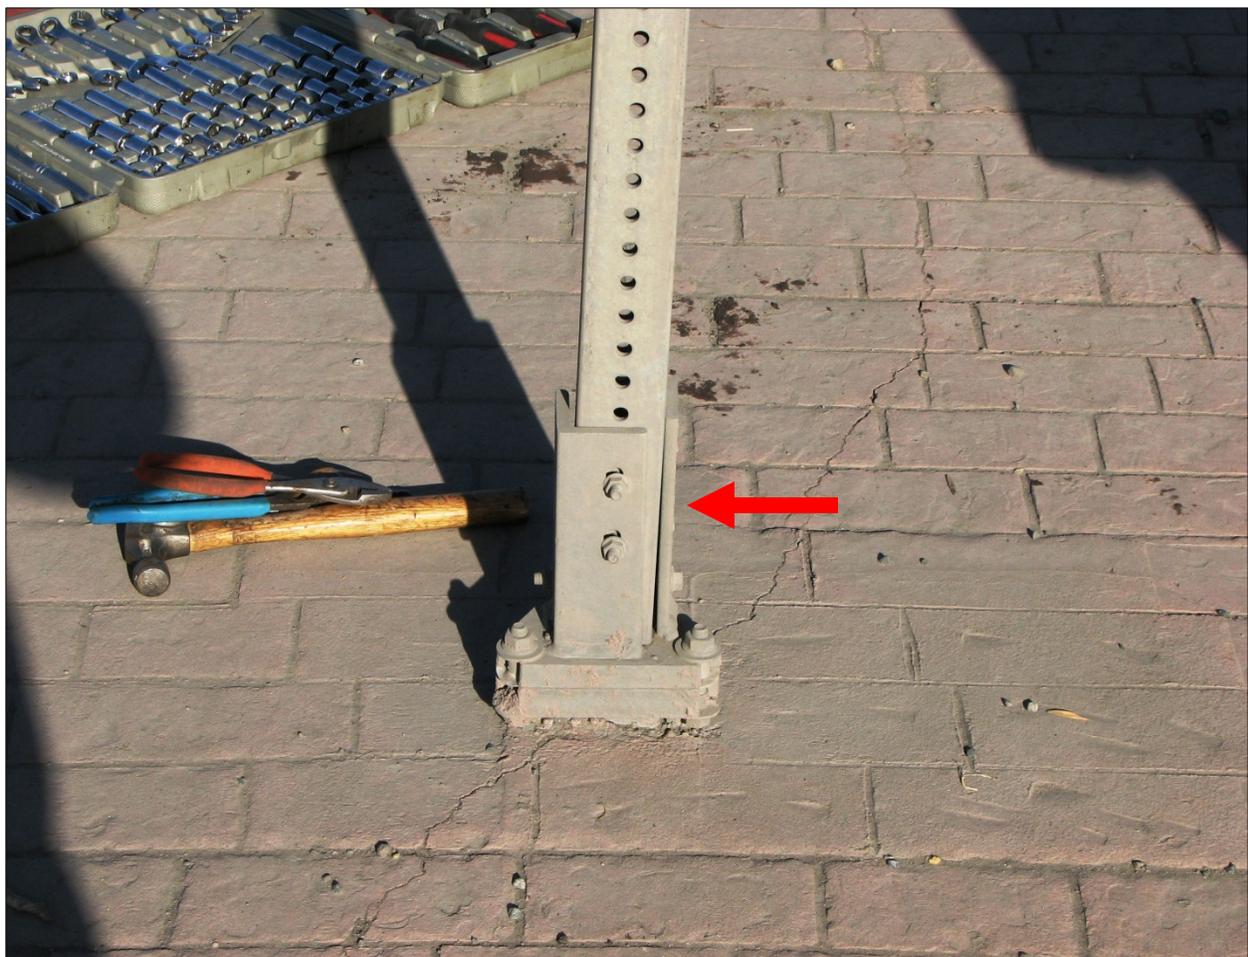
↑ Image of existing top half (3" outside diameter 'O. D.')

post receiver prior to exchange (red arrow).

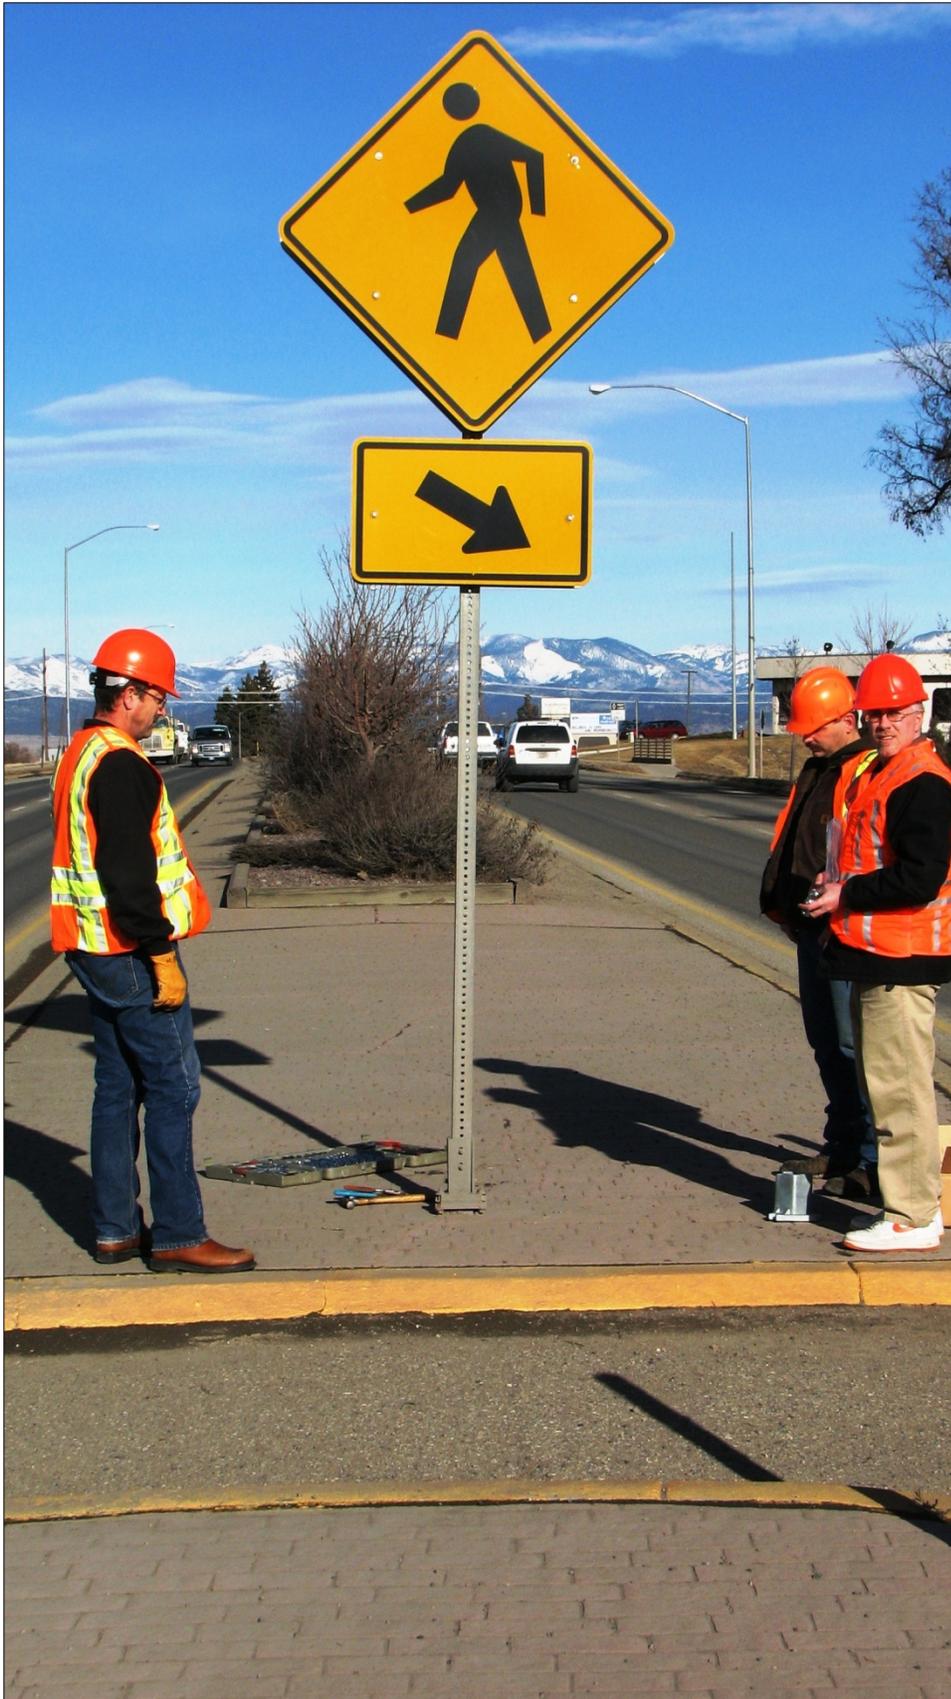
← Overall view of pedestrian crossing sign at median prior to installation of the Redi-Torque slip base. View is looking east.

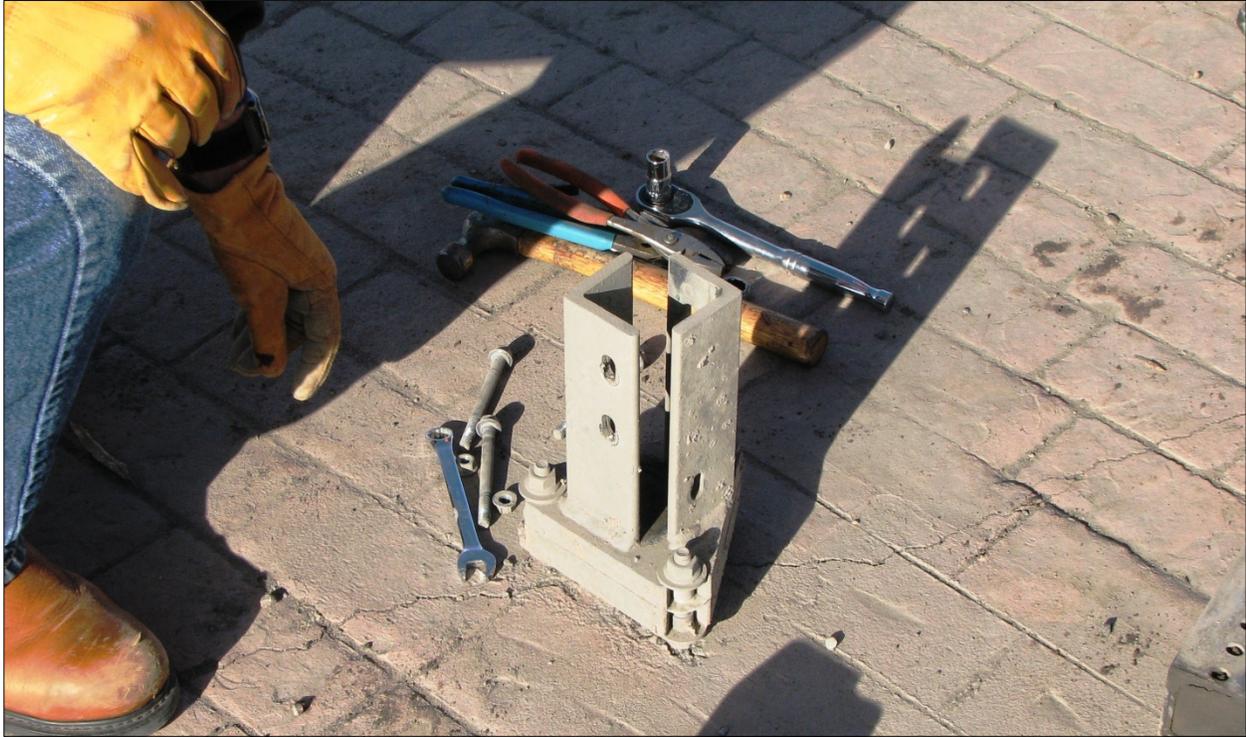
↑ The square sign support is removed and the existing triangular top half, slip base will be unbolted from the lower slip base.

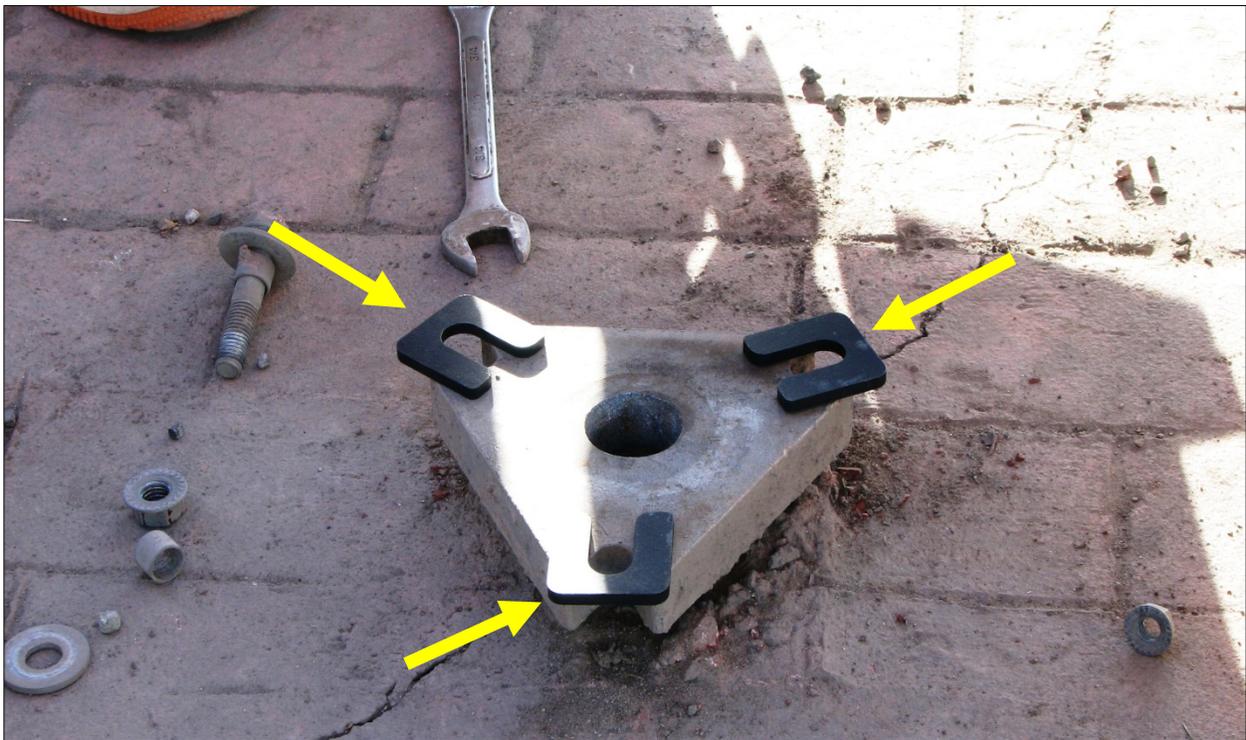
↑ Once the top slip base is removed, 3/16" thick Teflon coated slip washers are placed over the bottom half, bolt holes (yellow arrows). Note that this is the 'slip' feature of the system. Upon impact the slip washers are ejected away from the slip plates which allow the top receiver to depress enabling the Redi-Torque bolts to fall out releasing the top half-slip base from the lower half.

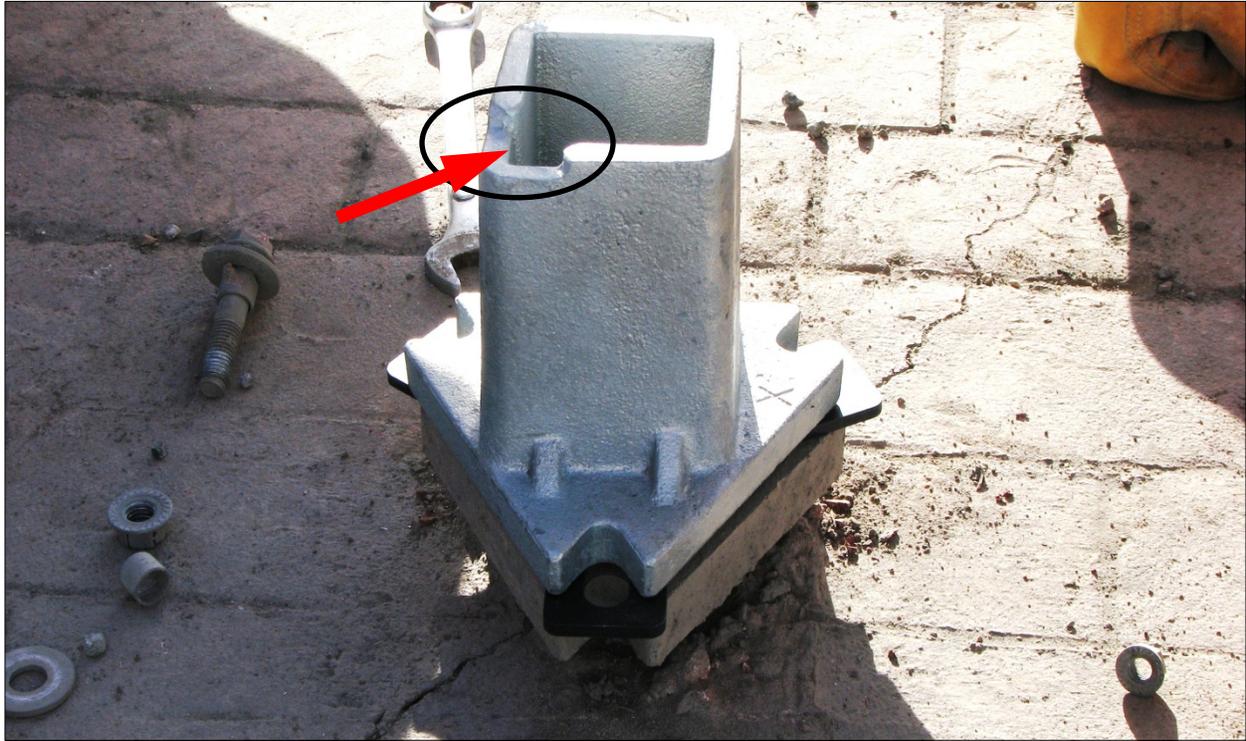
↑ The top receiver is then placed atop the teflon slip washers. Note the indent in the top receiver (red arrow); this will be used for the locking wedge as explained later in this report.

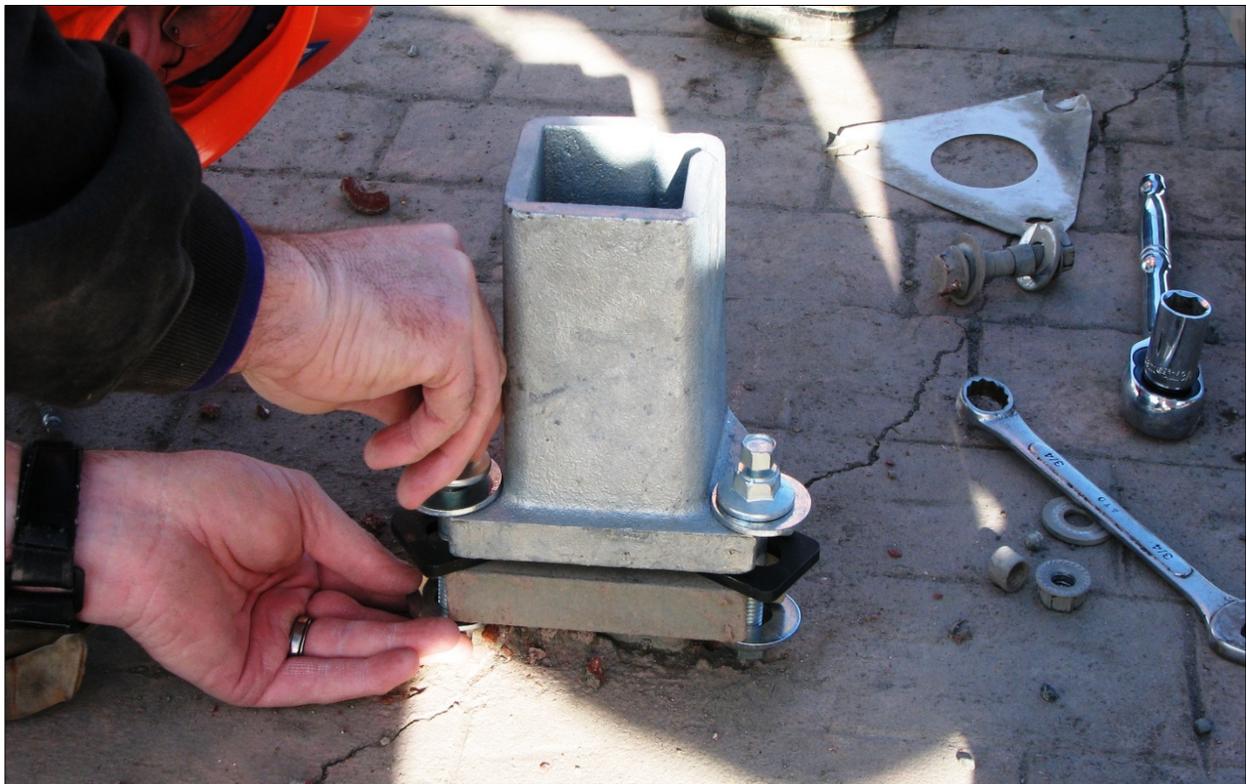
↑ Double Hex Redi-Torque bolts are then attached and hand tightened.

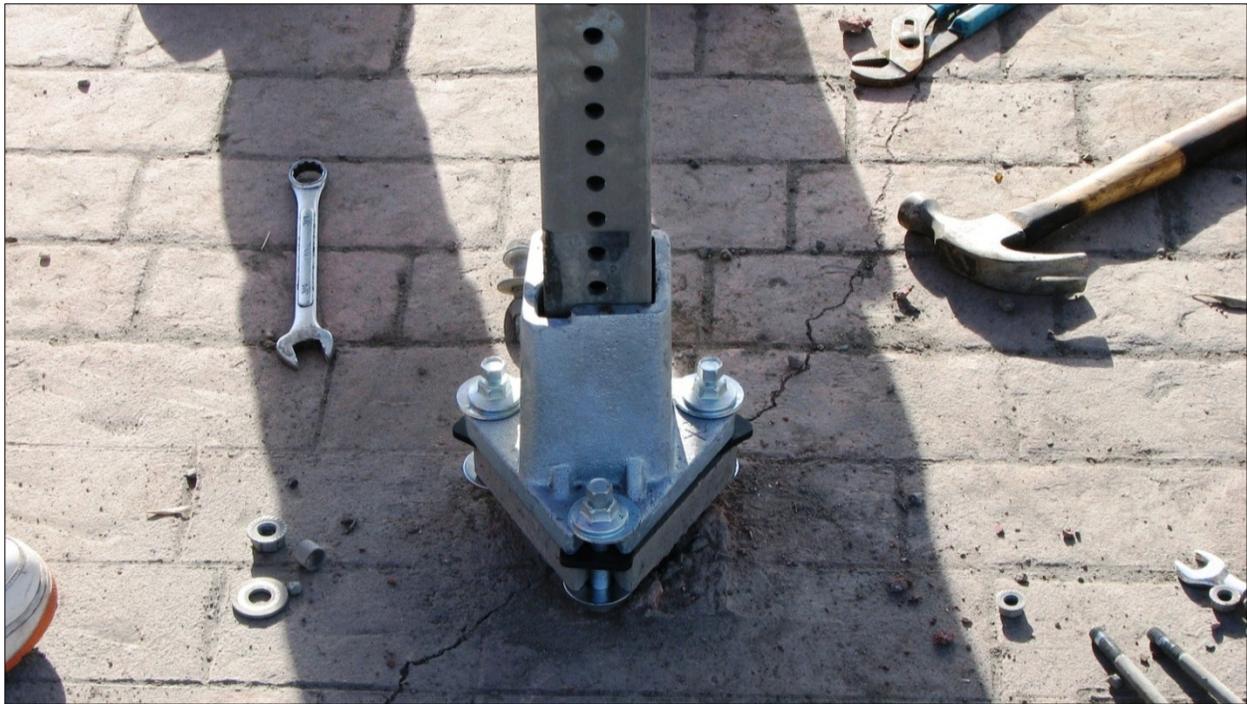
↑ The torque bolts have been pre-tightened to allow the sign support to be inserted into the top receiver.

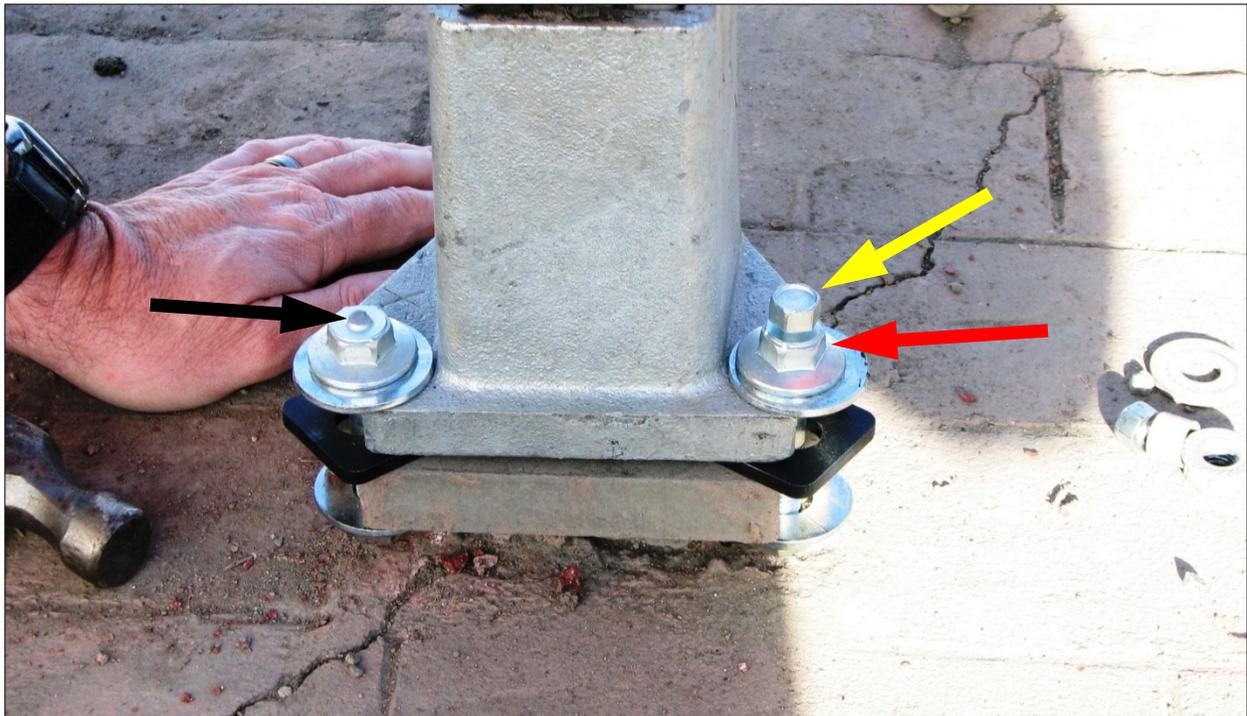
↑ The Double Hex Redi-Torque bolts are designed to apply the proper force (ft./lbs.) for the desired clamp load for the Model 280 system. The bolts can be partially tightened with the lower 3/4" hex head, enough to keep the bolt in place (red arrow); the top smaller, 9/16" hex head (yellow arrow) is to complete the tightening sequence by snapping off at the desired torque. The black arrow shows an example of the breakaway bolt.

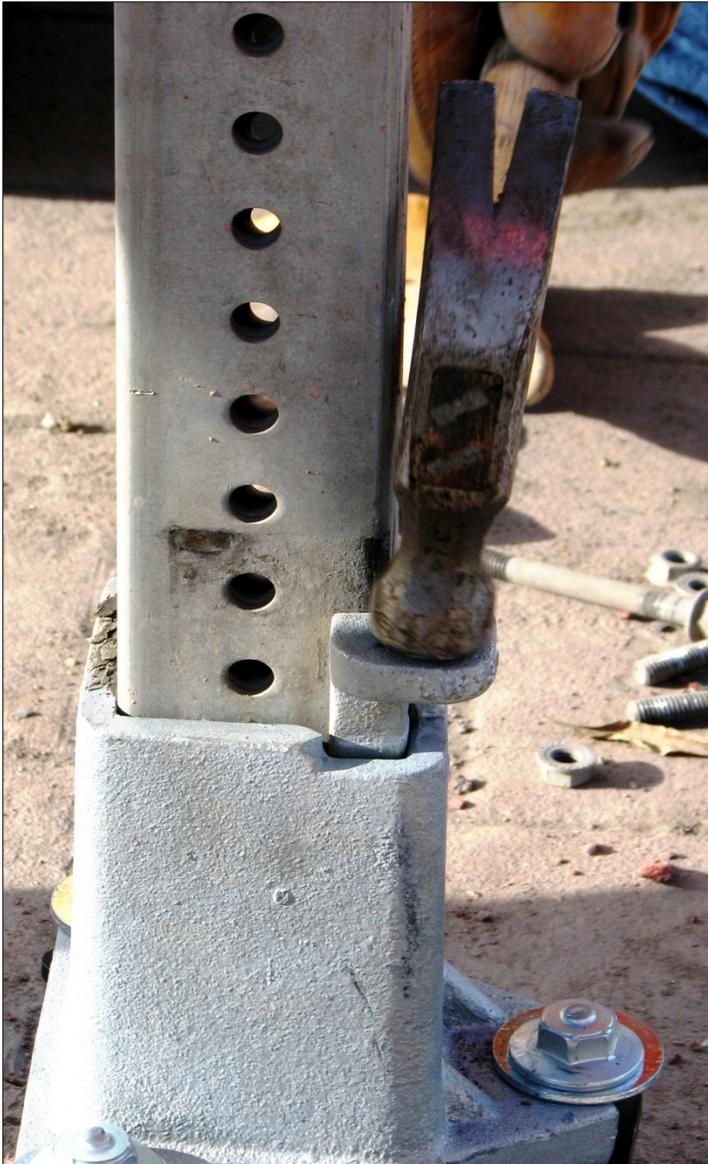
← Using a hammer, the square sign support locking wedge is positioned in the pre-determined corner and driven until firmly locked into place.

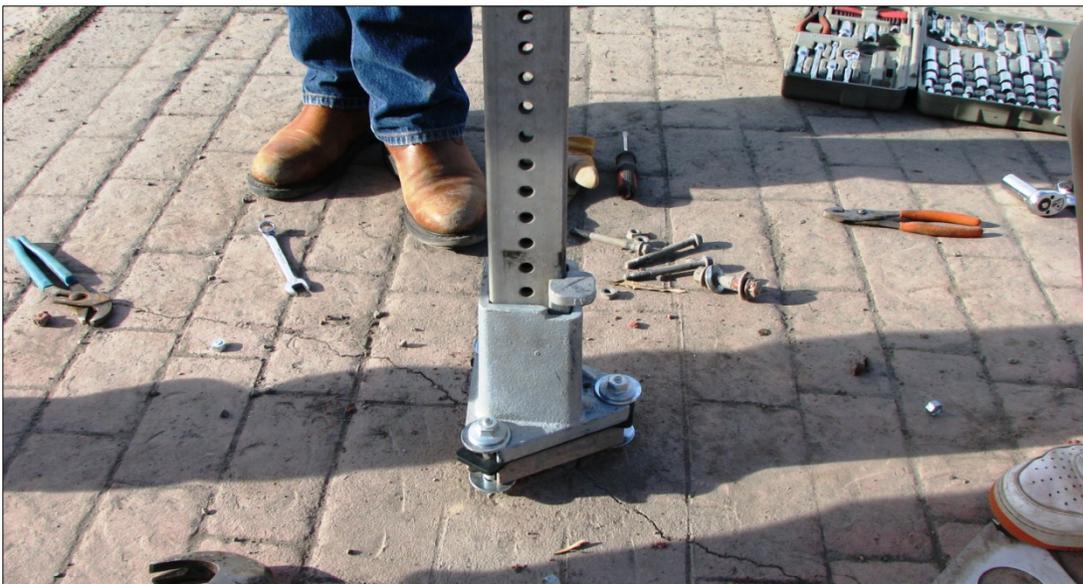
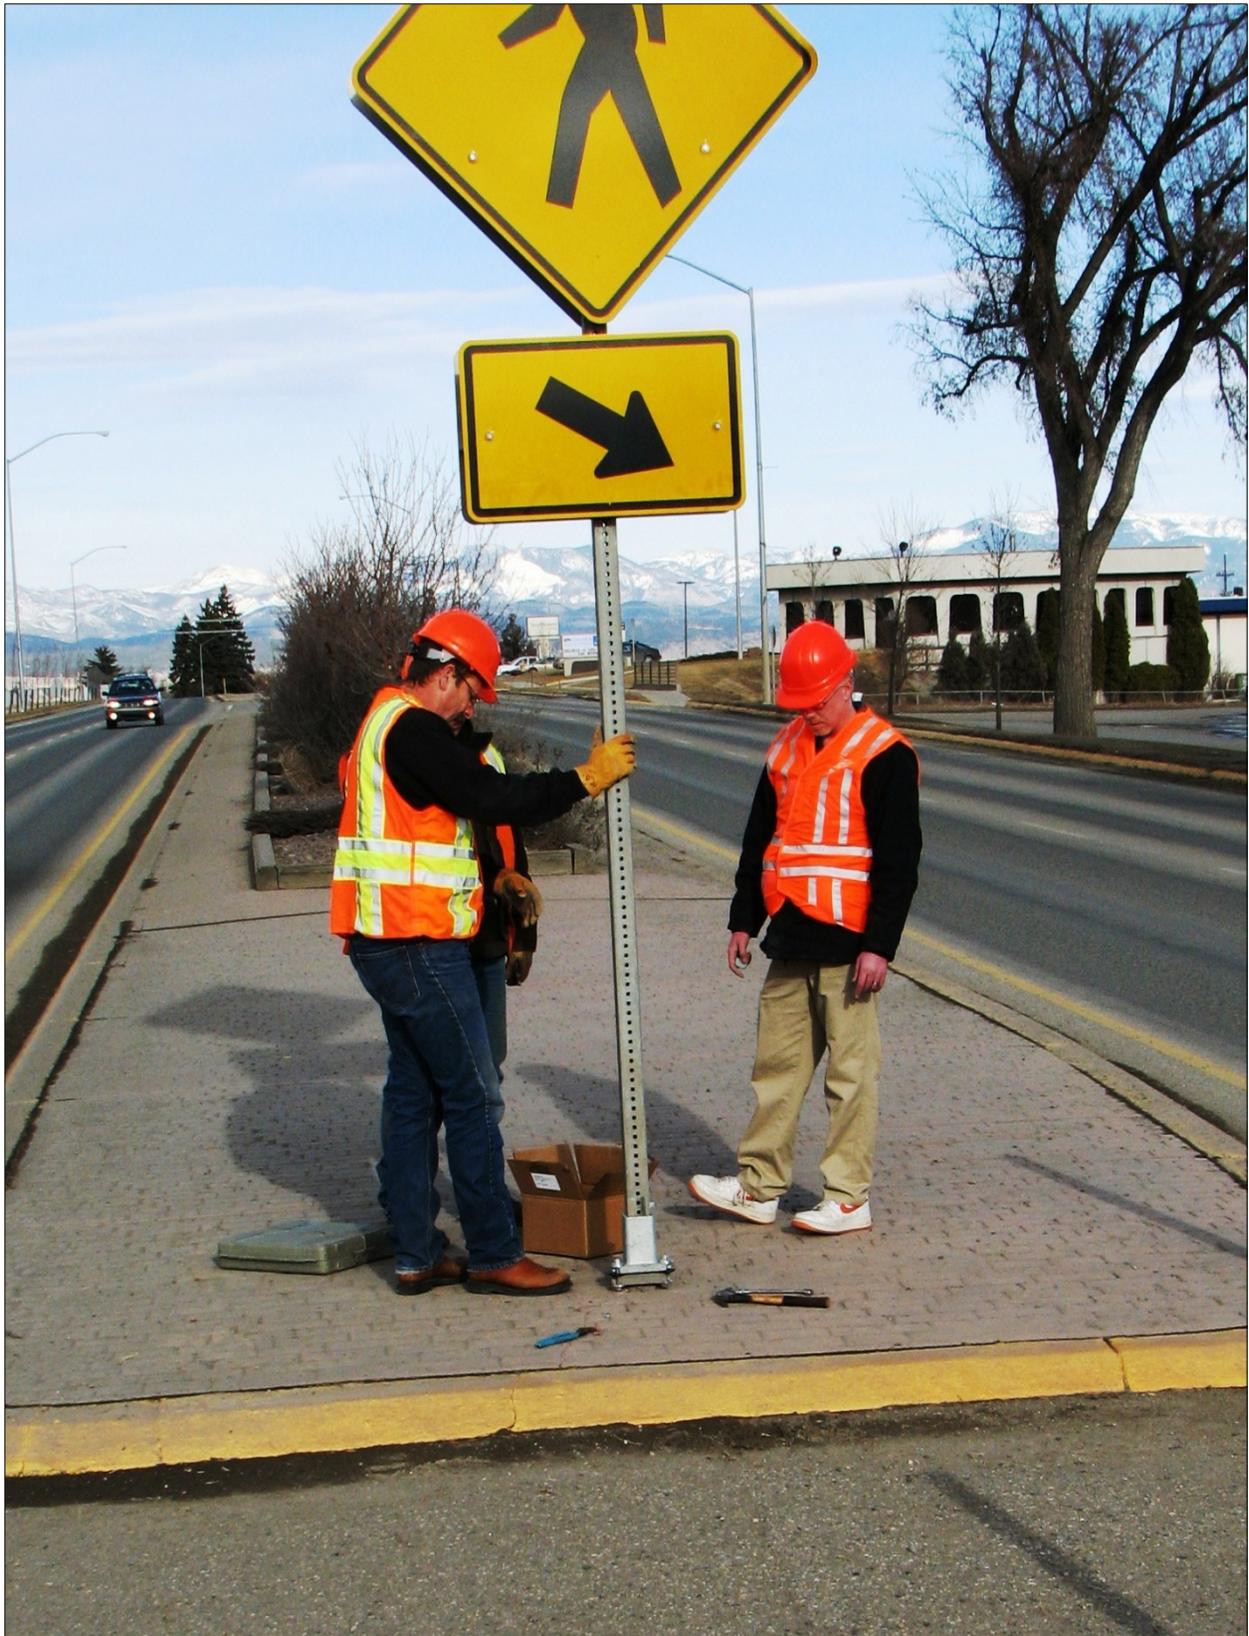
↓ The image below shows the completed installation.

↑ Overall view of the completed installation of the Redi-Torque Model 280 Omni Directional Slip Base.

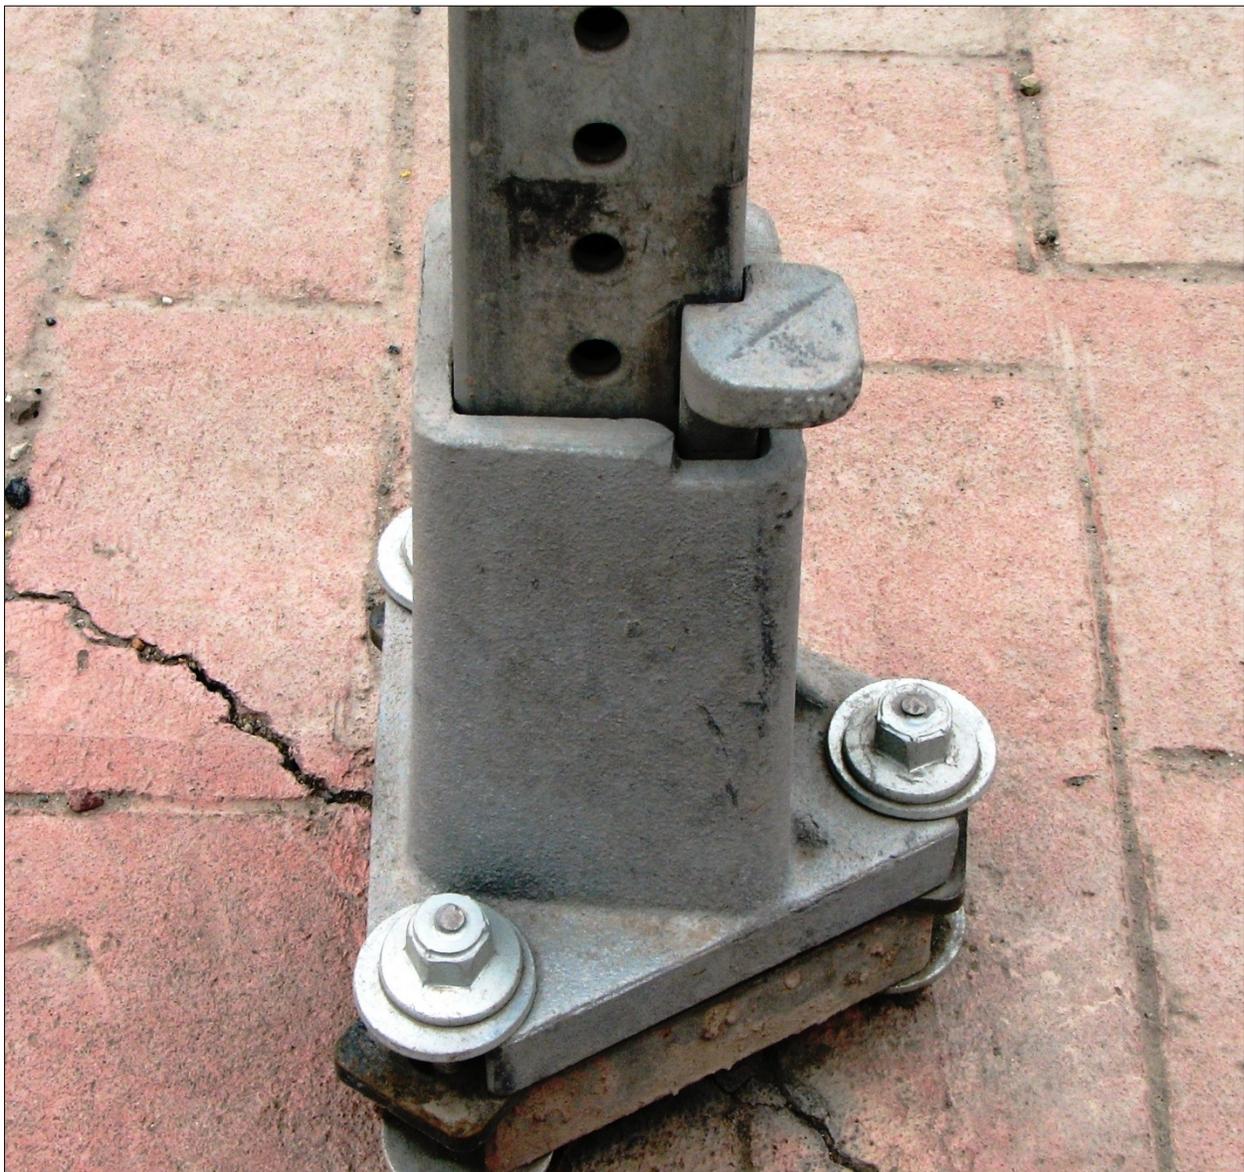
Research visited the site every two weeks to document performance of the Redi-Torque device. The locking wedge, bolts, and Teflon slip washers were scribed in a way to determine if any movement or shift of the attachment hardware occurred during the duration of the study. To date all of the components of the base exhibited no movement or release. All attachment hardware remained as rigid of the day it was installed. Research has rated the Redi-Torque Model 280 as having satisfactory performance.

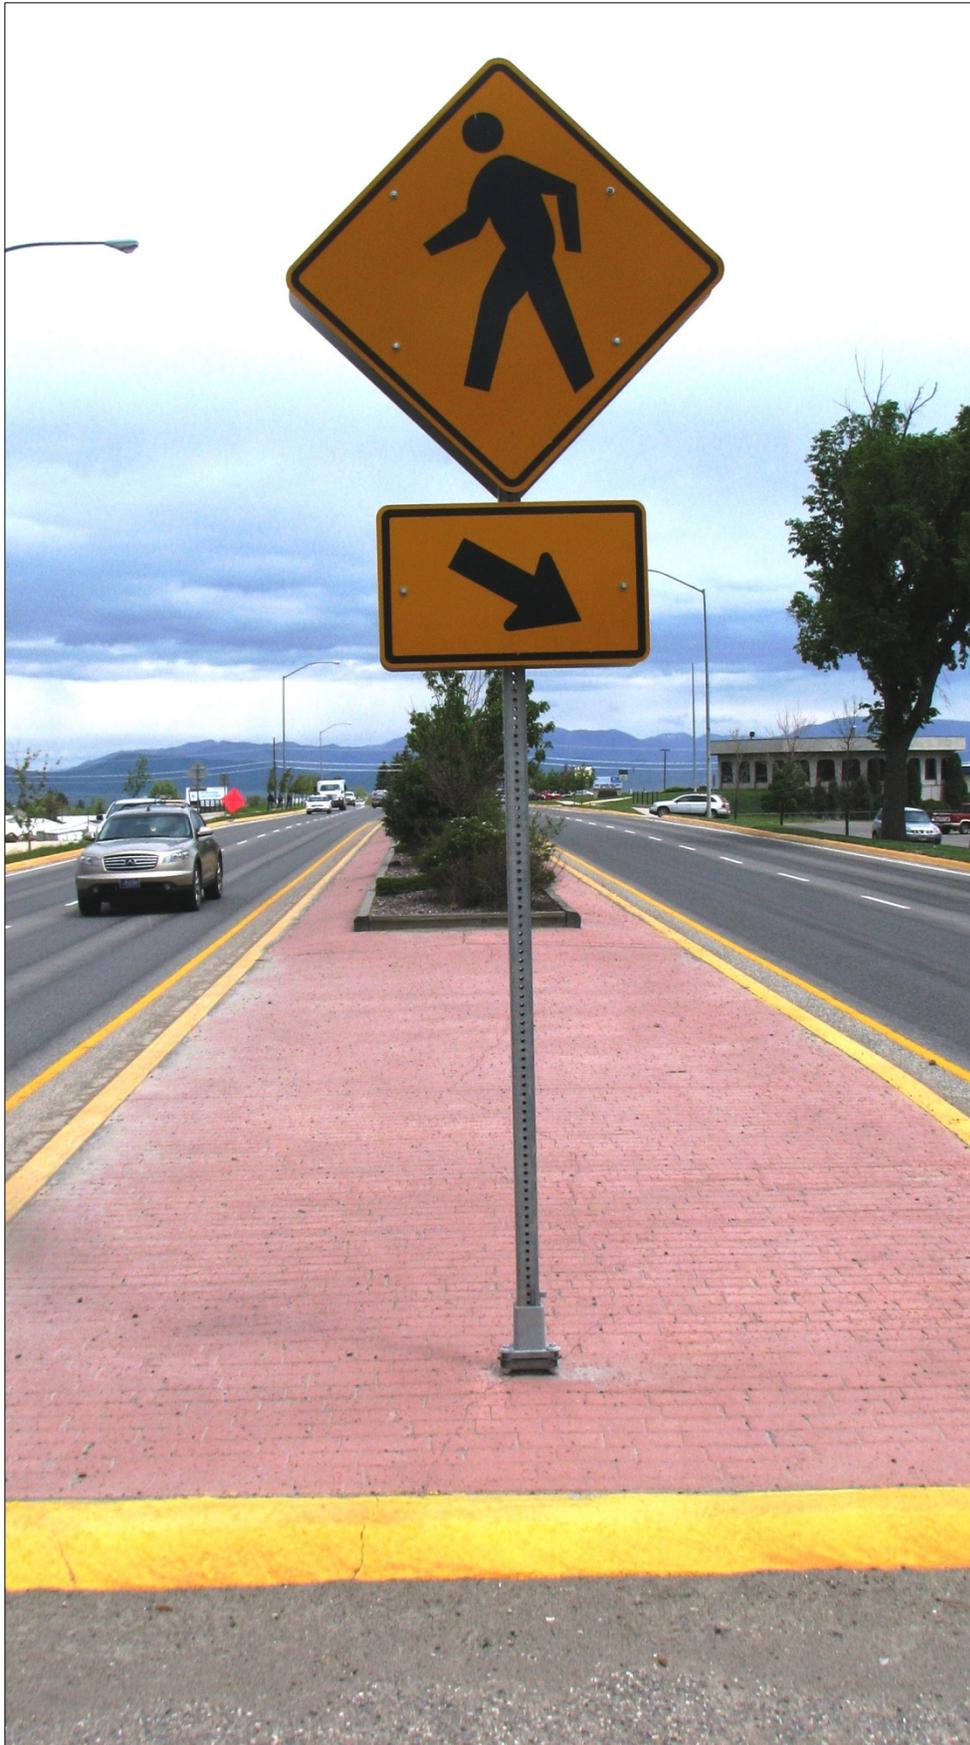
← Overview of sign placement as of June 17, 2011
