Experimental Features
Evaluation Report

**EVALUATION OF STRIETER-LITE WILD ANIMAL HIGHWAY WARNING
REFLECTOR SYSTEM™ ON REDUCING VEHICLE-ANIMAL COLLISIONS**

Project Name: Safety Improvement Project
Fencing – East of Whitehall

Project Number: HSIP 69-1(22)2

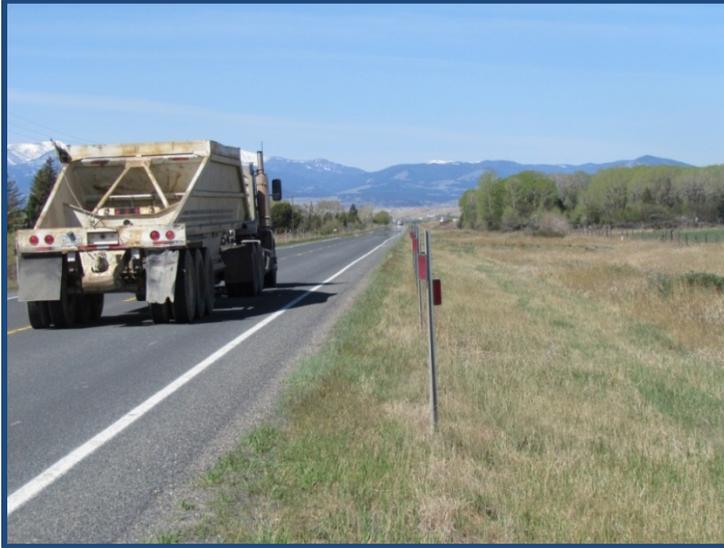
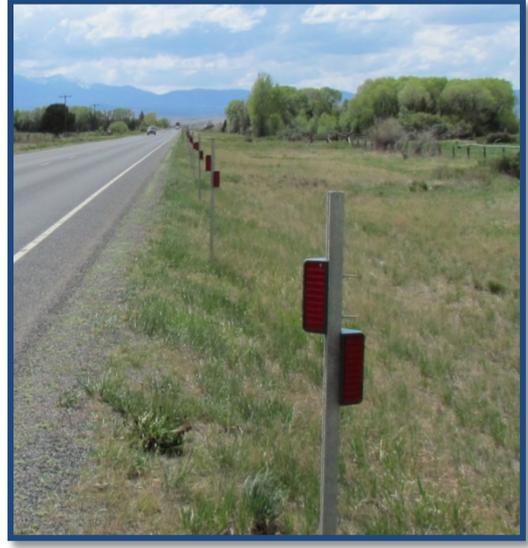
The site was visited May and October 2012 by Research staff to observe any visual changes. The reflectors looked clean and well maintained (Figure 1).

Figure 1- Reflector system 2012 [left], 2013 [right] and 2014 visit [lower right]

The site was visited late August 2014 to observe any visual changes. The whole site was mowed and the reflectors appeared clean (see Figure 1). Near Briggs Lane, three posts were missing and some out of alignment (Figure 3). MDT Maintenance confirmed a vehicle accident had occurred in this location. Throughout the project, posts were out of alignment and some were missing. A

The site was visited mid-September 2015. As in previous years, the whole site was mowed and the reflectors appeared clean. The eastbound side of the site had some posts out of alignment (Figure 4). On the same side of the roadway and further into the site, posts were installed but missing reflectors (Figure 5).

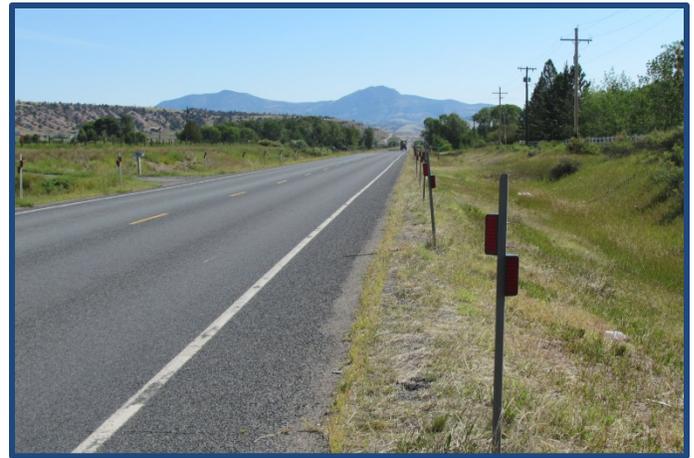
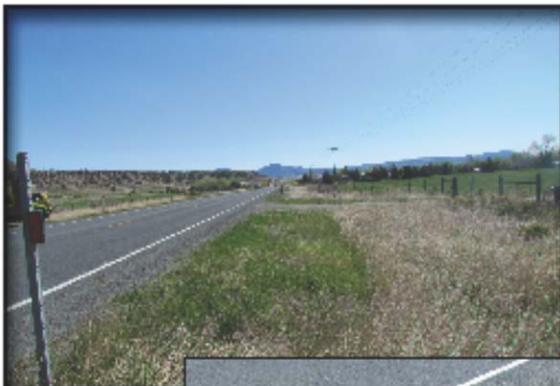
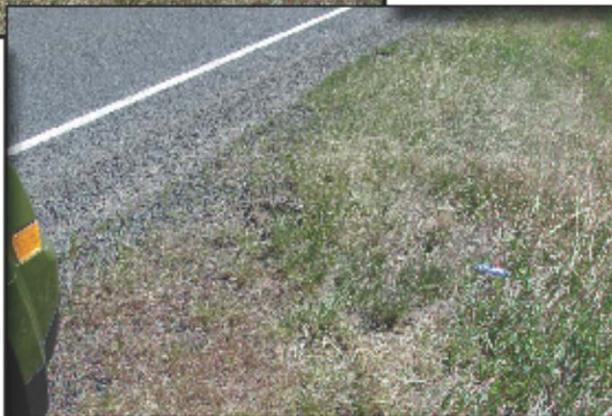
It appeared two reflectors were missing on the eastbound side of the road. One location was near a residential driveway and the other was just before mile marker 2. During the May

Figure 2-Missing reflectors (2012)

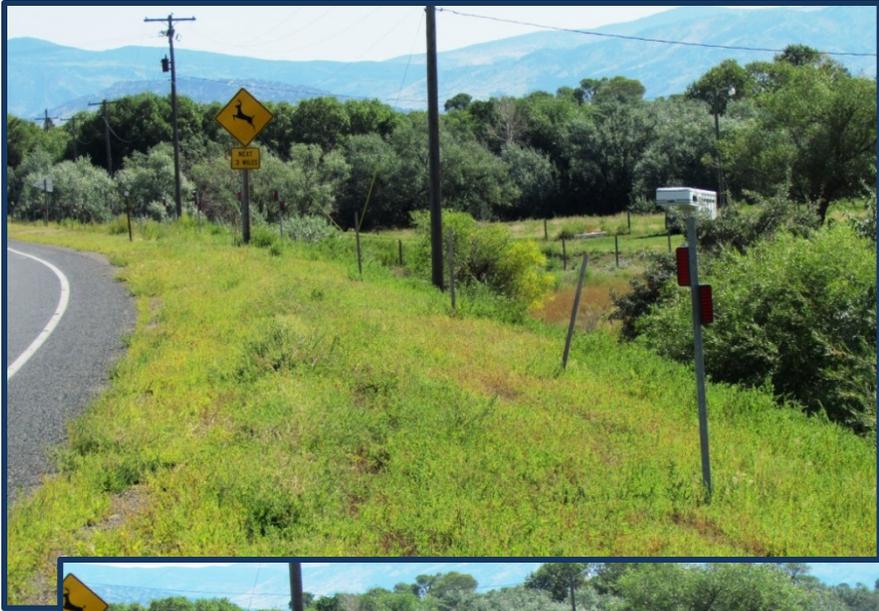
Figure 3- Missing reflectors from vehicle accident (2014) MDT Maintenance marked locations with wooden lathes

The reflector system had some damage from being knocked out of alignment by MDT Maintenance activities and vehicle accidents. Replacement posts were ordered and will be replaced. Reflector supply is adequate for needed repairs.

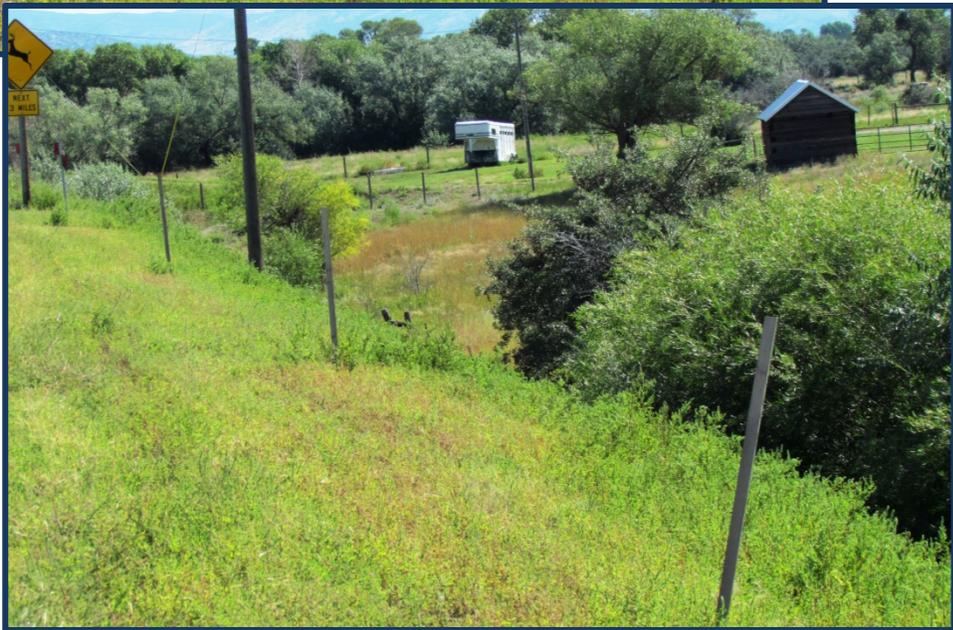
The site was visited May 2013 by Research staff to observe any visual changes. None of the reflectors appeared to be missing and all were in good repair. Two reflectors were slightly crooked on the eastbound side of the road. Two deer carcasses were spotted on the eastbound side of the road in the ditch near reference point 3.

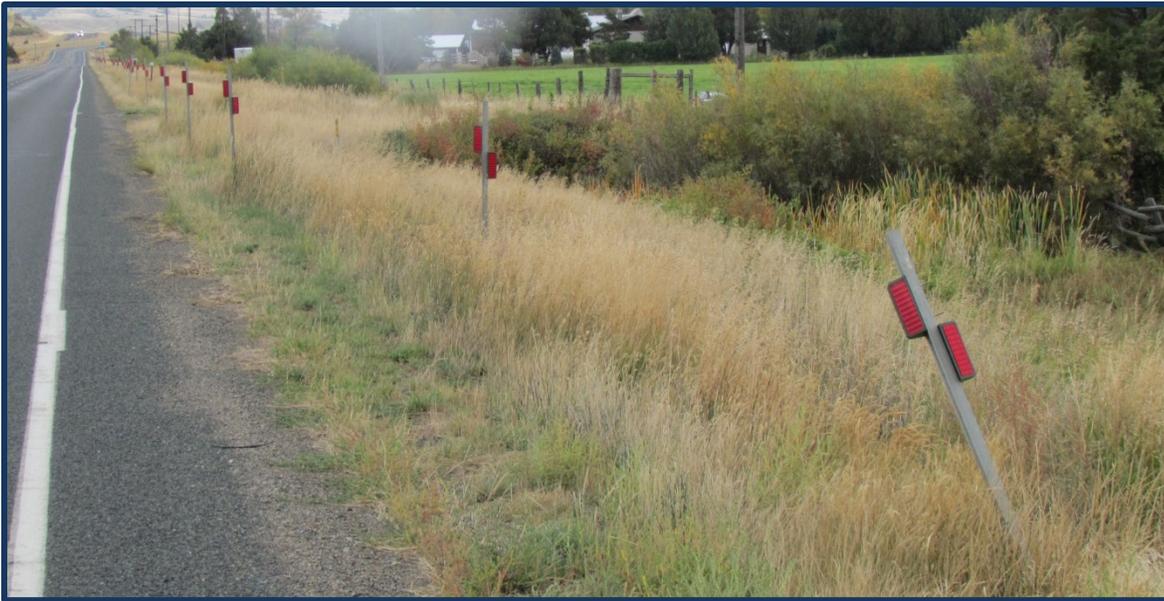
Figure 4- Eastbound side posts out of alignment

As mentioned in the construction report, the eastbound/south side of the highway required installation by hand to prevent hitting fiber optics and other underground utilities, which makes it difficult to keep posts in alignment. Approximately 10 to 12 posts and their reflectors need repair or replacement from damaged by vehicle accidents or maintenance activities. Summer of 2015 was the last purchase of two boxes of reflectors at the cost of \$1020 with 22 reflectors per box for an approximate cost of \$23.00 per reflector.

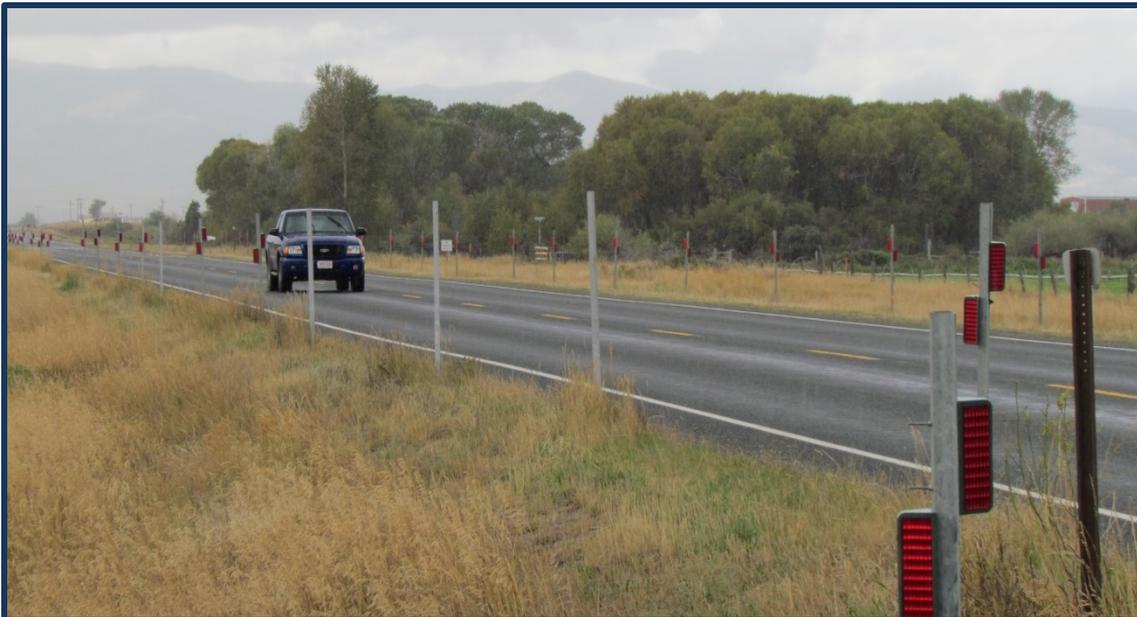
Figure 5- Eastbound side posts missing reflectors
