**EXPERIMENTAL PROJECTS CONSTRUCTION REPORT AND ANNUAL  
INSPECTION**

**EVALUATION OF THE METADOME TRUNCATED DOME USED IN EXISTING  
AND NEW ASPHALT APPLICATIONS**

**Project Name:** ADA Asphalt DWD

**Exp. Project Number:** MT-12-06

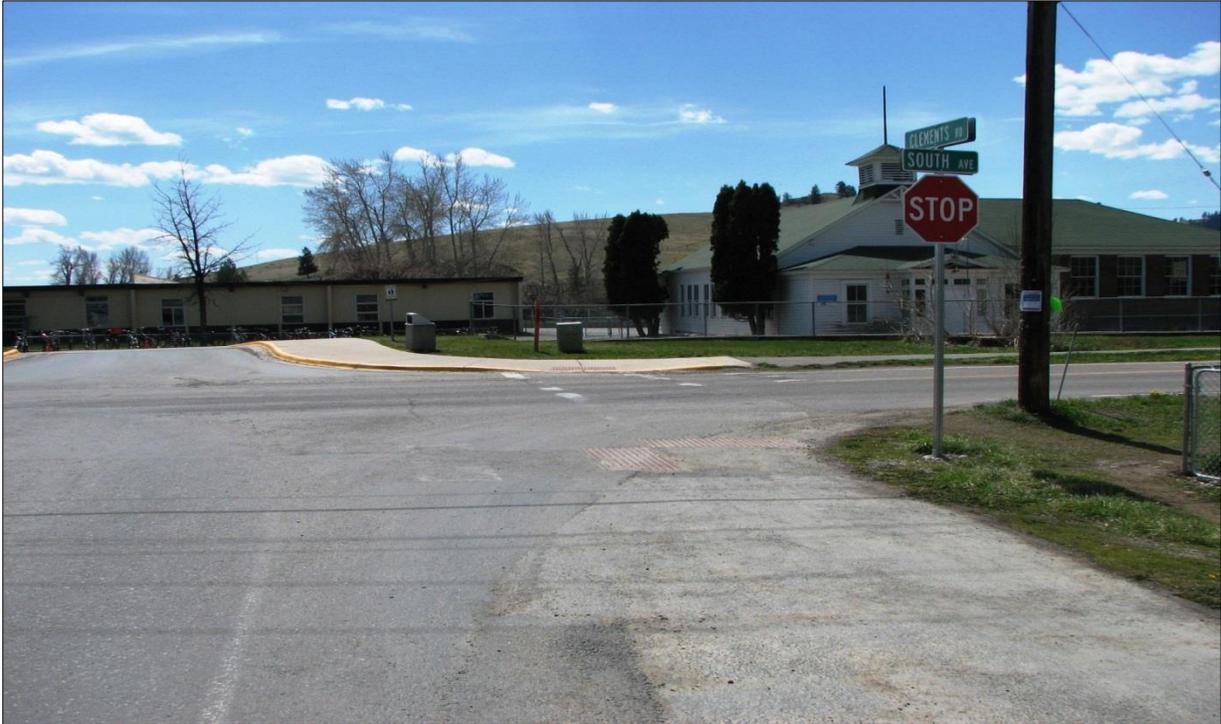
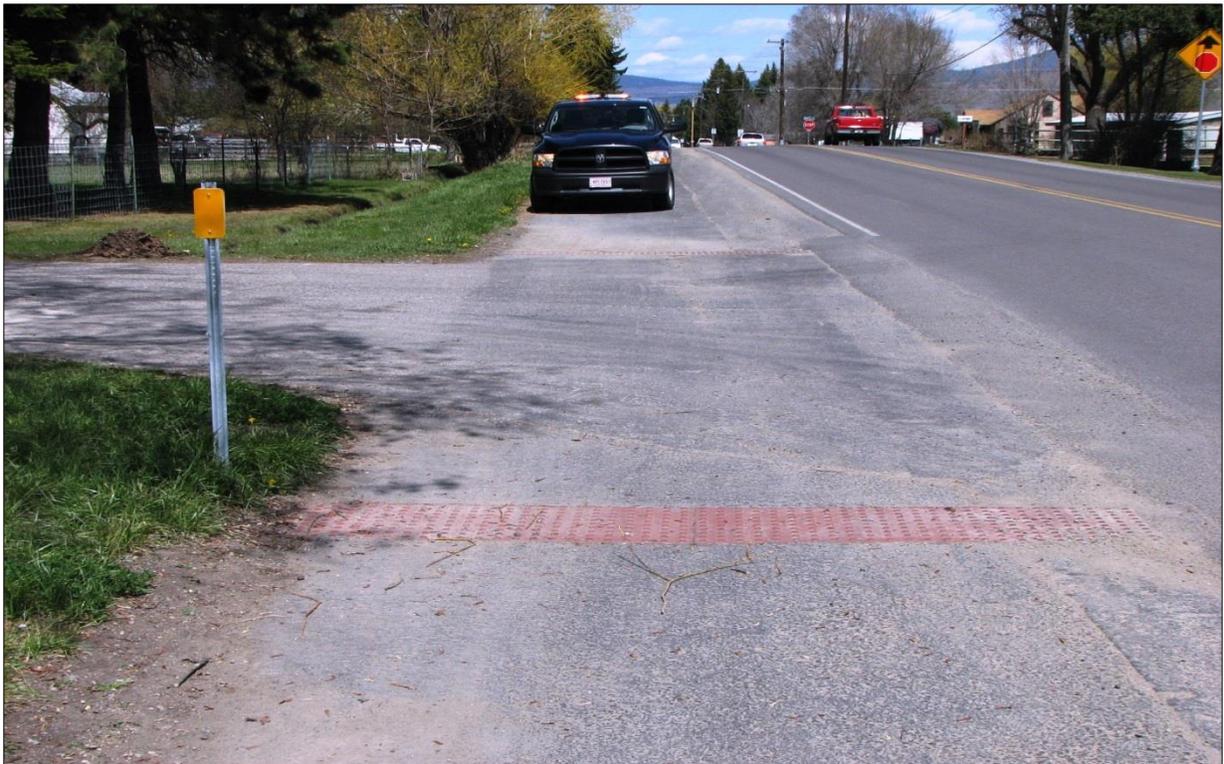
↑↓ All panels which exhibited damage from plowing activities were located on the west side of the project with the pedestrian/bike path essentially an extension of the roadbed as seen from these images. This allowed the plow truck to treat the path as an extended lane. The east side DWD installations is a basic widened sidewalk which to date has no visual damage since it can be assumed it was not cleared by fixed-blade.

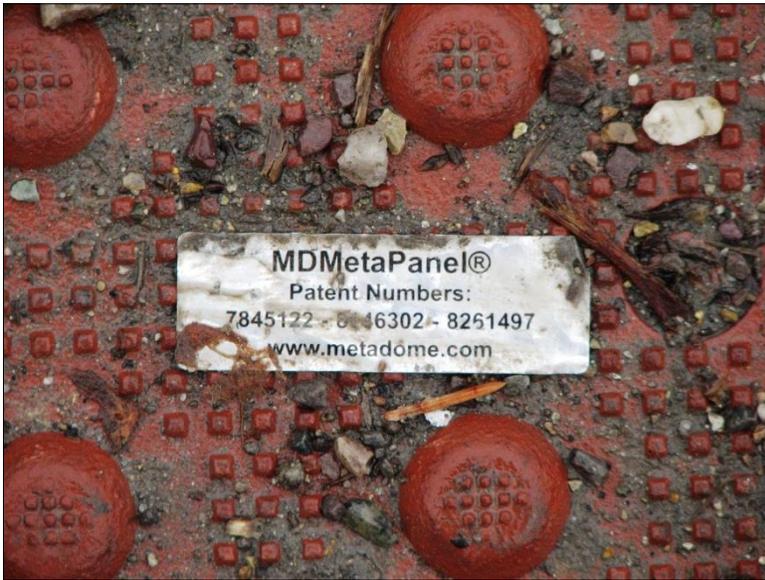
← Close-up of the Metadome cast-iron MetaPanel DWD's replacing the damaged stainless-steel units.

These are the same panels being used on the Three Forks project which were placed in new asphalt on October 2012.

As the stainless-steel panels begin to exhibit distress or are actually damaged they are replaced with cast iron units in a perimeter of portland cement concrete (PCC).

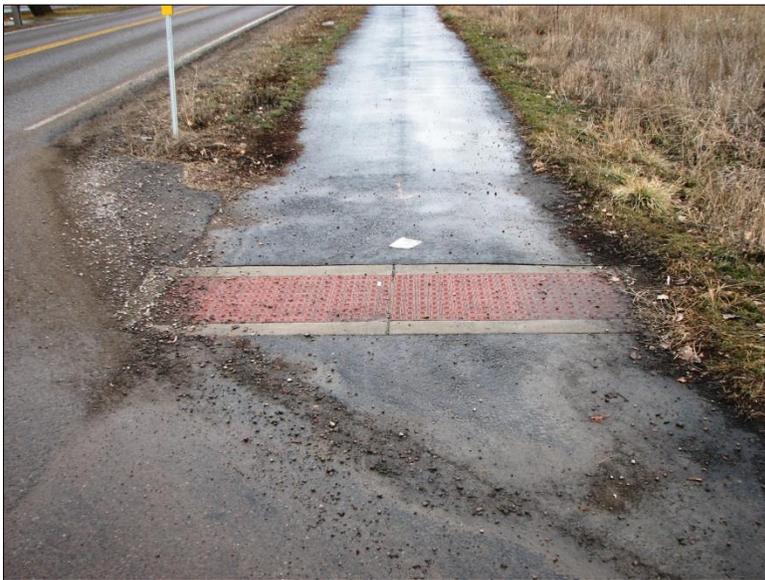
← Another example of a replaced DWD at the intersection of Spurgin and Clements Rd. (southwest corner).

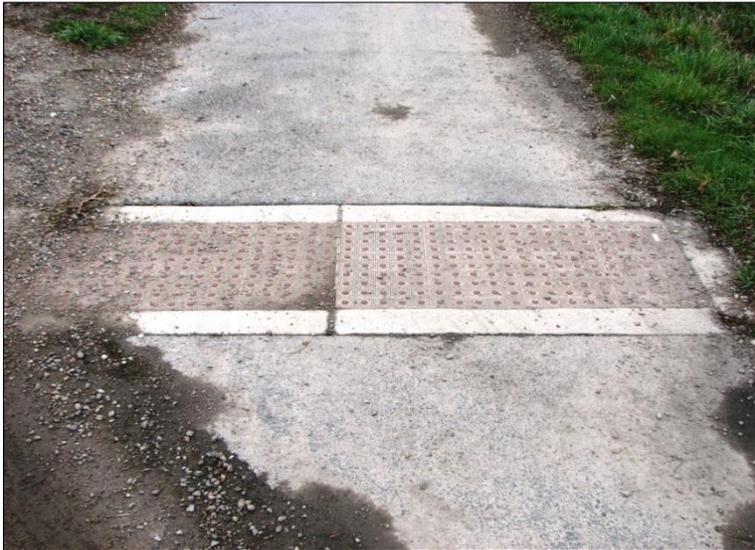
↙ Another unit at the Spurgin Rd. intersection that has been replaced by cast-iron DWD's.

As stated in earlier site inspections the District is replacing the damaged stainless steel DWD's with cast iron units.

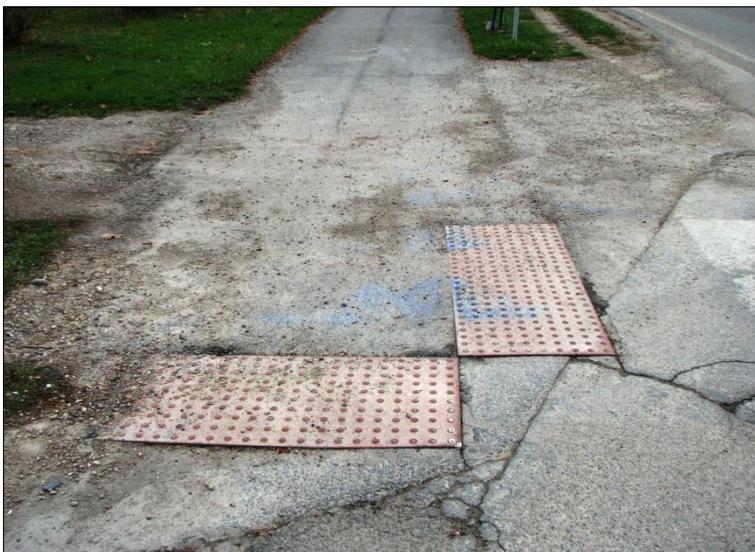
↙ DWD's at the Mound Ave. intersection.

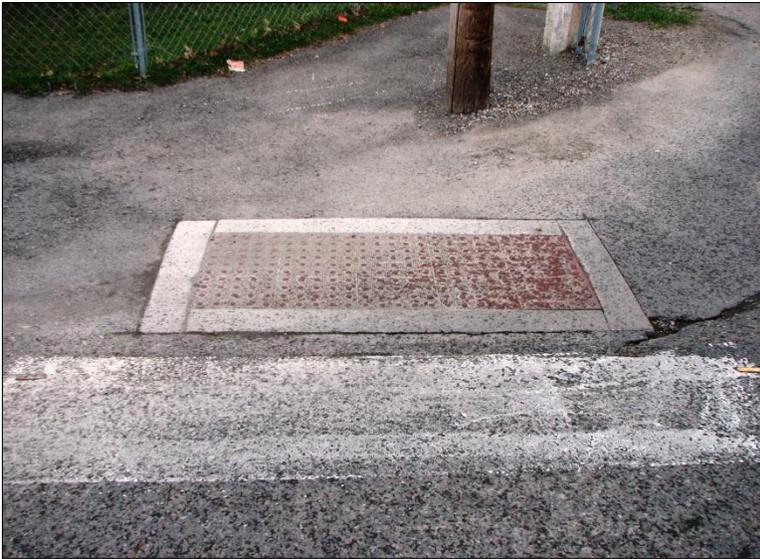
← Another unit replaced with cast-iron at the Mount Rd. intersection.

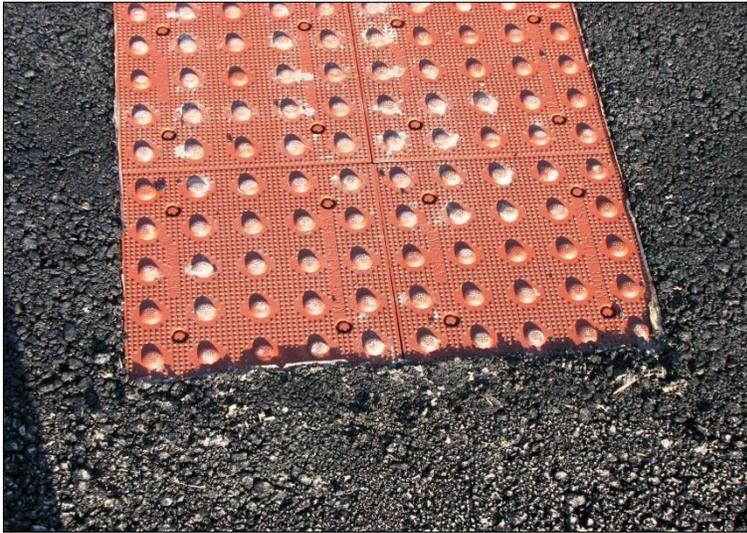
← Close-up of completed ADA asphalt DWD cast iron panels.

All panels installed on the project inspected were visually placed well in the pavement with plate edges either flush to the asphalt surface or several millimeters below. All plates appeared securely anchored.

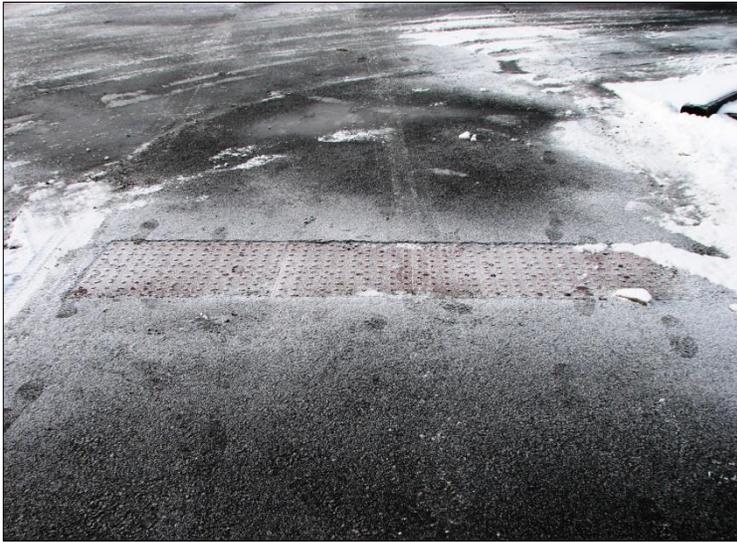
↙ The images on this page represent the average condition of the cast-iron DWD's.

All units on the project exhibited no distress, movement or debonding from the asphalt cement (AC) base.

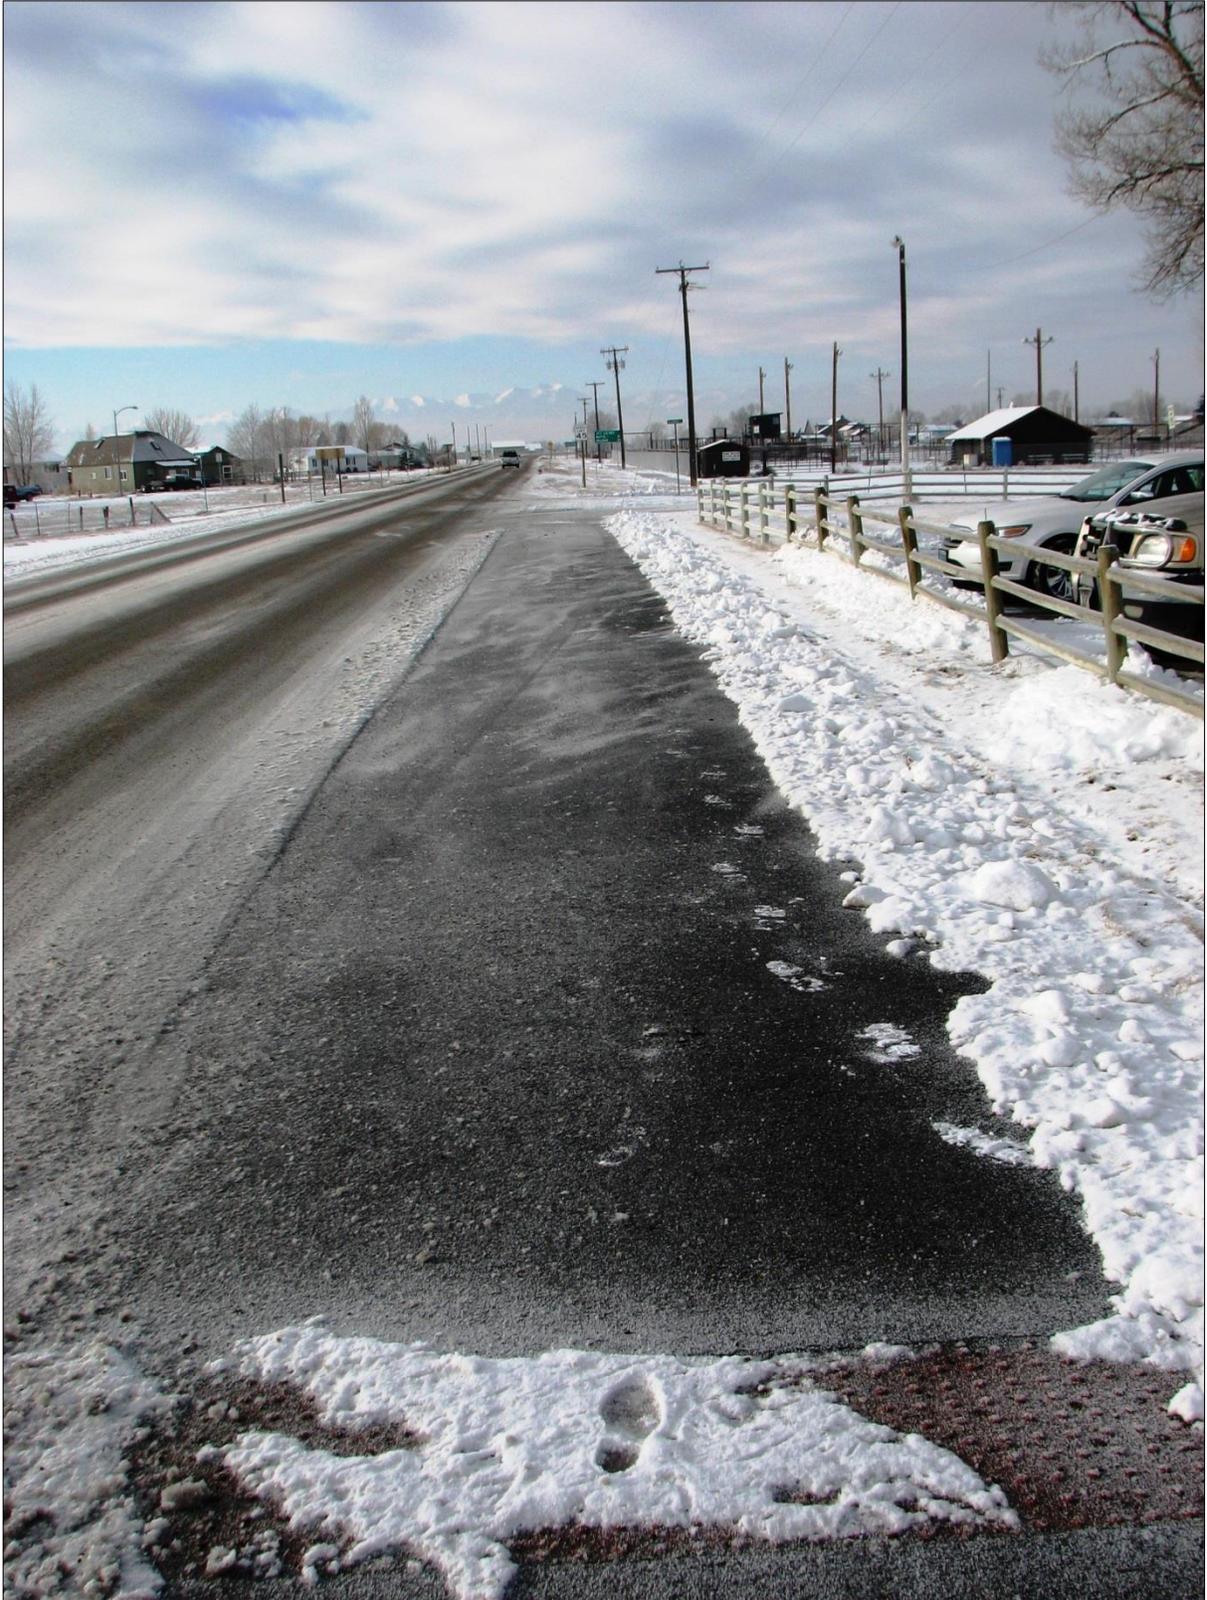
↑ Per information received from the Three Forks Road Superintendent, the bike/walk pathway snow removal is maintained by truck-mounted snow plow. They report no issues with plow blade moving over the DWD's

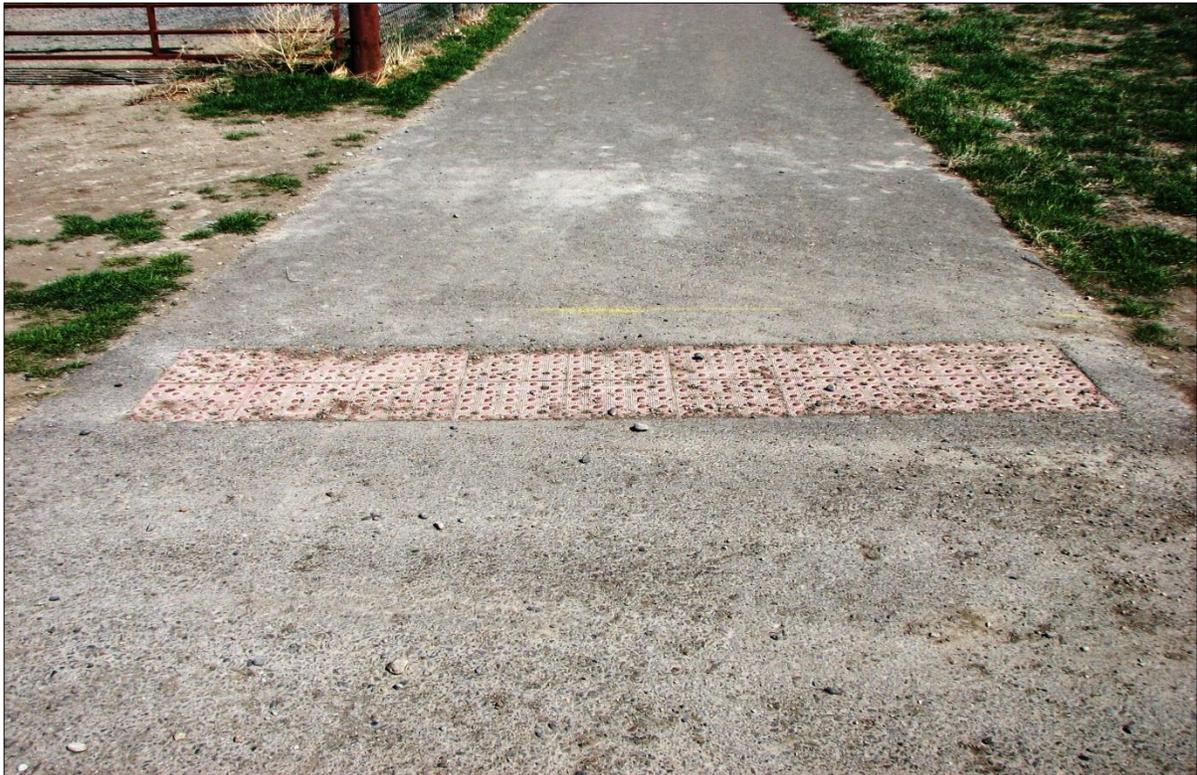
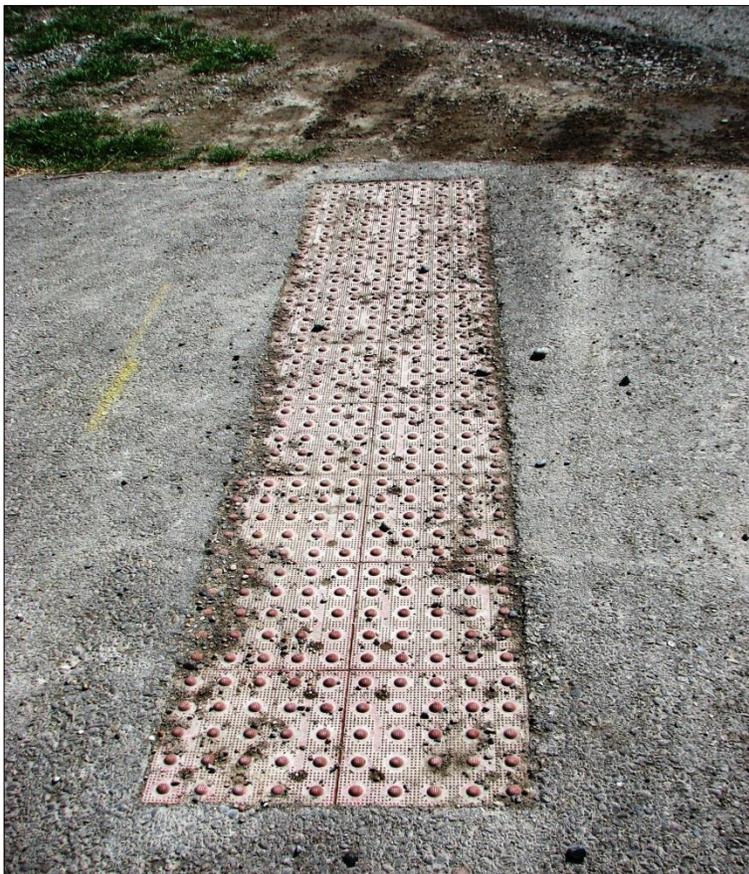
**April 2015 Three Forks Site Inspection**

↑ ← Representative images of the general condition of the project DWD's.

All units are intact with no appreciable performance issues to date.
