EXPERIMENTAL EVALUATION REPORT

Thin-Whitetopping Bonded Composite

Location: Glendive, Montana – Dawson County

Project No.: STPP 20-1(6)0 P-20, Highway 16, Milepost 0-.6

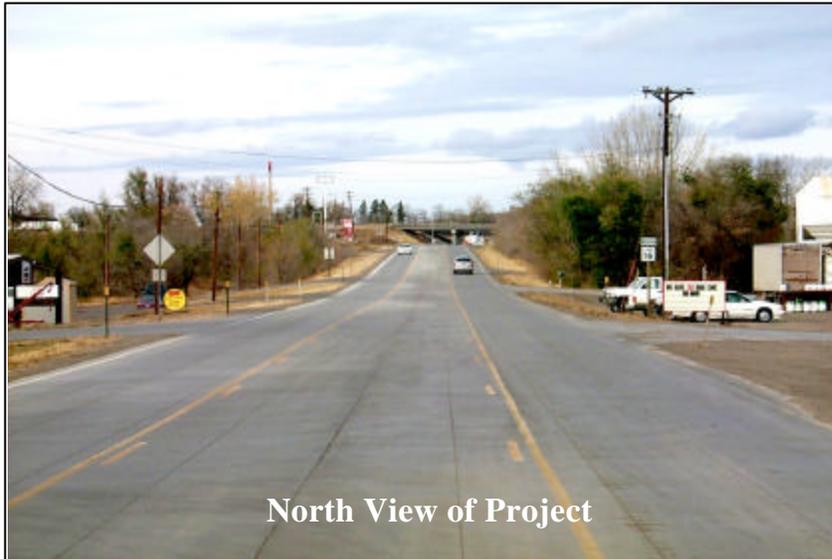
North View of Project

Highway 16 (P-20) suffered from rutting, plastic deformation and transverse cracking with the previous AC pavement. The Montana Department of Transportation decided to construct a thin-whitetopping project based on minor rehabilitation criteria.
