Montana Department of Transportation
Research Programs
October 2008

Experimental Project Construction Report

HIGHWAYS FOR LIFE (HFL) CULVERT REHABILITATION PROJECT

Project Name: NH-HFL 8-1(30)23 MacDonald Pass Guardrail/Erosion

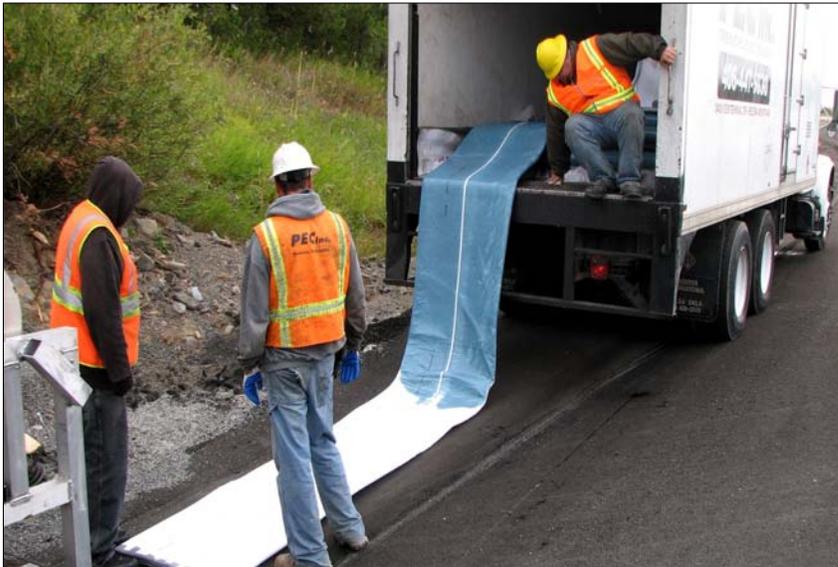
The CIPP liner is being pulled out of the refrigerated truck in preparation for insertion into the CSP. Normally the resin is clear in color. A dye has been added to better aid in the final inspection once the cure is complete.

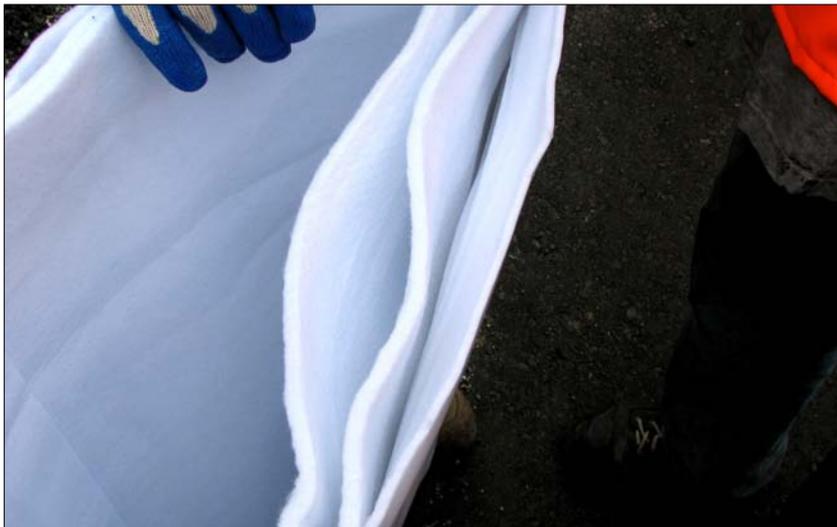
Close-up view of the polyester (non-impregnated) liner. It has three separate layers with the outer (thinner) layer having a tighter (or denser) weave than the two inner layers. Once cured, all layers will be bonded as one. The denser layer will be the new interior of the culvert.

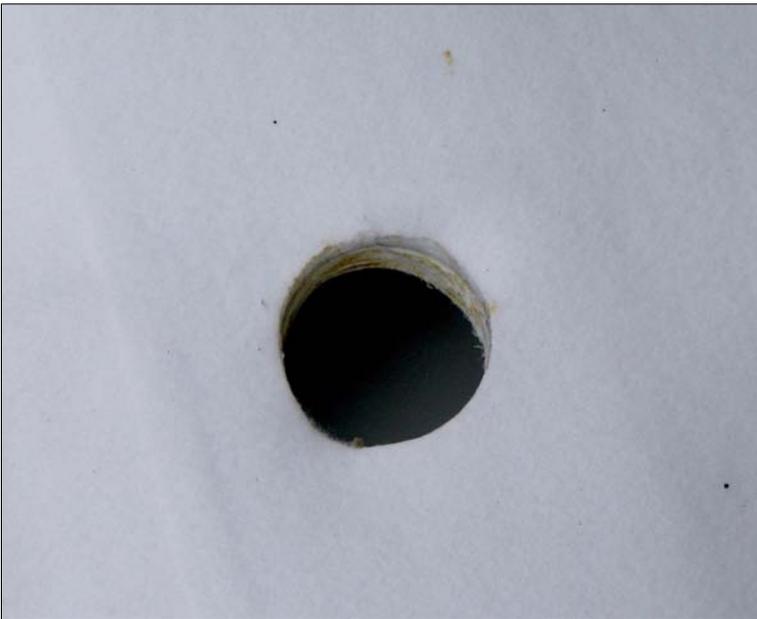
Close-up of the hole through all three felt layers created for the air pressure line.

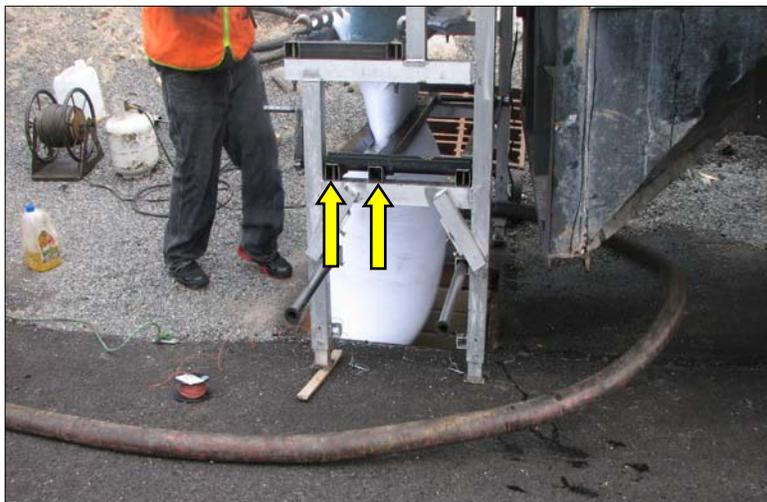
The CIPP is now fully expanded and beginning to be pushed (or flow) towards the entrance of the CSP. Note that the liner has been compressed by a vice (yellow arrows), that allows the installer to control the flow of the liner and to insure adequate air pressure to maintain the flow.

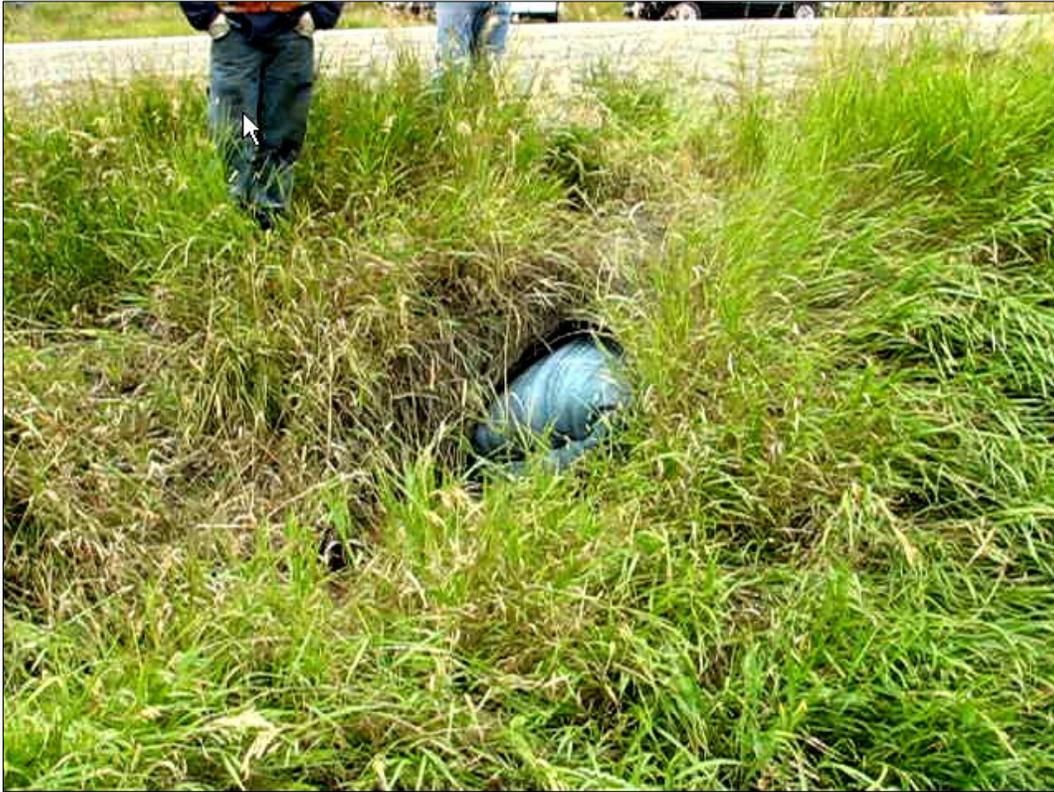
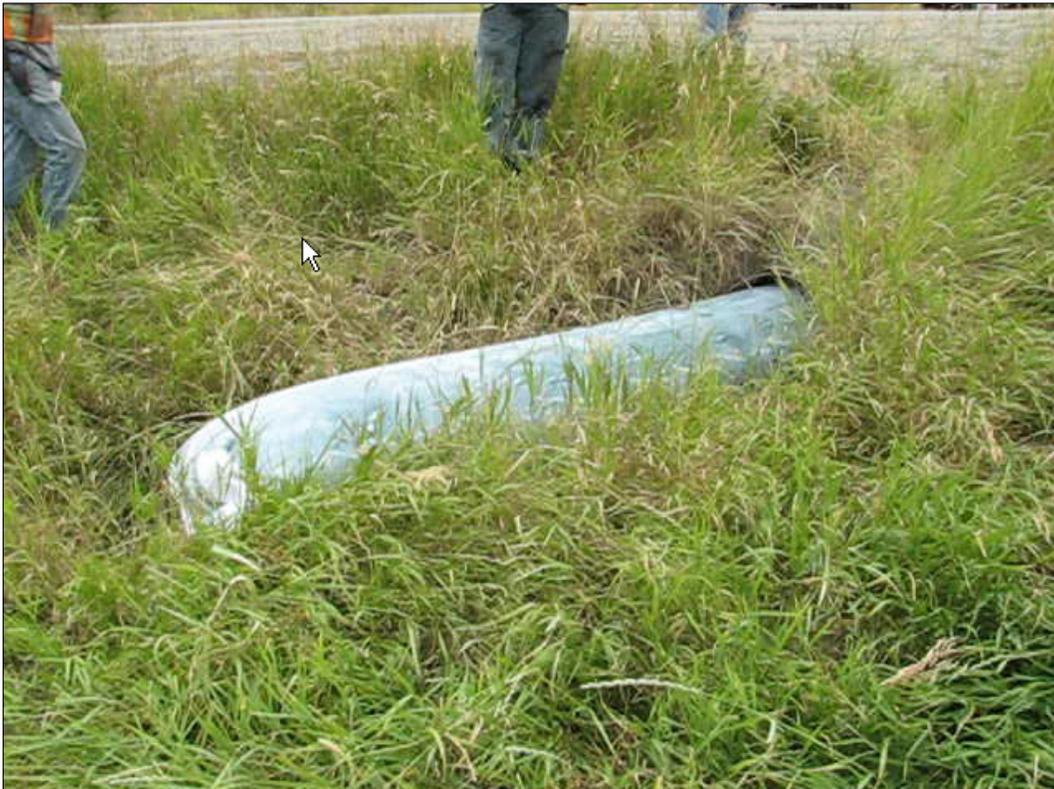
In the above image the inverted CIPP is just beginning to exit the outlet of the CSP. On average with the MacDonald pass installations (based on an average 130' CSP length); the time for complete liner insertion phase was at thirty minutes. Below, the liner is almost fully extended.

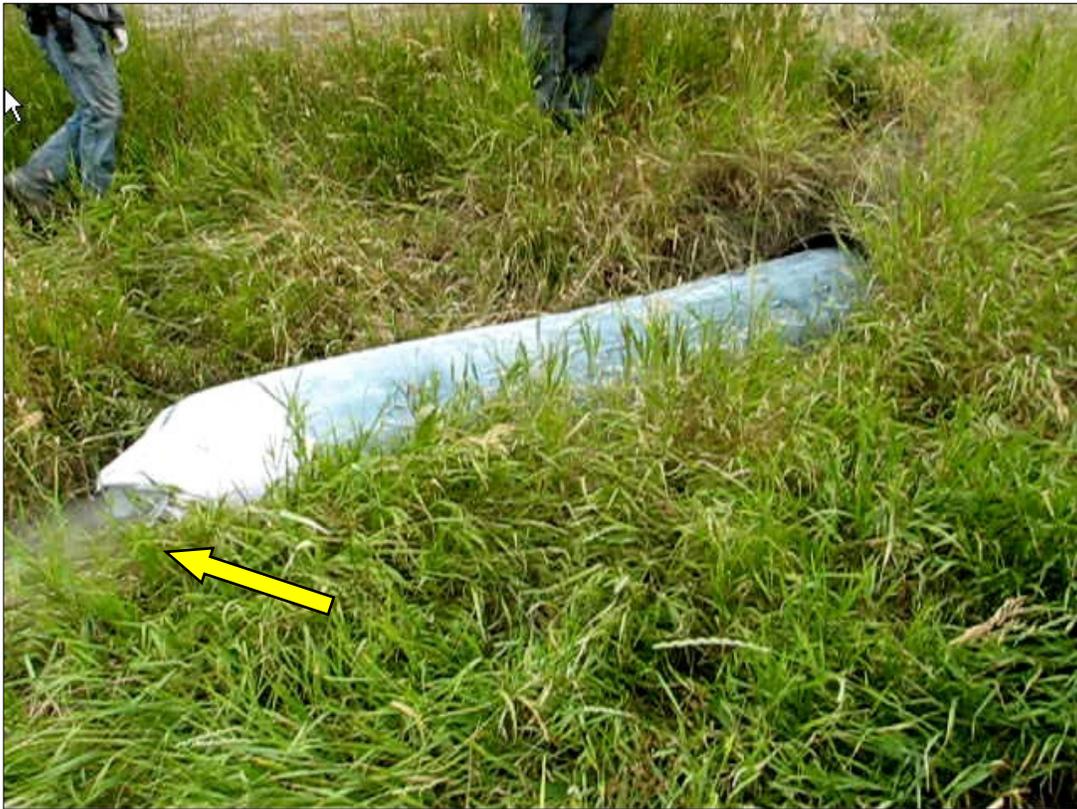
The CIPP has fully exited the outlet end of the CSP and released the air pressure which had forced it through the culvert (yellow arrow). Since the liner was initially inverted it retained a natural plug until it reached the end of the cut length of the CIPP. Now fully deflated, the liner is ready for the curing phase as seen below.

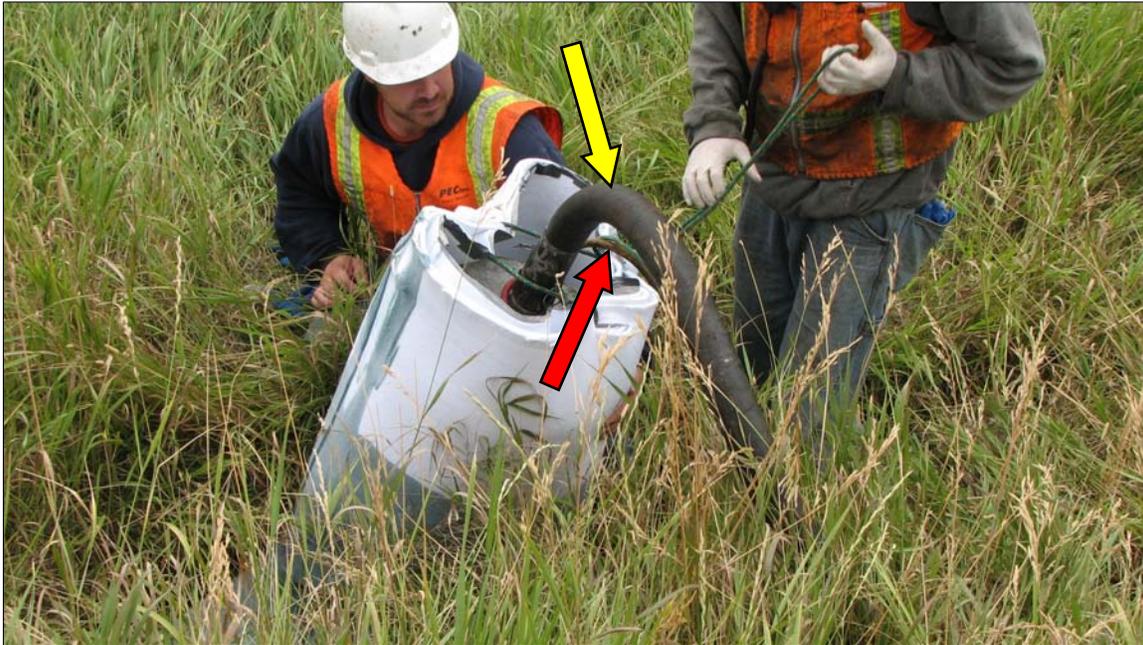
The installer places a large rubber plug on the inside discharge end of the CIPP (outlet). It is sewn in by the inner layers with rope. The plug has two connections at the end which allow the attachment of the smaller air line (red arrow) and the larger steam line (yellow arrow). The air line will be used to expand the CIPP to conform to the interior of the existing CSP. The steam line is for the actual curing of the liner.

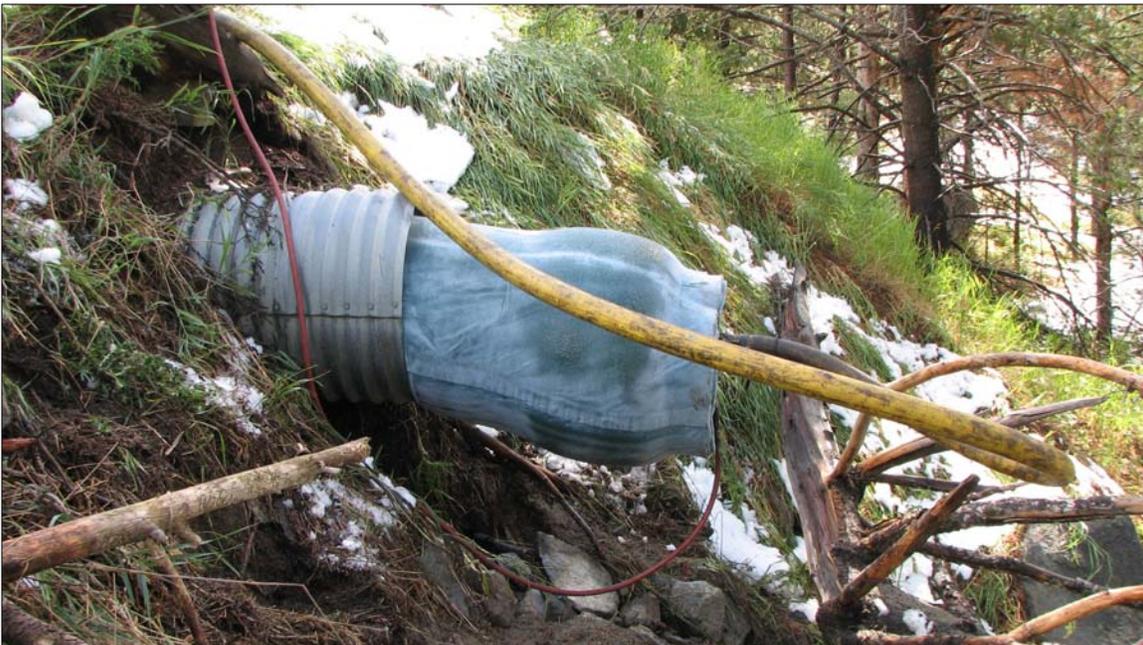
Air is now inflating the CIPP liner. Once fully inflated, steam will be injected into the liner at an average of 5 PSI and an average temperature of 235° F (113° C). Note that air (under pressure) alone can complete the cure, however by using steam heat it decreases the cure time down from 2-3 weeks to 1.5 hours.

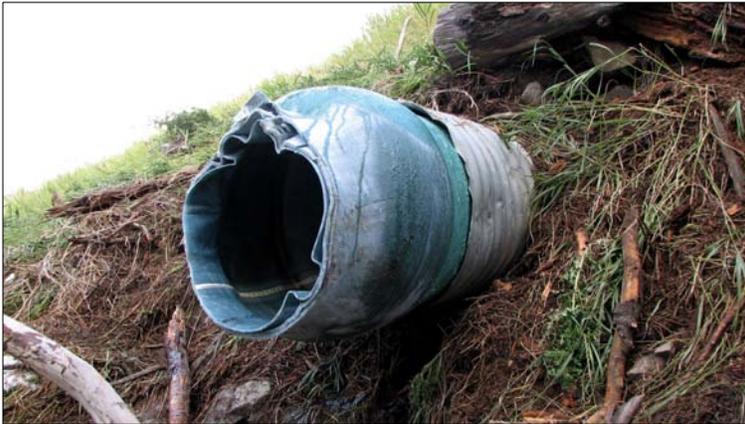
The CIPP has been allowed to cool for 1.5 hours after the completion of the steam phase. The plug has been removed and the CIPP is trimmed flush to the CSP.

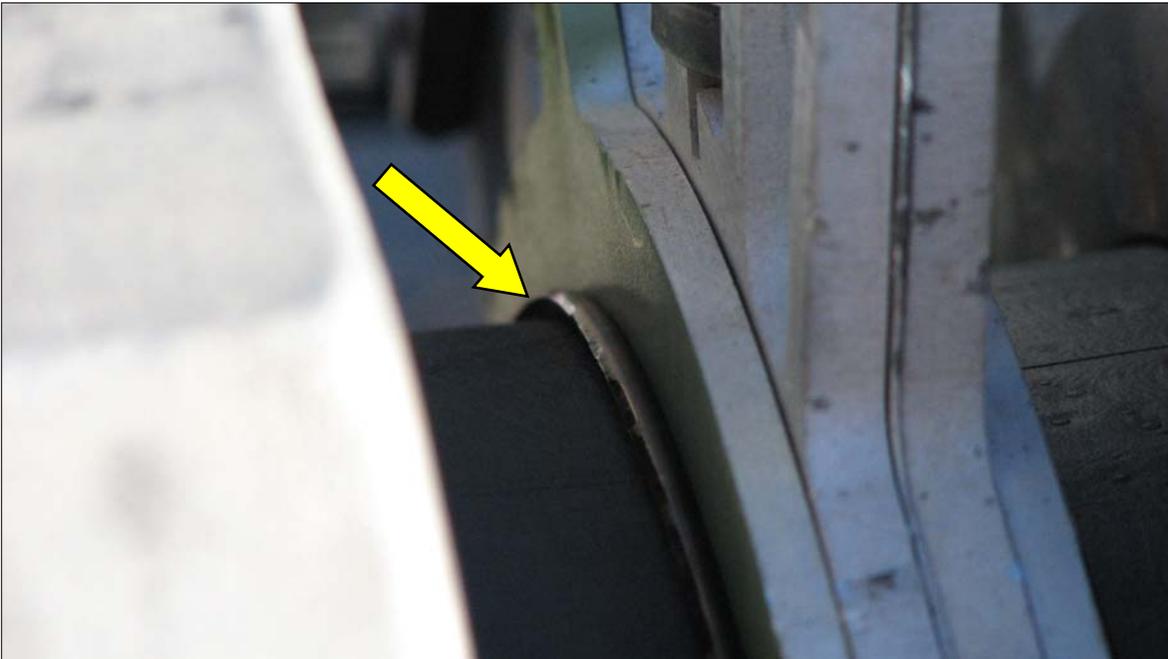
As you can see a bead is beginning to form at the edge of the HDPE as it is being pressed against the iron plate. The size of the bead is an indication of when the HDPE is at the temperature required to fuse the pipe sections. The duration of the heated iron to pipe ranges from 2-3 minutes with average temperature of 425° F (218° C).

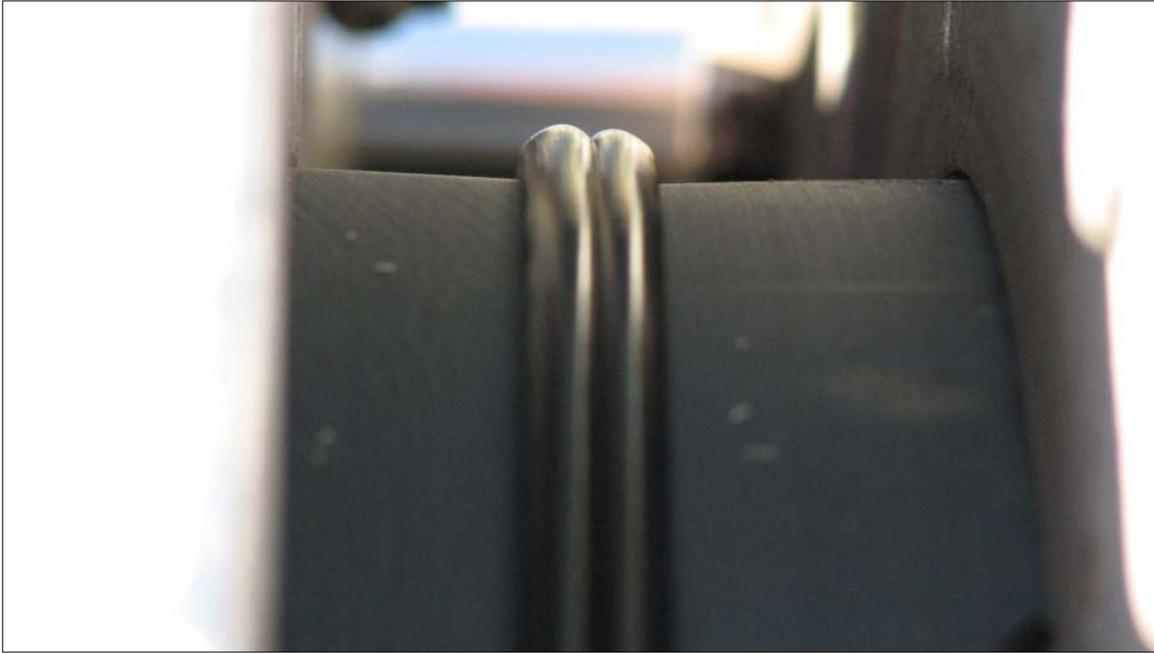
The HDPE is now heated to a temperature where the pipe ends can now be pressed together to complete the fusing. The above image shows the iron has been removed to allow the pipe welder to apply adequate pressure on the section ends to perform the fuse. The plastic continues to bead during the process. The ends are allowed to cool in place. Based on ambient air temperature, the average time to complete the weld can range from 15-20 minutes. Manufacturer's specifications state that a competent fused seam is structurally stronger than the pipe body itself. The exposed bead is not part of the structural bond.

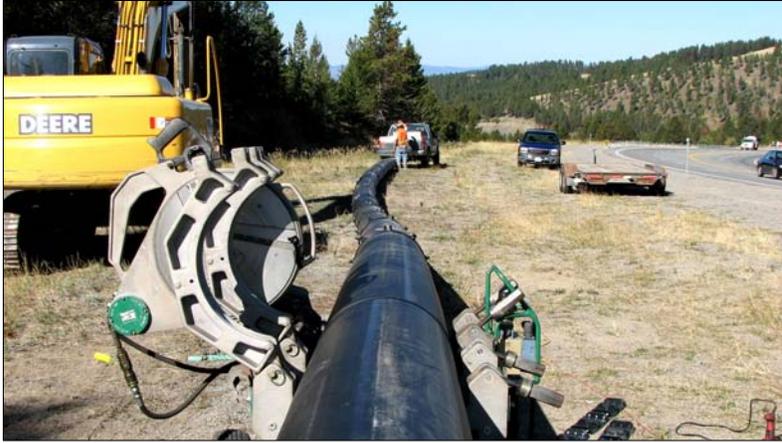
The completed HDPE culvert liner is attached to a pick-up truck and dragged to the installation site. For this particular installation, the assembly site to the culvert location was over $\frac{1}{4}$ (0.25) miles away. The HDPE liner incurred no damage by this method of transportation.

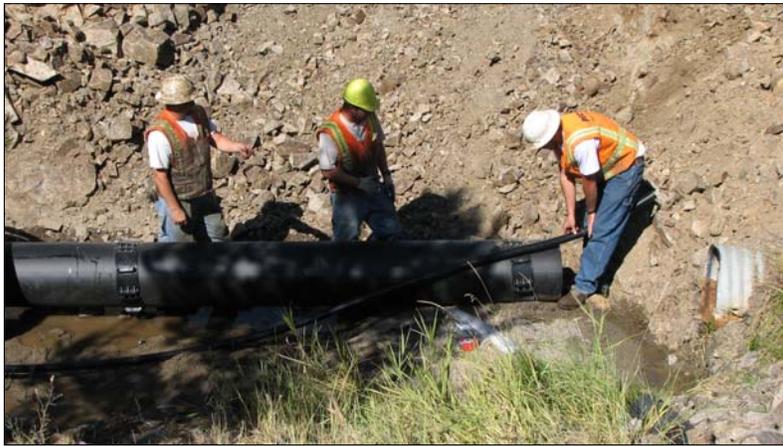
The grout tube will now be affixed to the end of the HDPE. The grout tube will follow the entire length of the liner up to the culvert inlet.

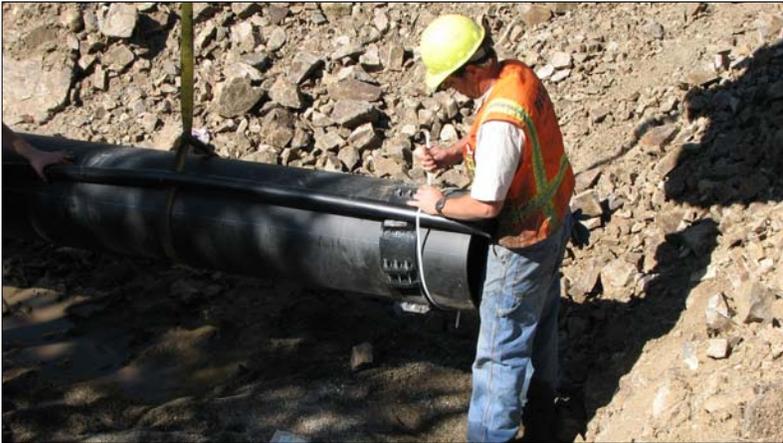
The grout tube is initially connected by nylon ties.

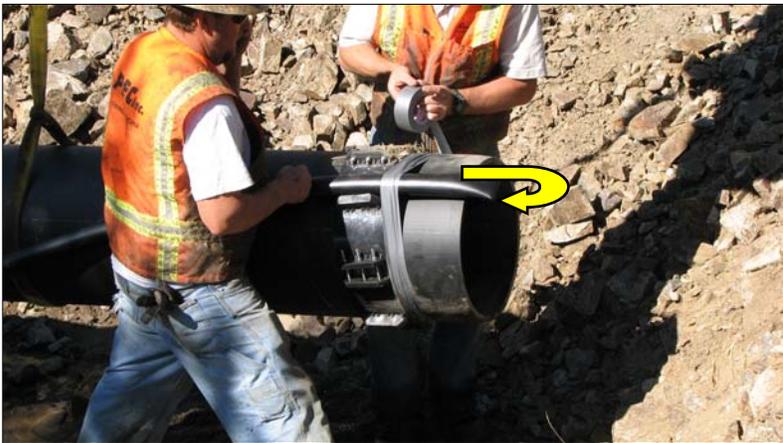
The tube is then firmly duct taped to the HDPE. Although difficult to see in this image, the grout tube is bent back on itself and inserted into the HDPE liner about three feet (yellow arrow). This will allow enough lead at the inlet to be attached to the grout pump line.

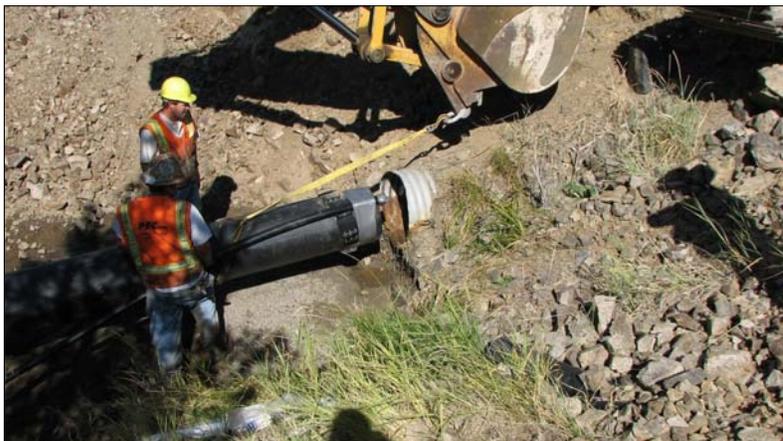
The excavator will incrementally move the HDPE liner and the attached grout tube through the existing CSP to the culvert inlet.

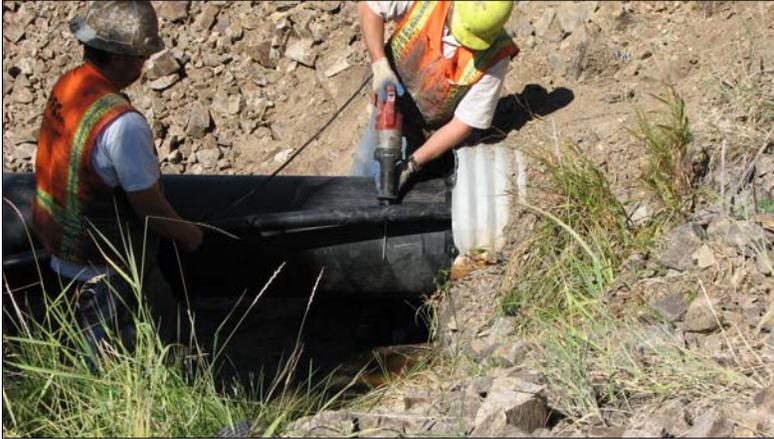
With the HDPE liner fully inserted into the CSP culvert, the excess liner is trimmed by a saw.

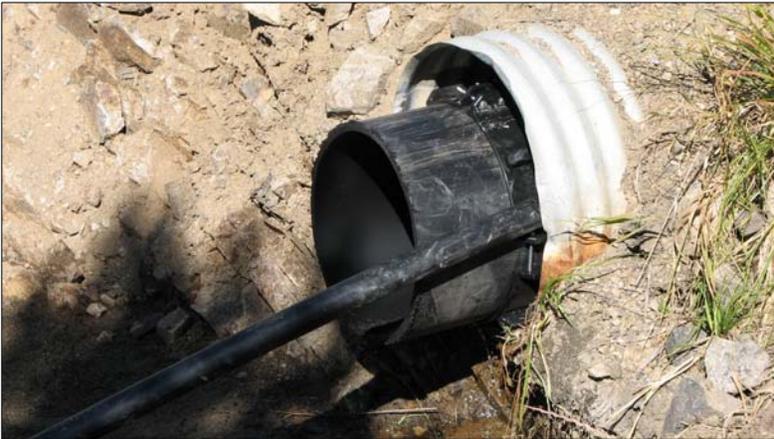
The HDPE outlet is now ready for the bulkhead application.

The grouting tube will be cut and positioned at the backside of the bulkhead.

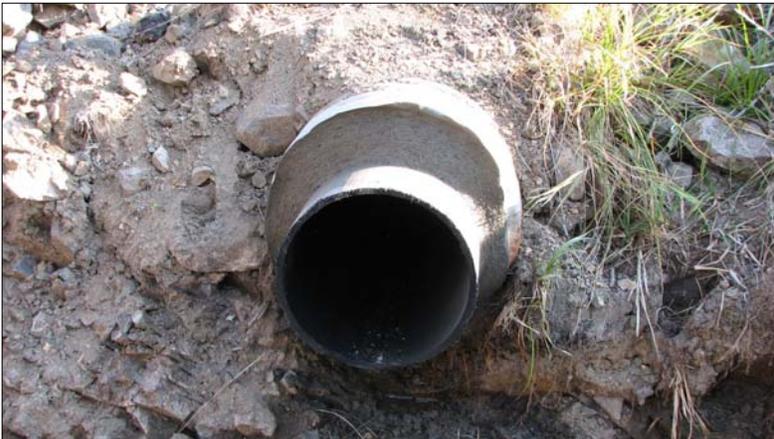
Completed bulkhead.

The purpose of the bulkhead, which basically is a grouted partition, is a barrier for the grout application. The tube will be slowly pulled back as grout is pumped to fill the void between the HDPE liner and the existing CSP.

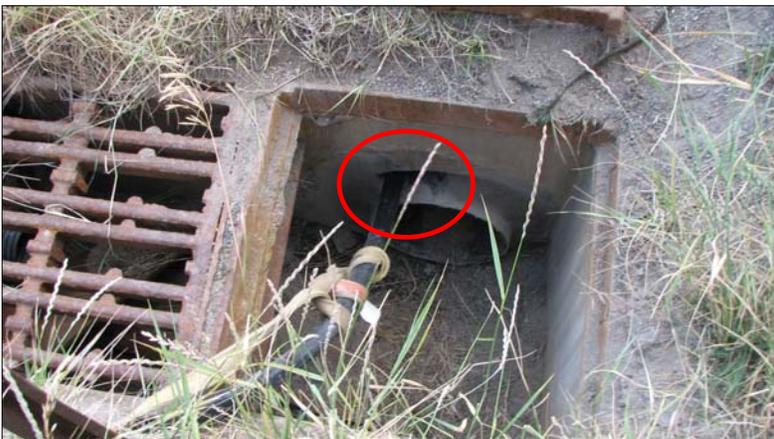
The culvert inlet received the same bulkhead treatment as the outlet. With exception of leaving a gap (see red circle) near the top to allow the tube to be pulled back during the grouting phase. Once completed, the tube is removed and the hole capped; the installation is complete.

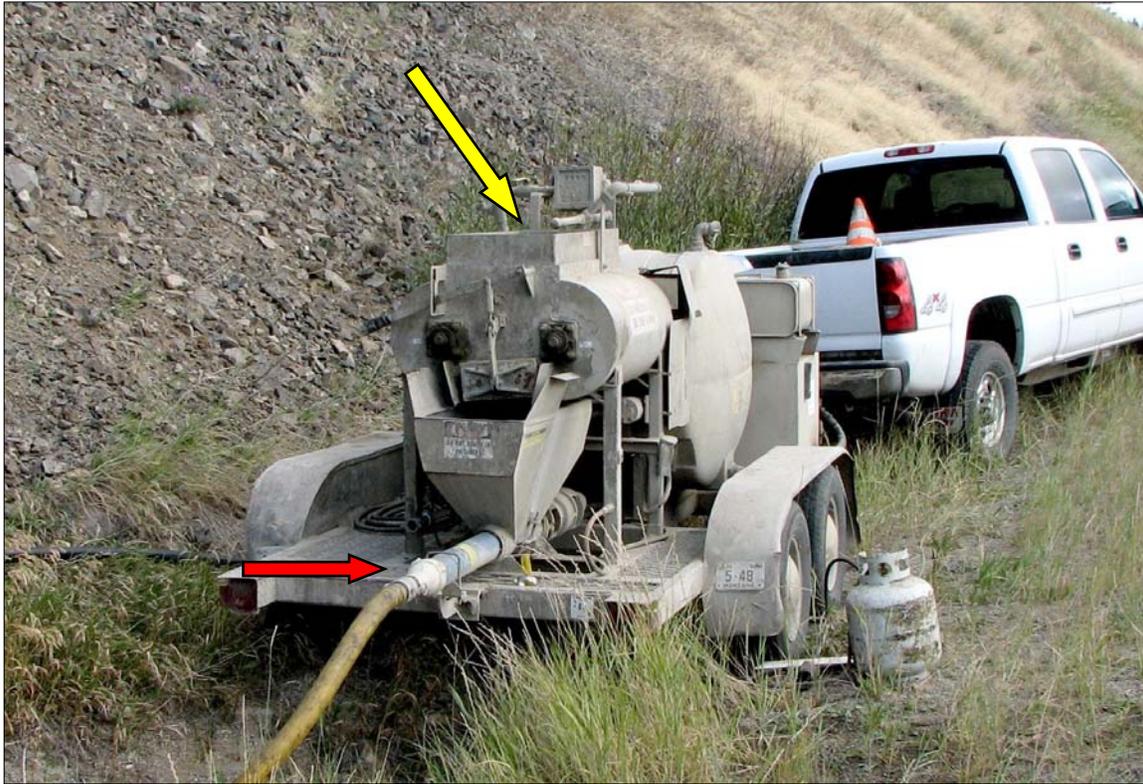
Sample image of the device used to apply the grout. The grout is entered through the hopper on top (yellow arrow) and by piston is pumped through to the attached hose (red arrow) which connects to the grout tube adjacent to the HDPE liner.

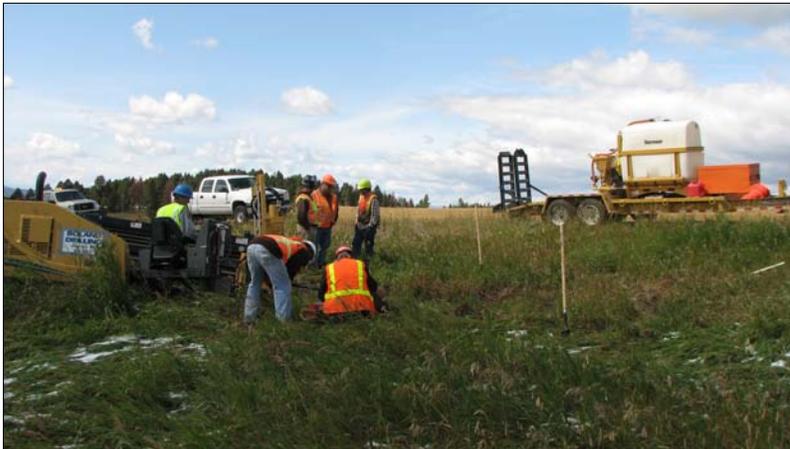
Sample image of directional borer on site.

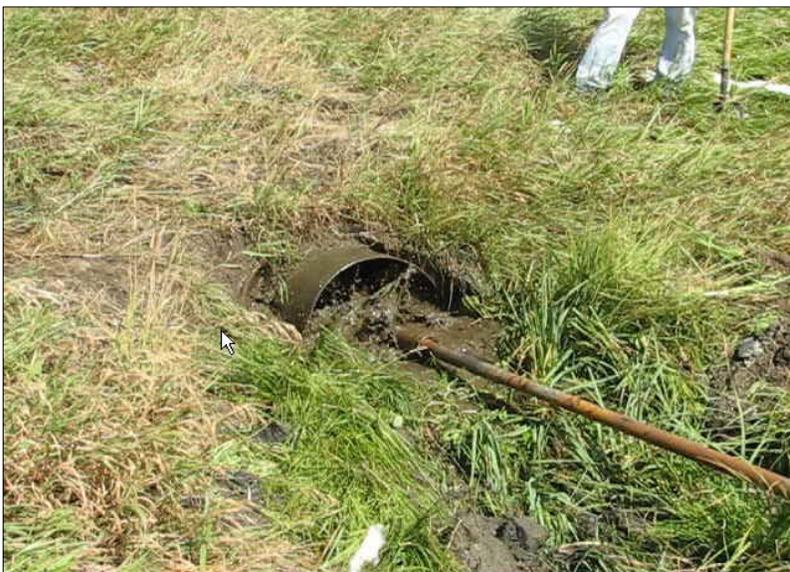
Sample image of auger head
