**EXPERIMENTAL PROJECTS FINAL REPORT**  
**URETHANE EPOXY PAVEMENT MARKINGS**

**Project Name:** Elk Park

**Project Number:** HWY-310386-RP

**Experimental Project No.** MT-12-02

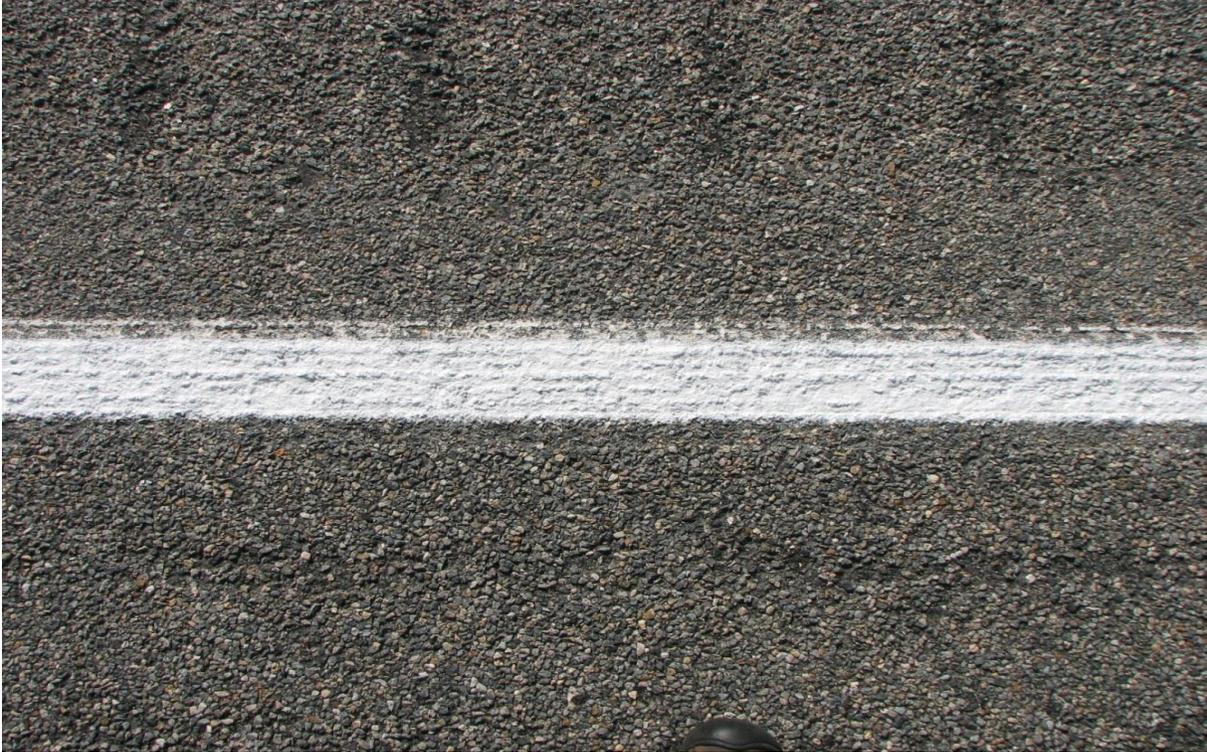
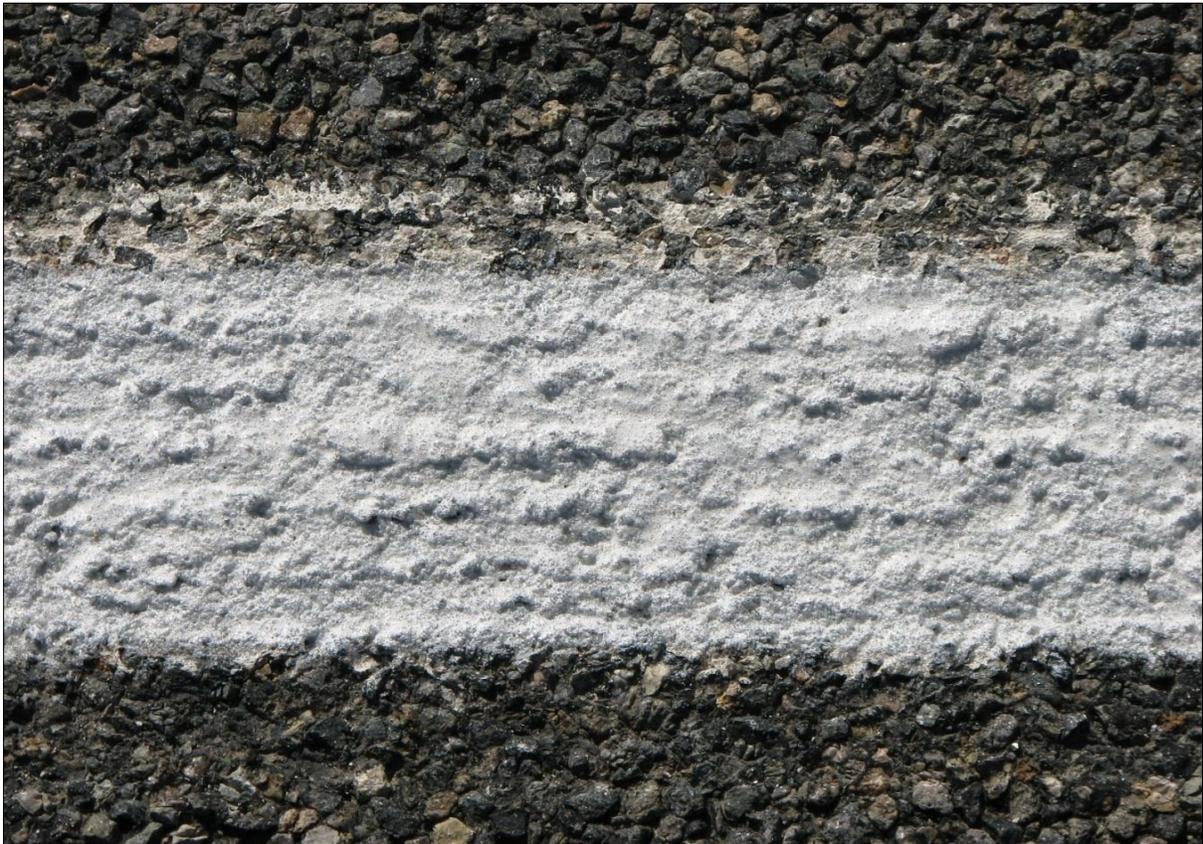
↑↓ Representative images of the Poly-Carb NB control section after the pavement marking application.

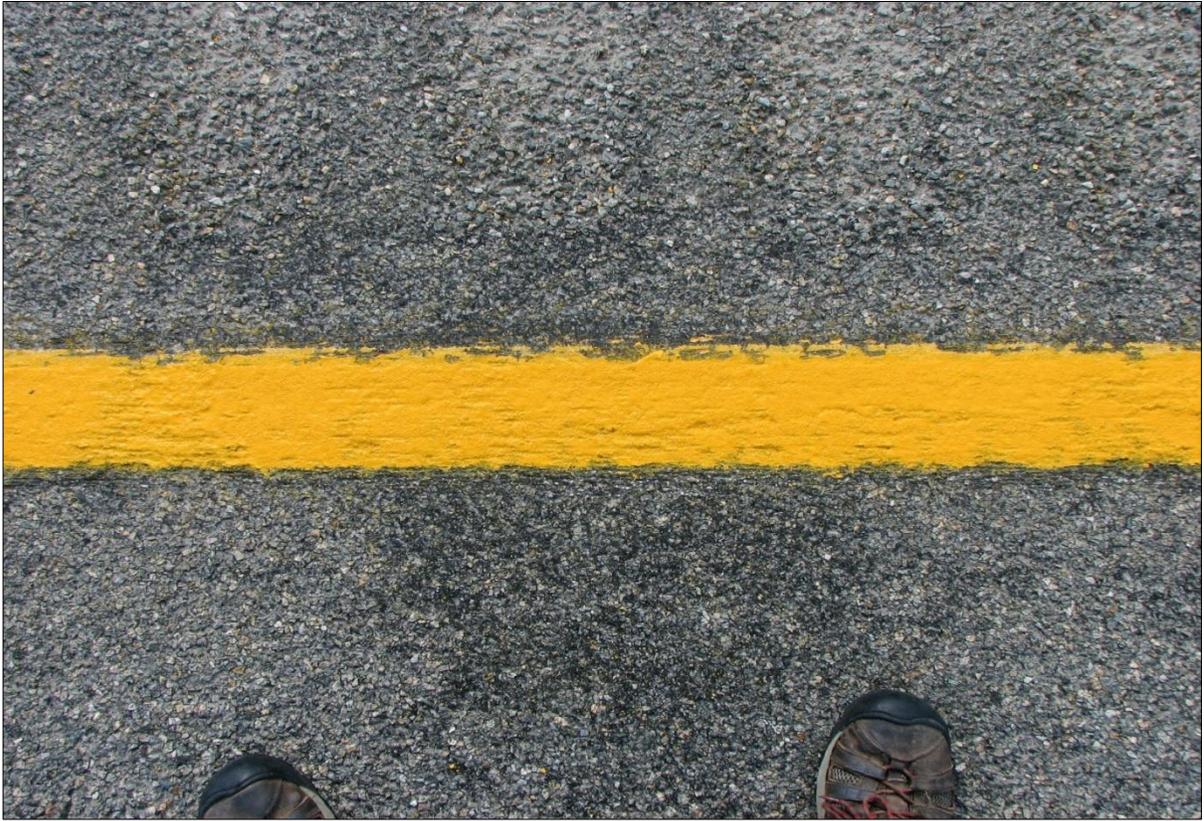
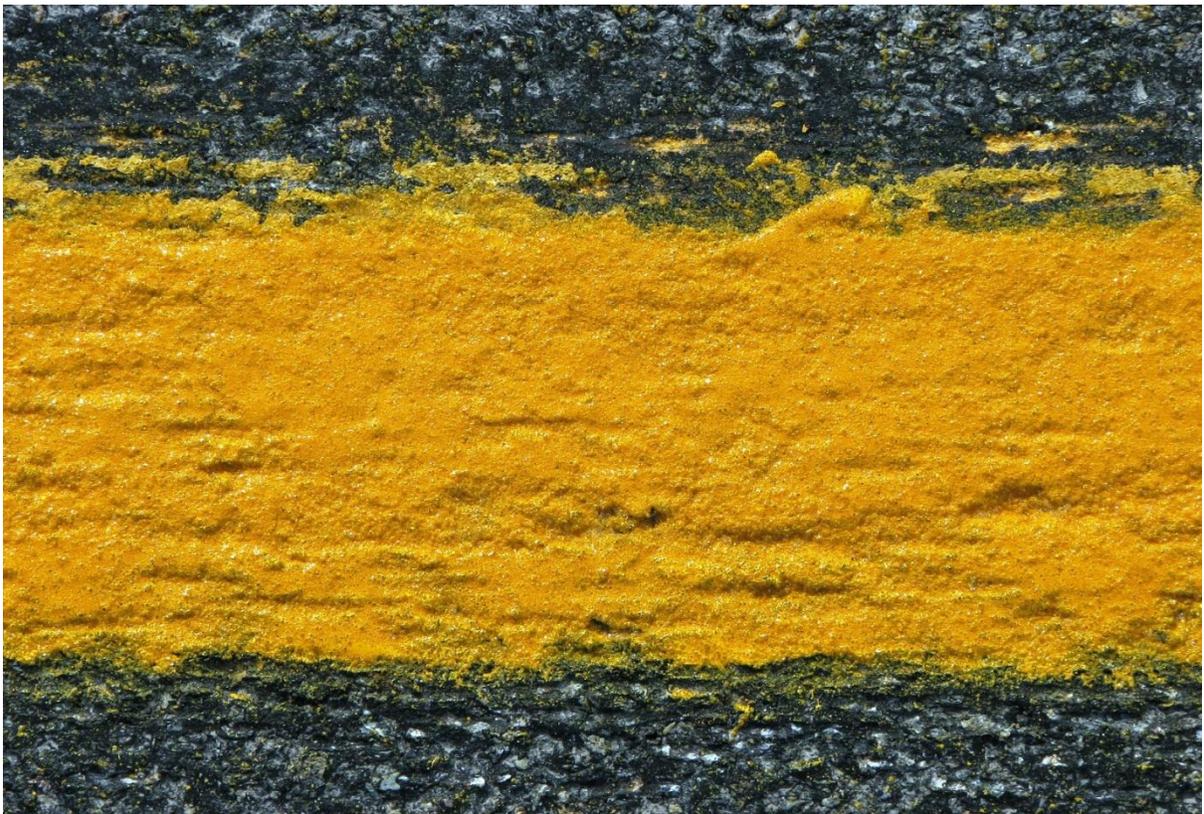
↑↓ Representative images of the yellow Poly-Carb NB control section after the pavement marking application.

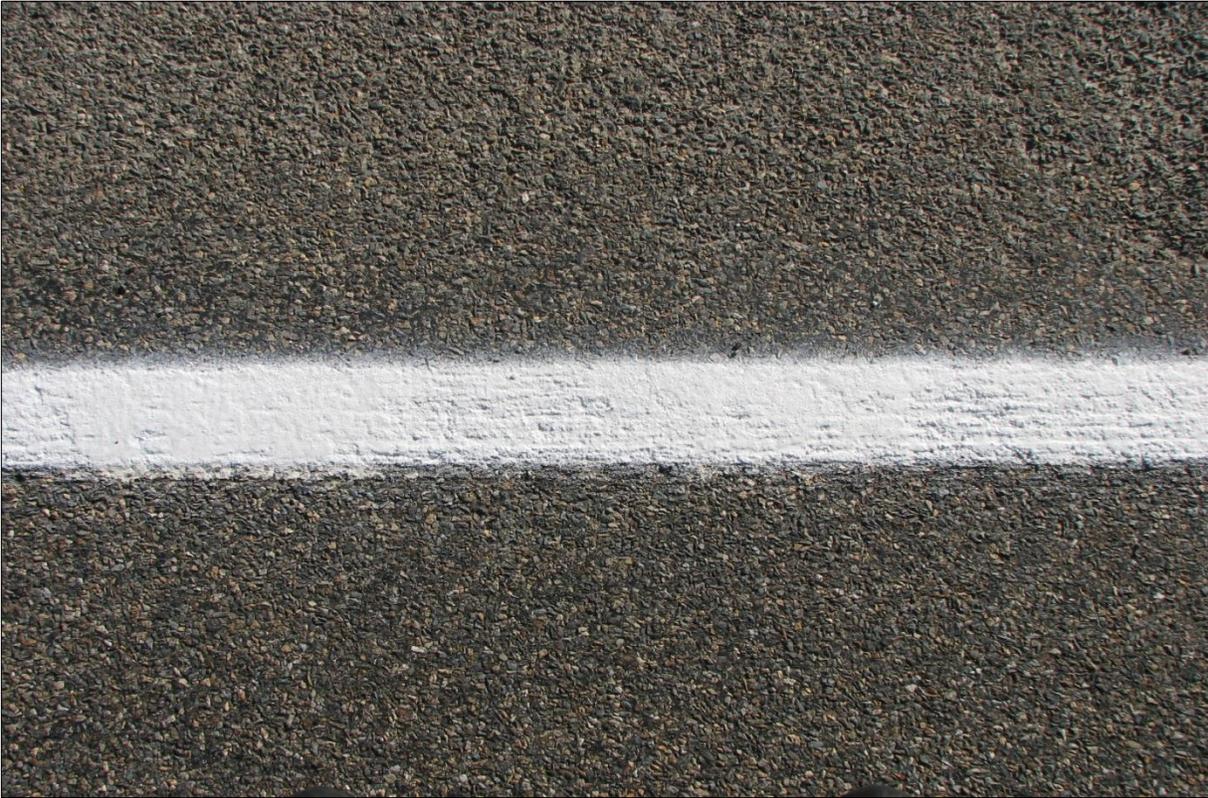
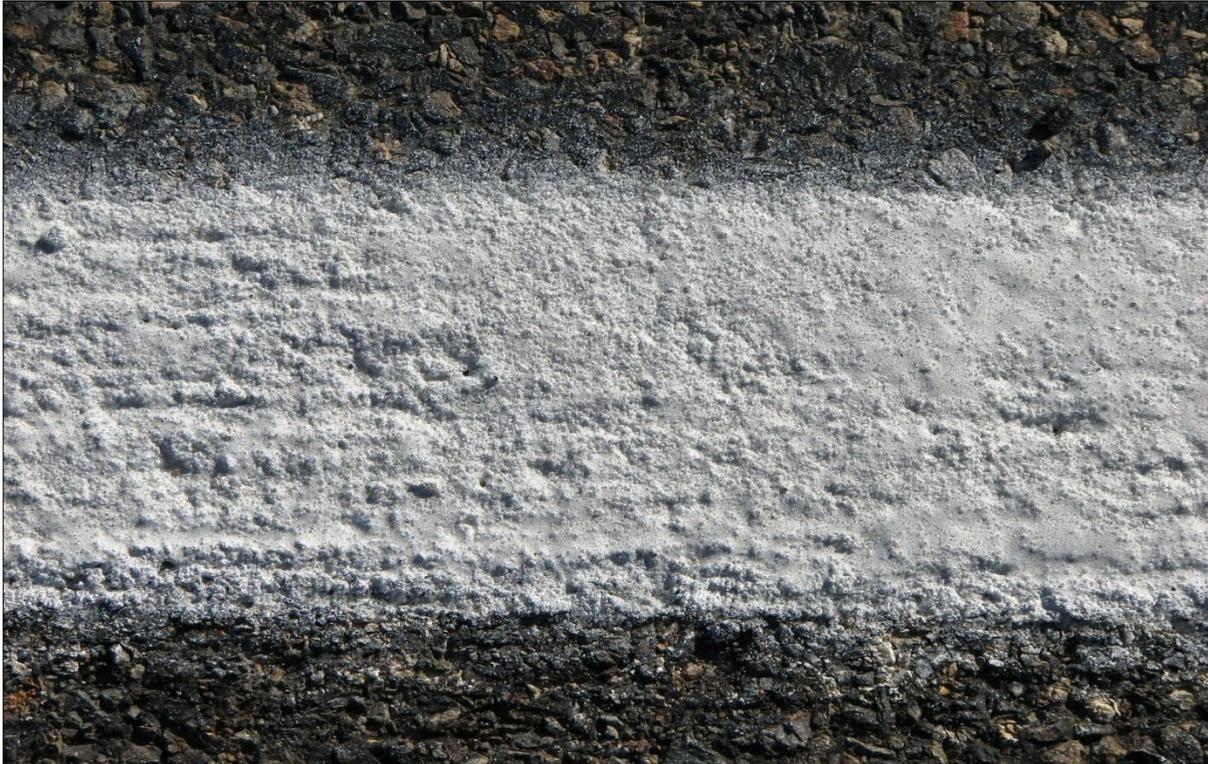
**Test Section: Ennis HPS-4 – Heavy Grind South Bound (SB) Lanes MP153-163**

↑↓ Representative images of the white Ennis HPS-4 test section after the pavement marking application.

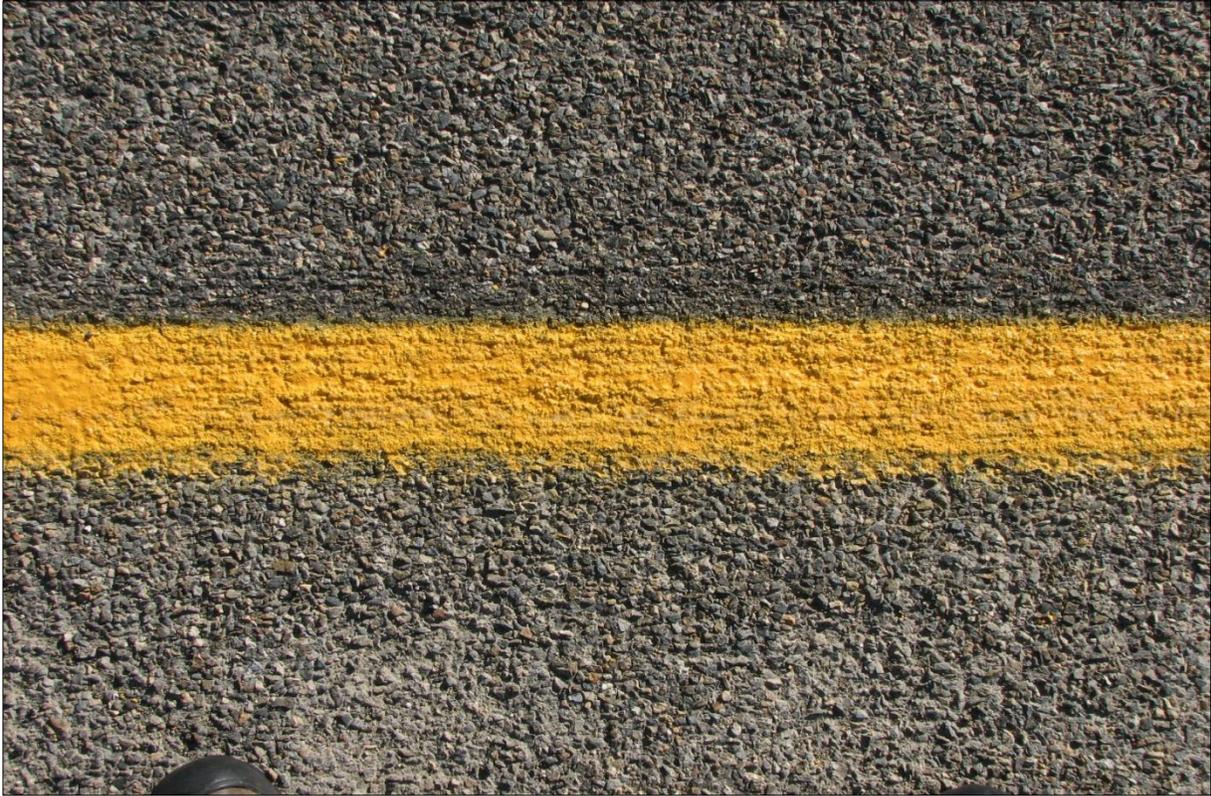
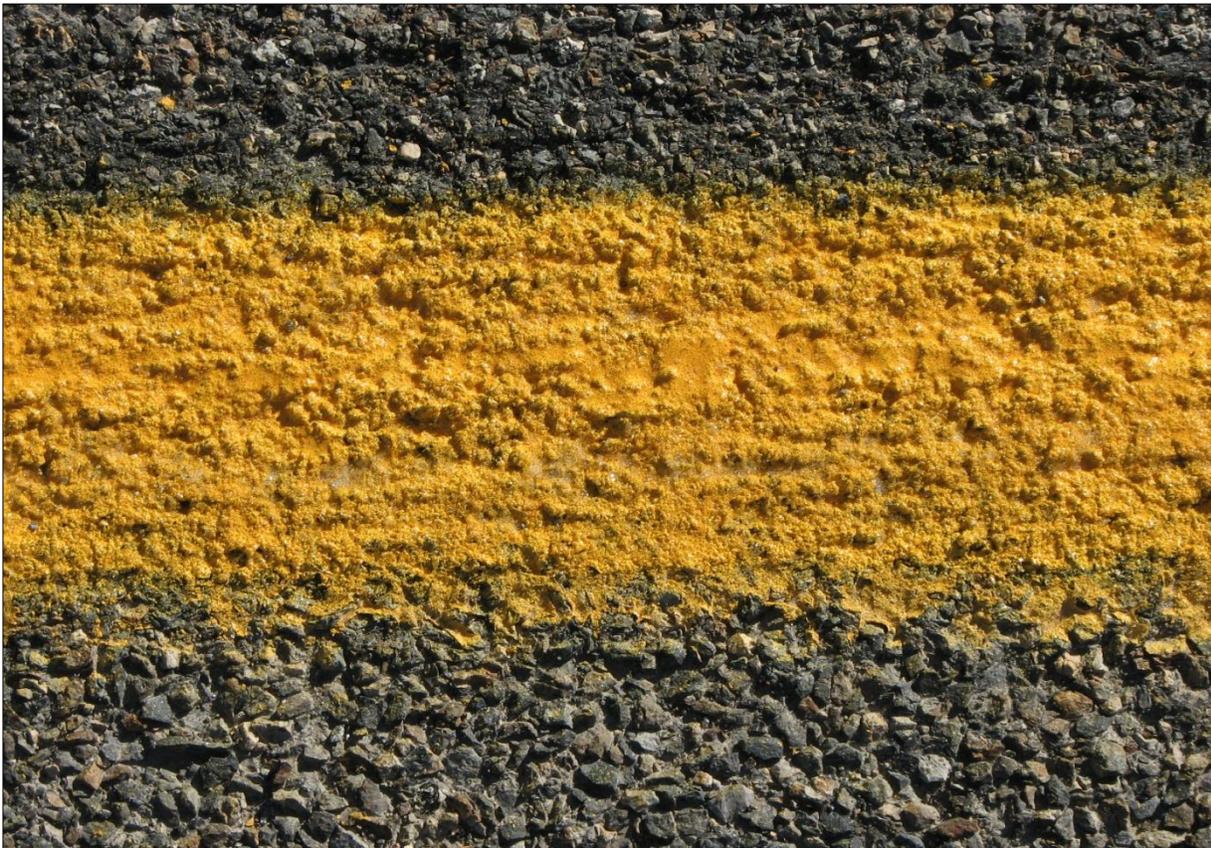
↑↓ Representative images of the yellow Ennis HPS-4 test section after the pavement marking application.

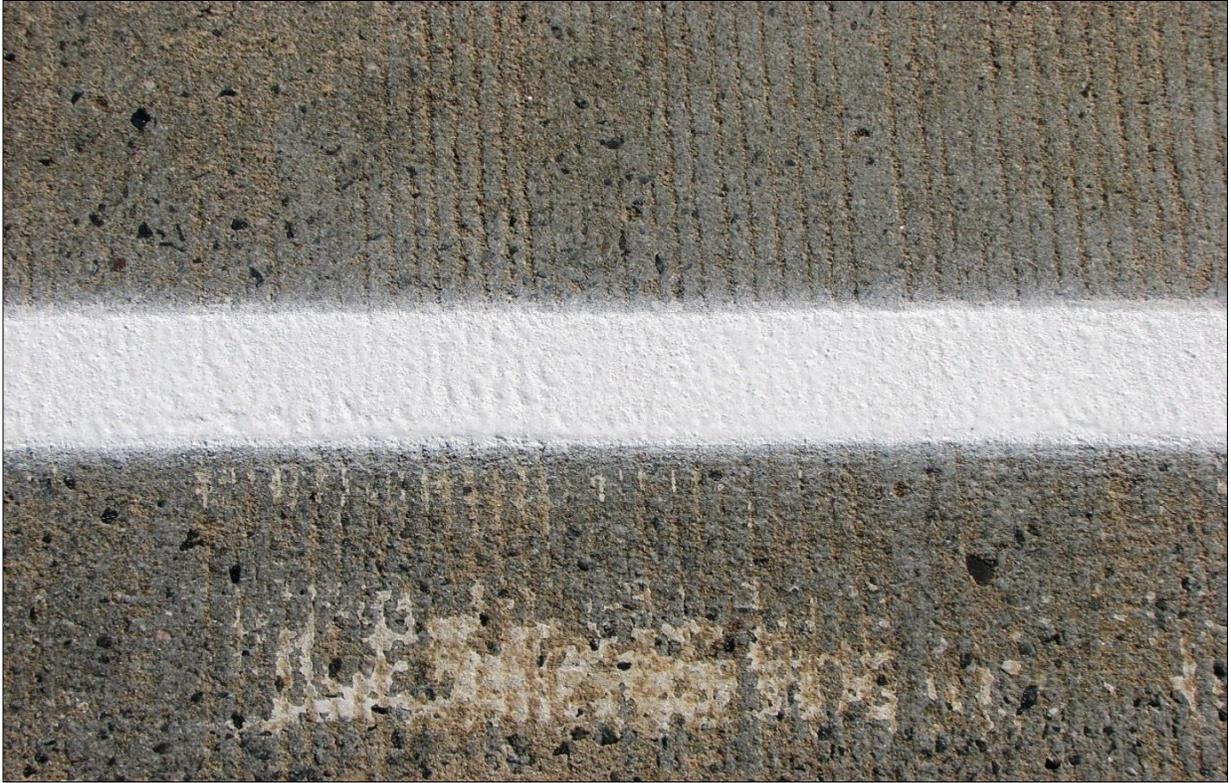
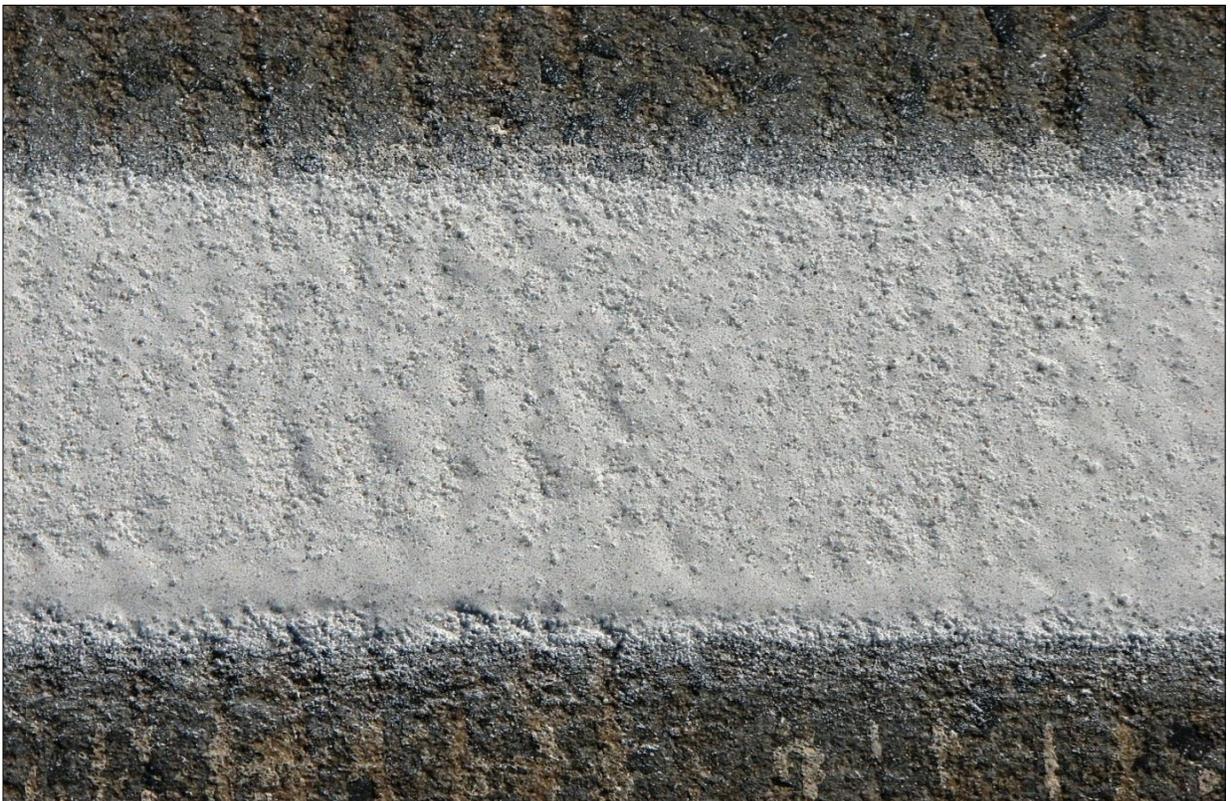
↑↓ Representative images of the white Ennis HPS-4 test section after the portland cement concrete pavement (PCCP) pavement marking application.

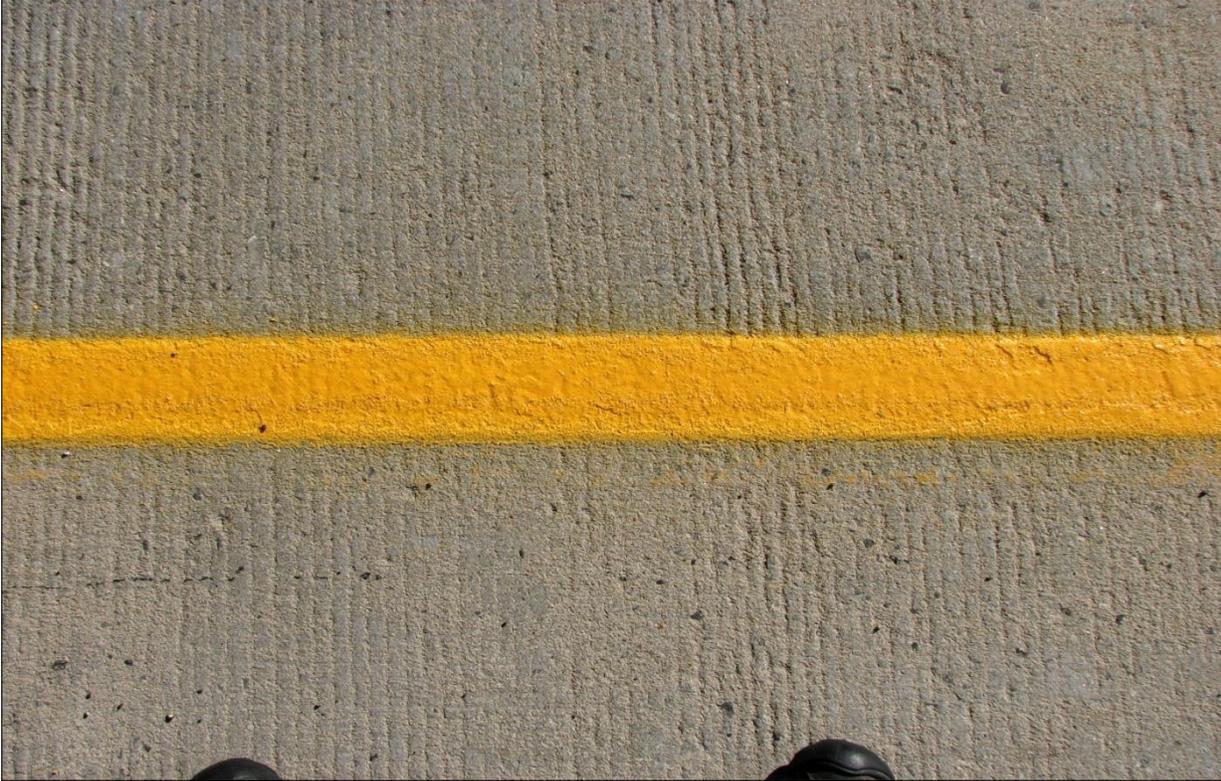
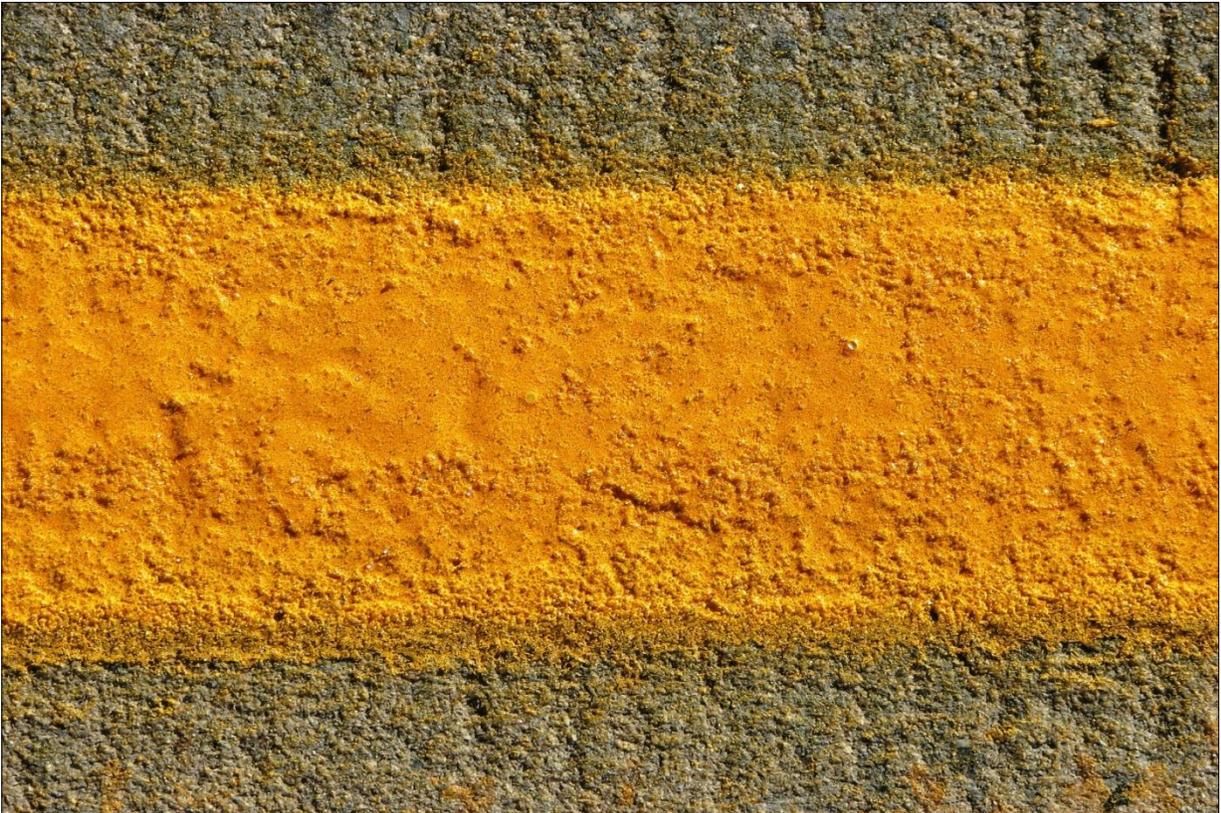
↑↓ Representative images of the yellow Ennis HPS-4 test section after the PCCP pavement marking application.

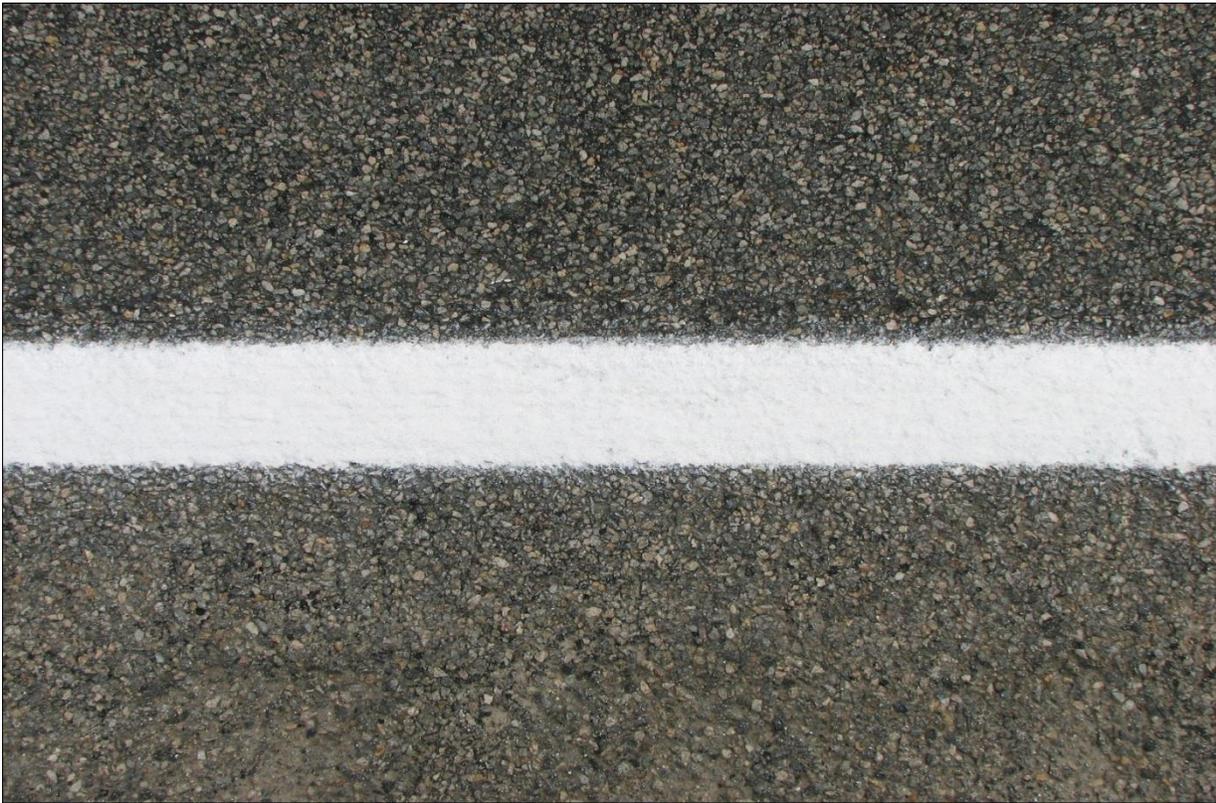
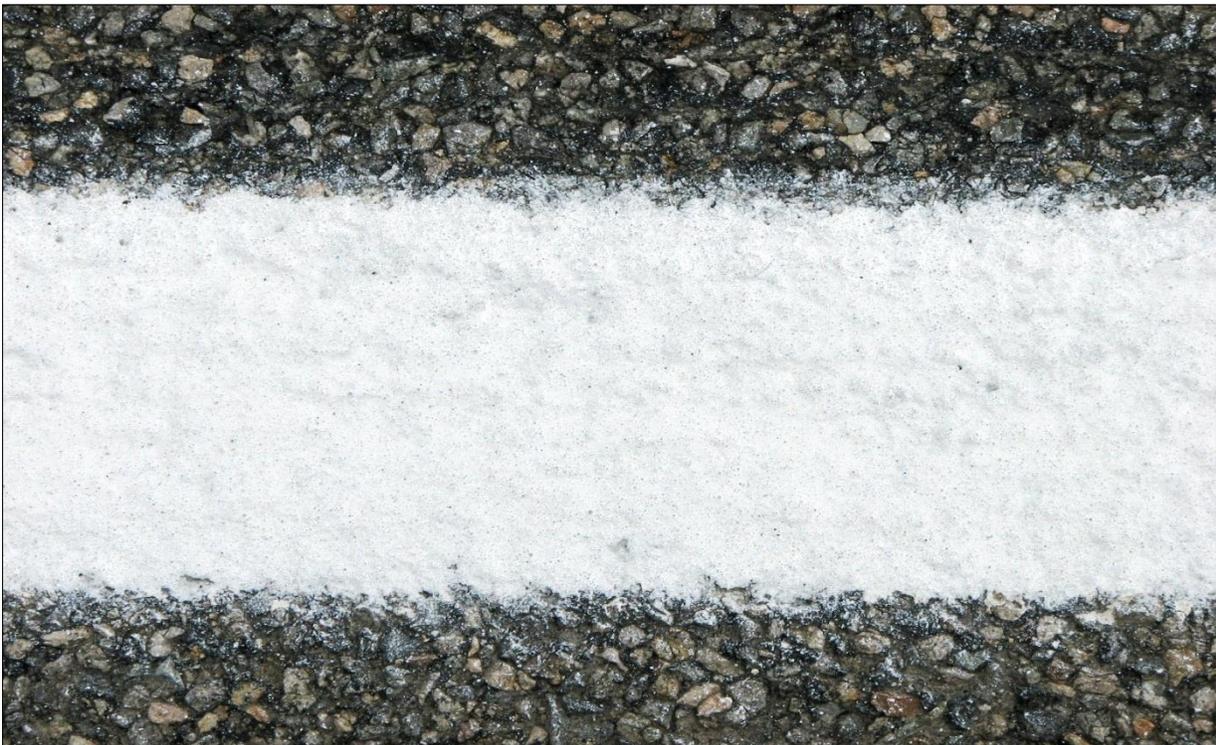
**Test Section: Swarco MFUA-10 – Heavy Grind North Bound (NB) Lanes MP153-163**

↑↓ Representative images of the white Swarco MFUA-10 test section after the pavement marking application.

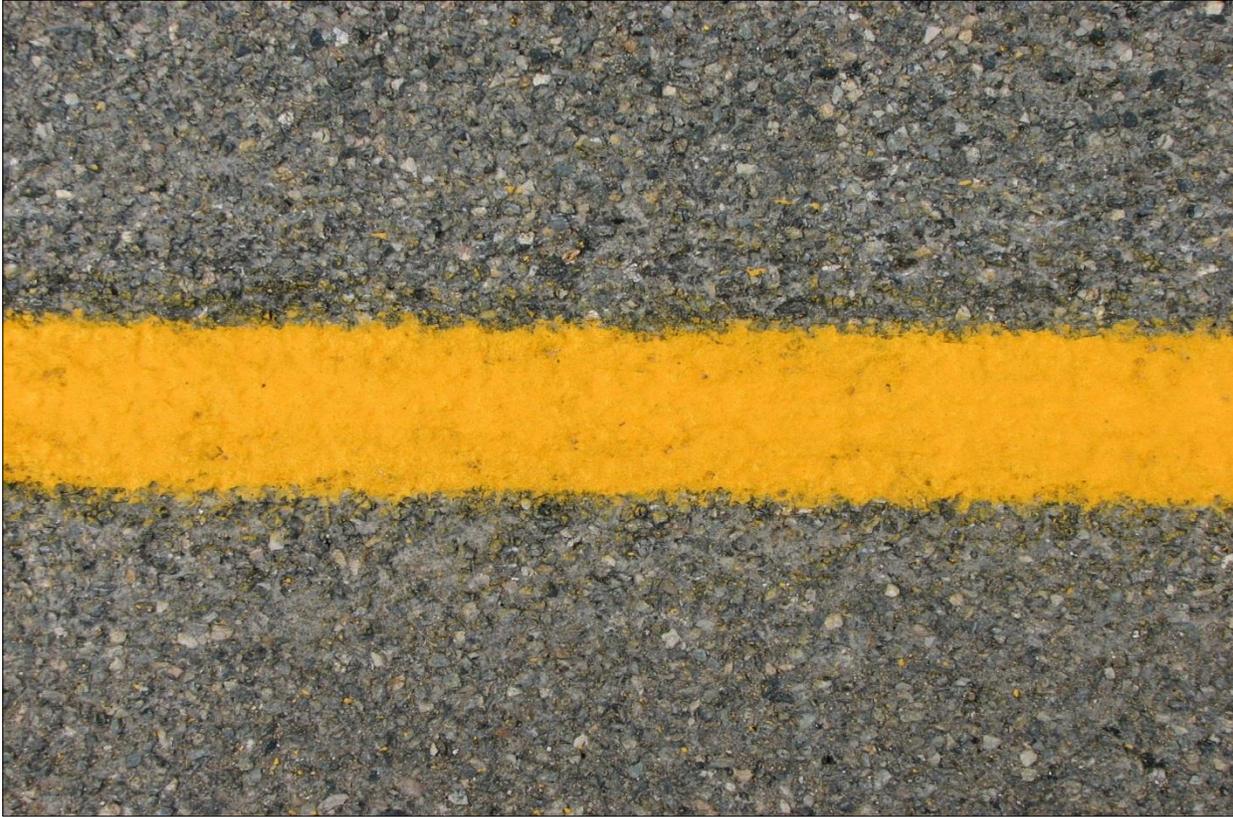
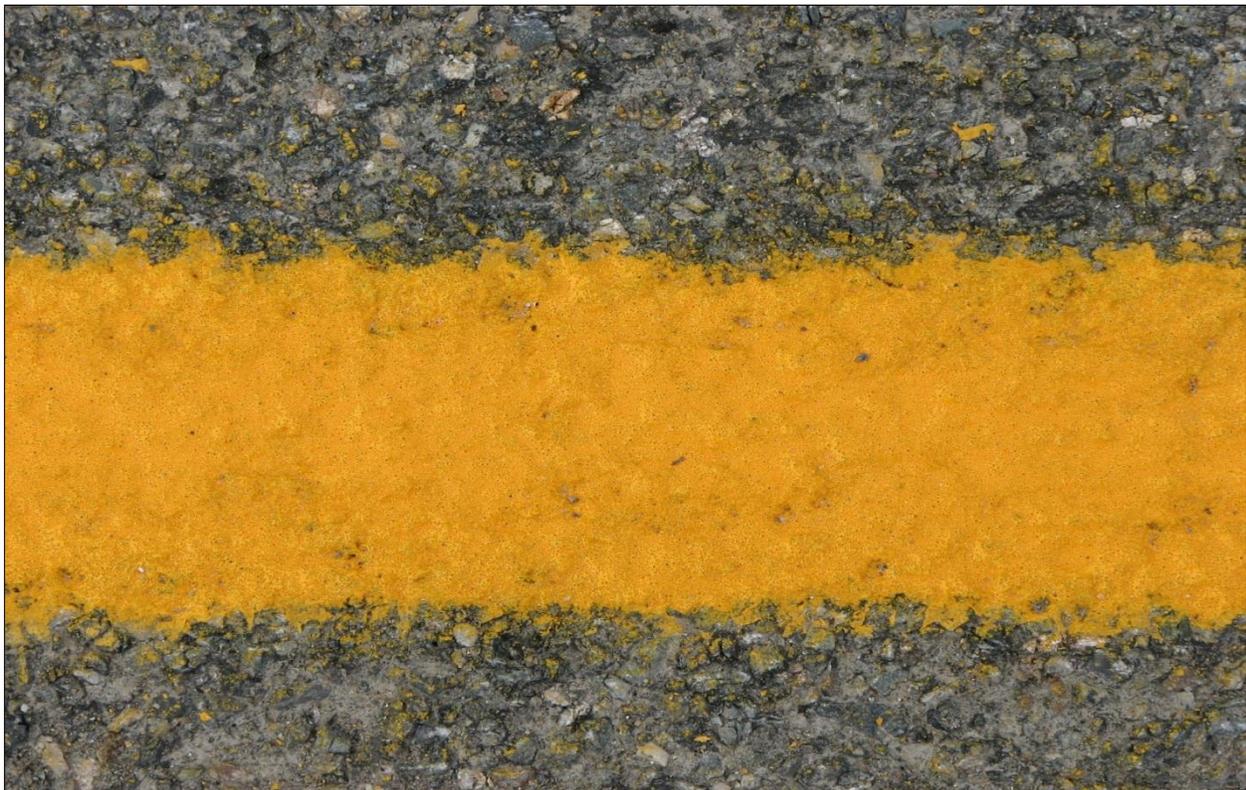
↑↓ Representative images of the yellow Swarco MFUA-10 test section after the pavement marking application.

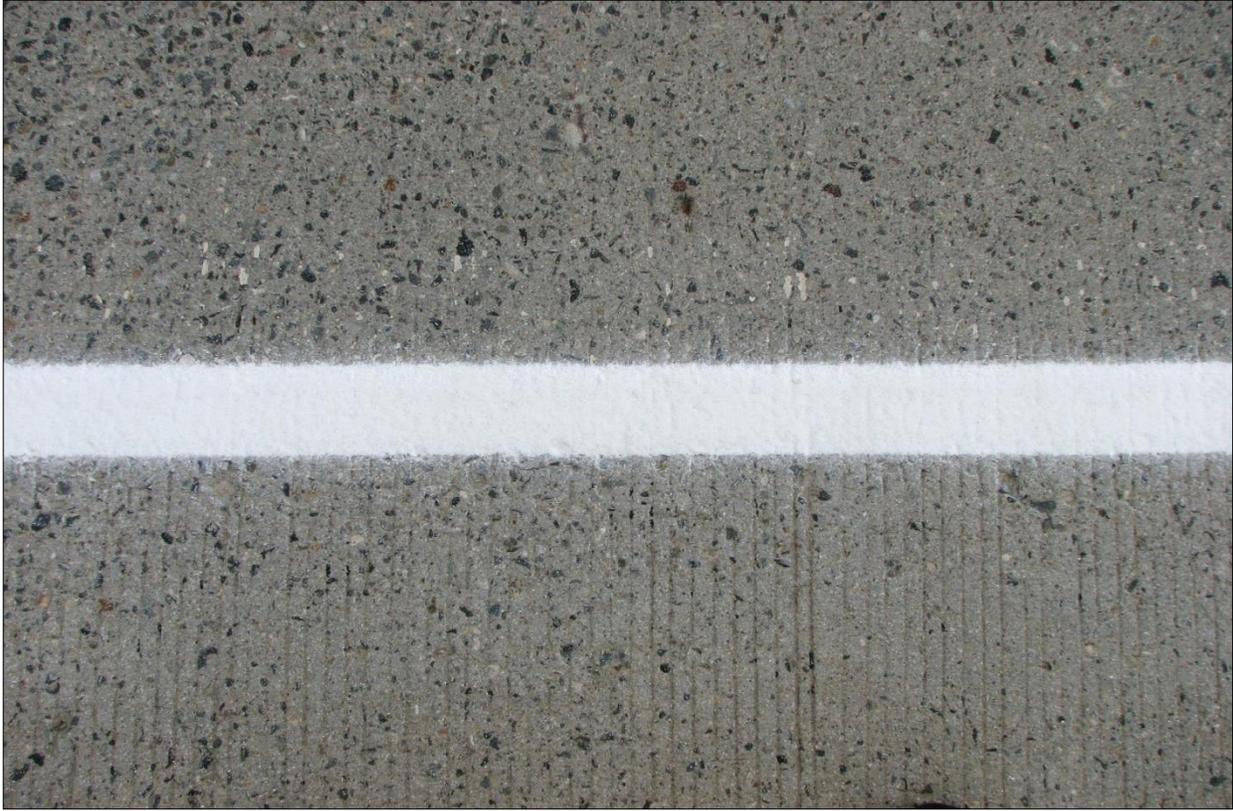
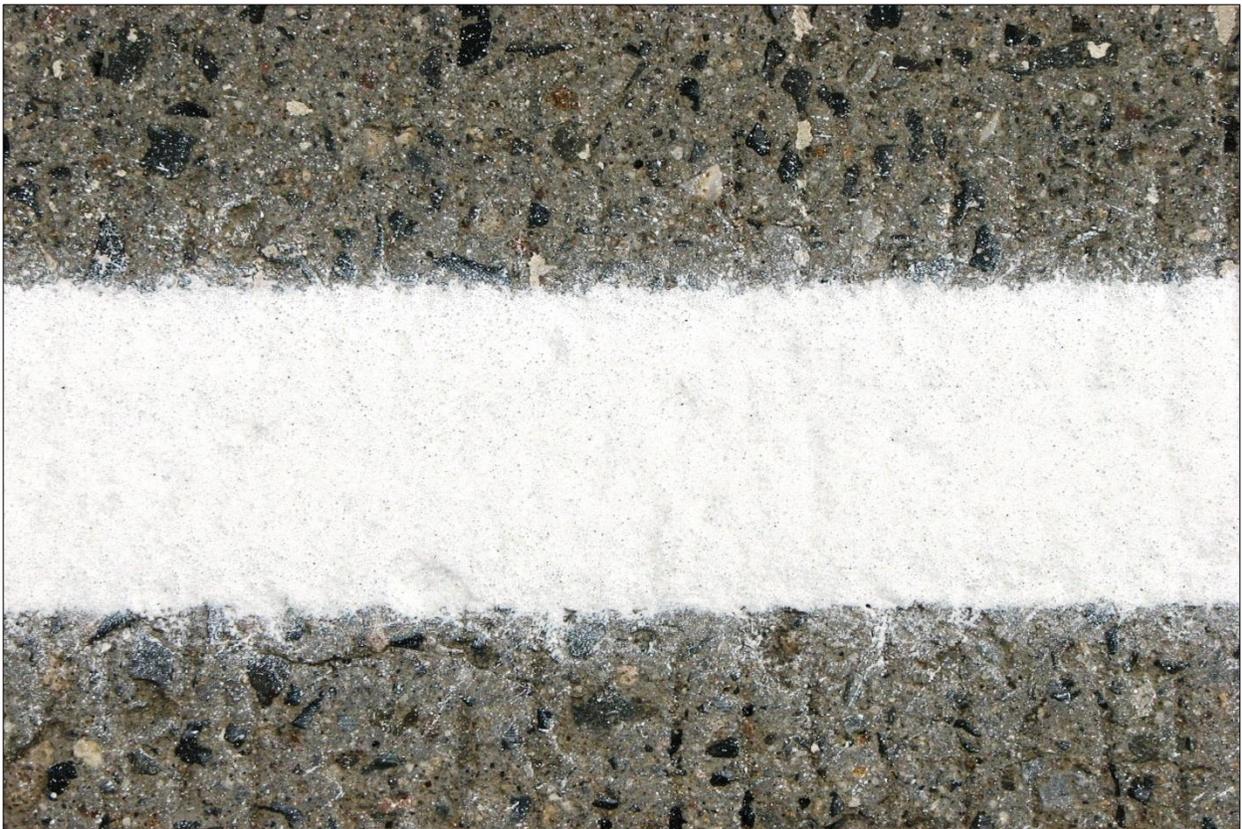
↑↓ Representative images of the white Swarco MFUA-10 test section after the PCCP pavement marking application.

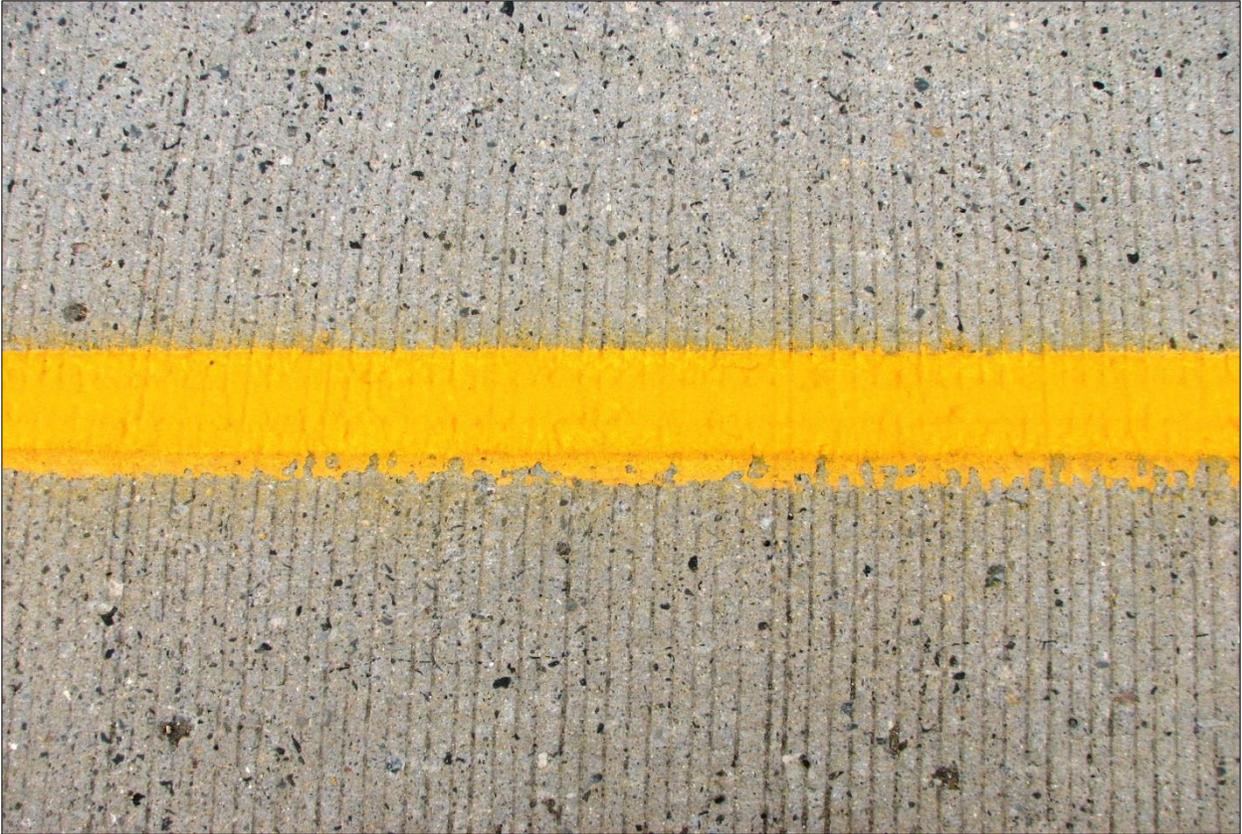
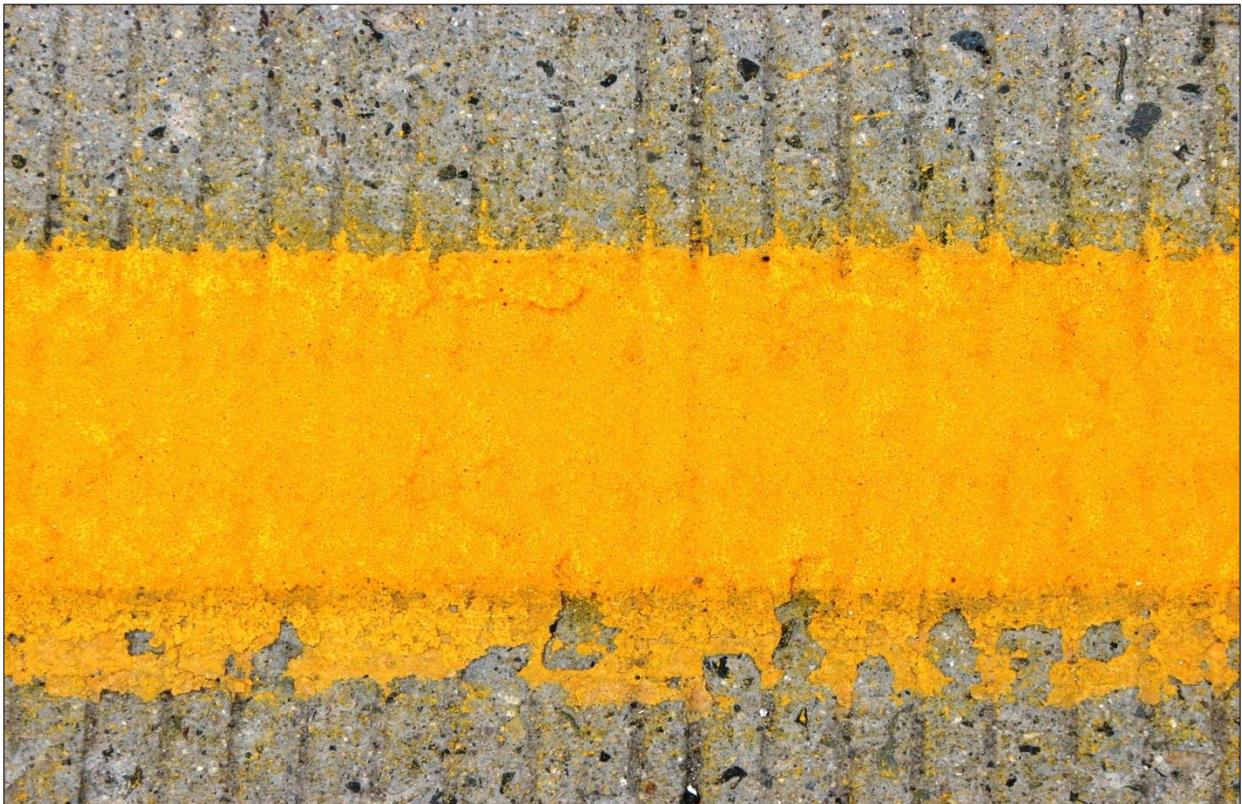
↑↓ Representative images of the yellow Swarco MFUA-10 test section after the PCCP pavement marking application.
