**EXPERIMENTAL PROJECTS FINAL REPORT**  
**URETHANE EPOXY PAVEMENT MARKINGS**

**Project Name:** Elk Park

**Project Number:** HWY-310386-RP

**Experimental Project No.** MT-12-02

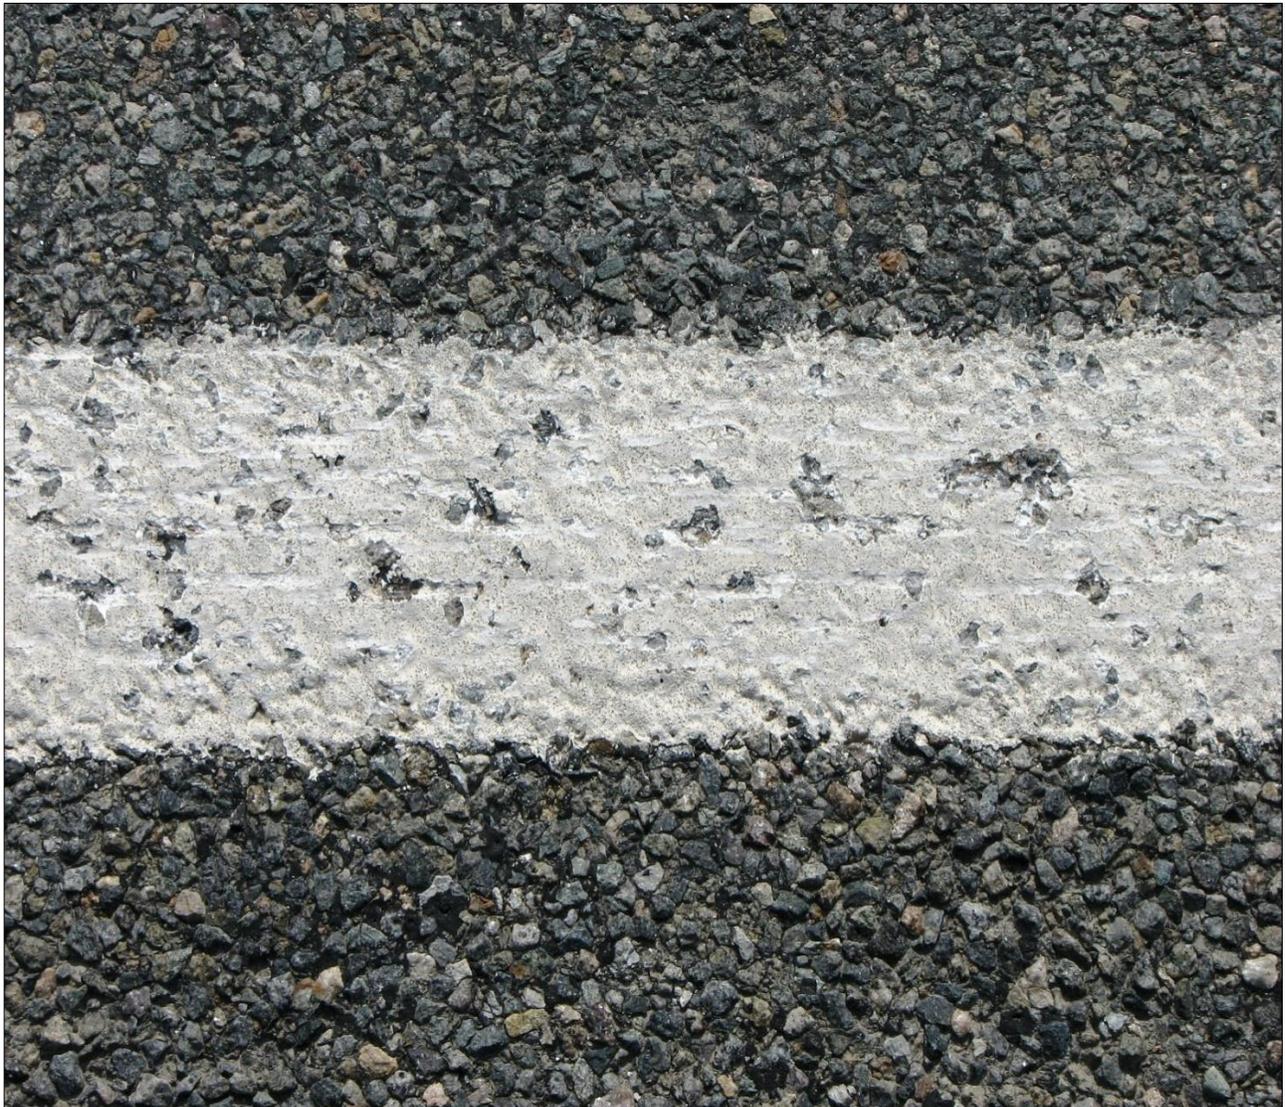
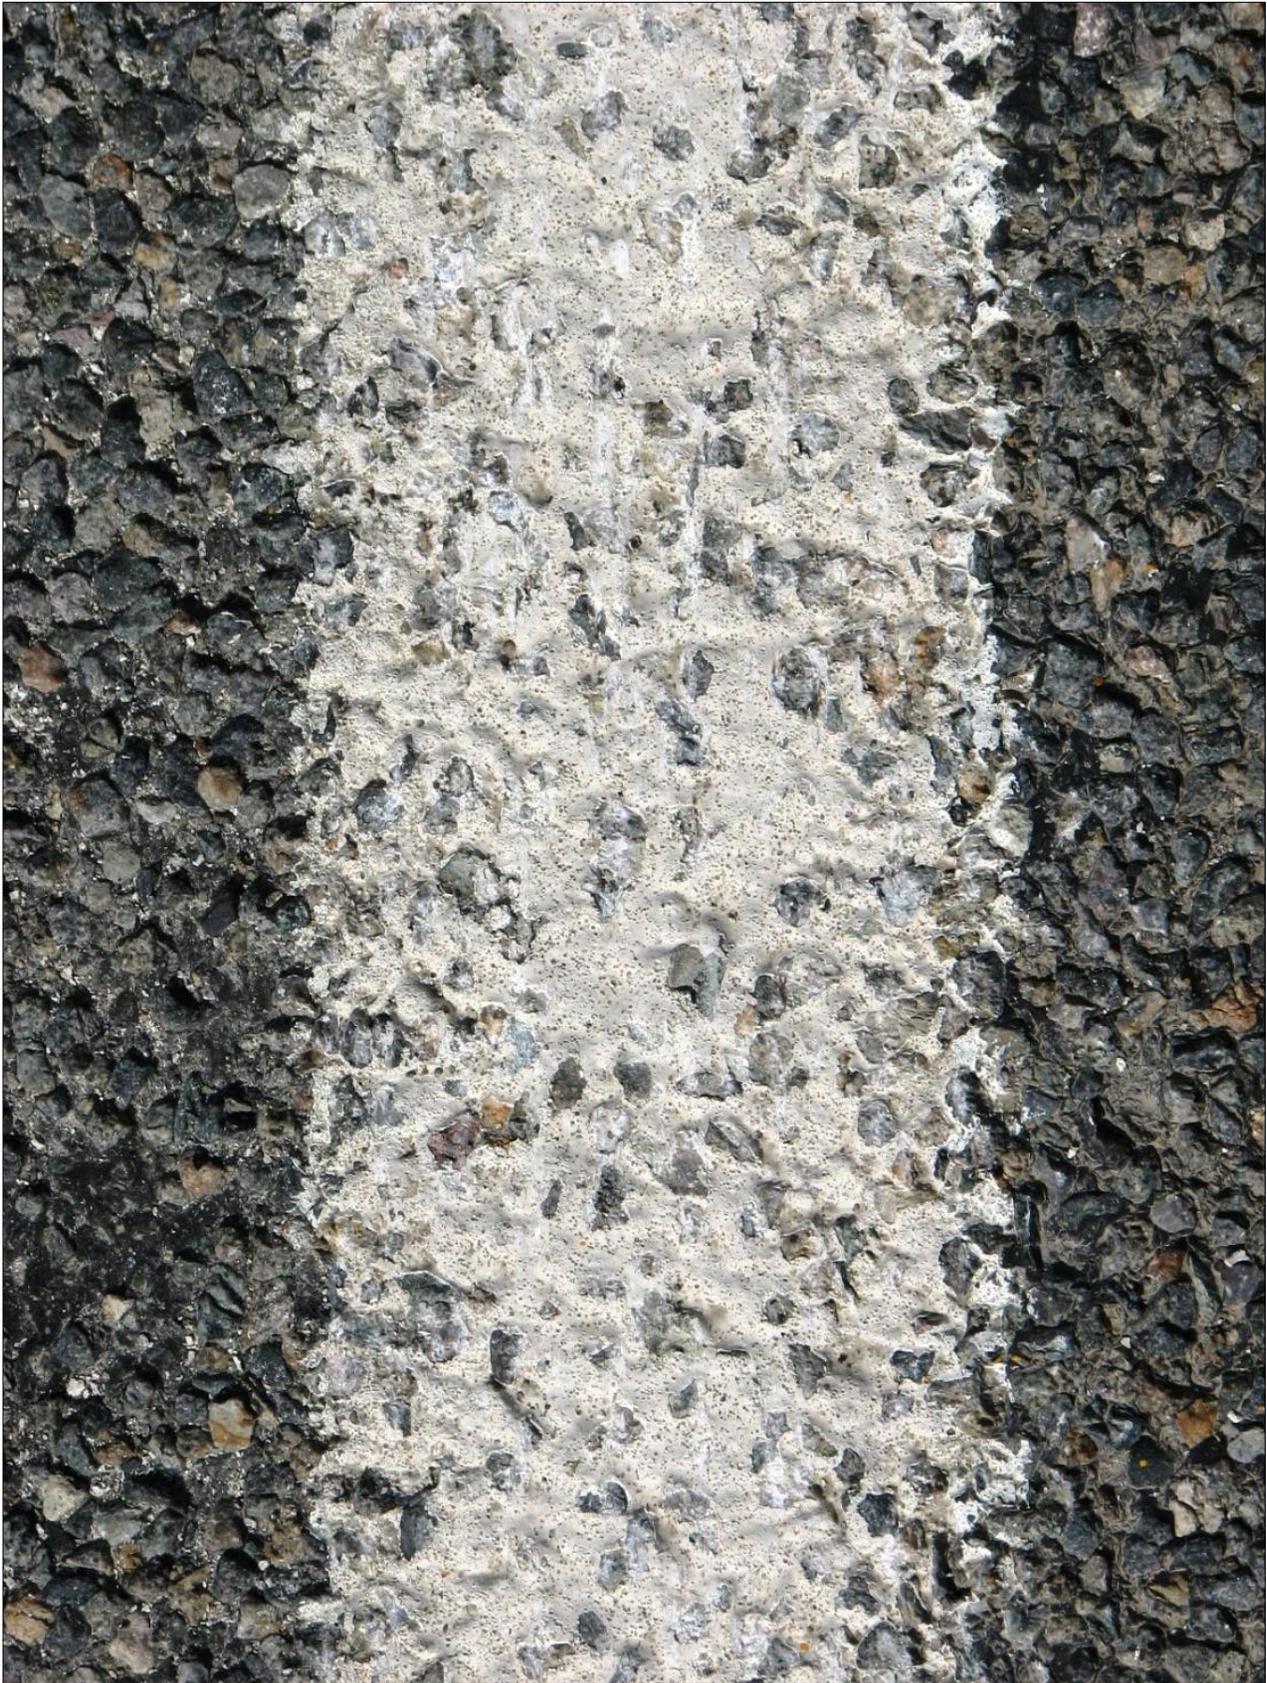
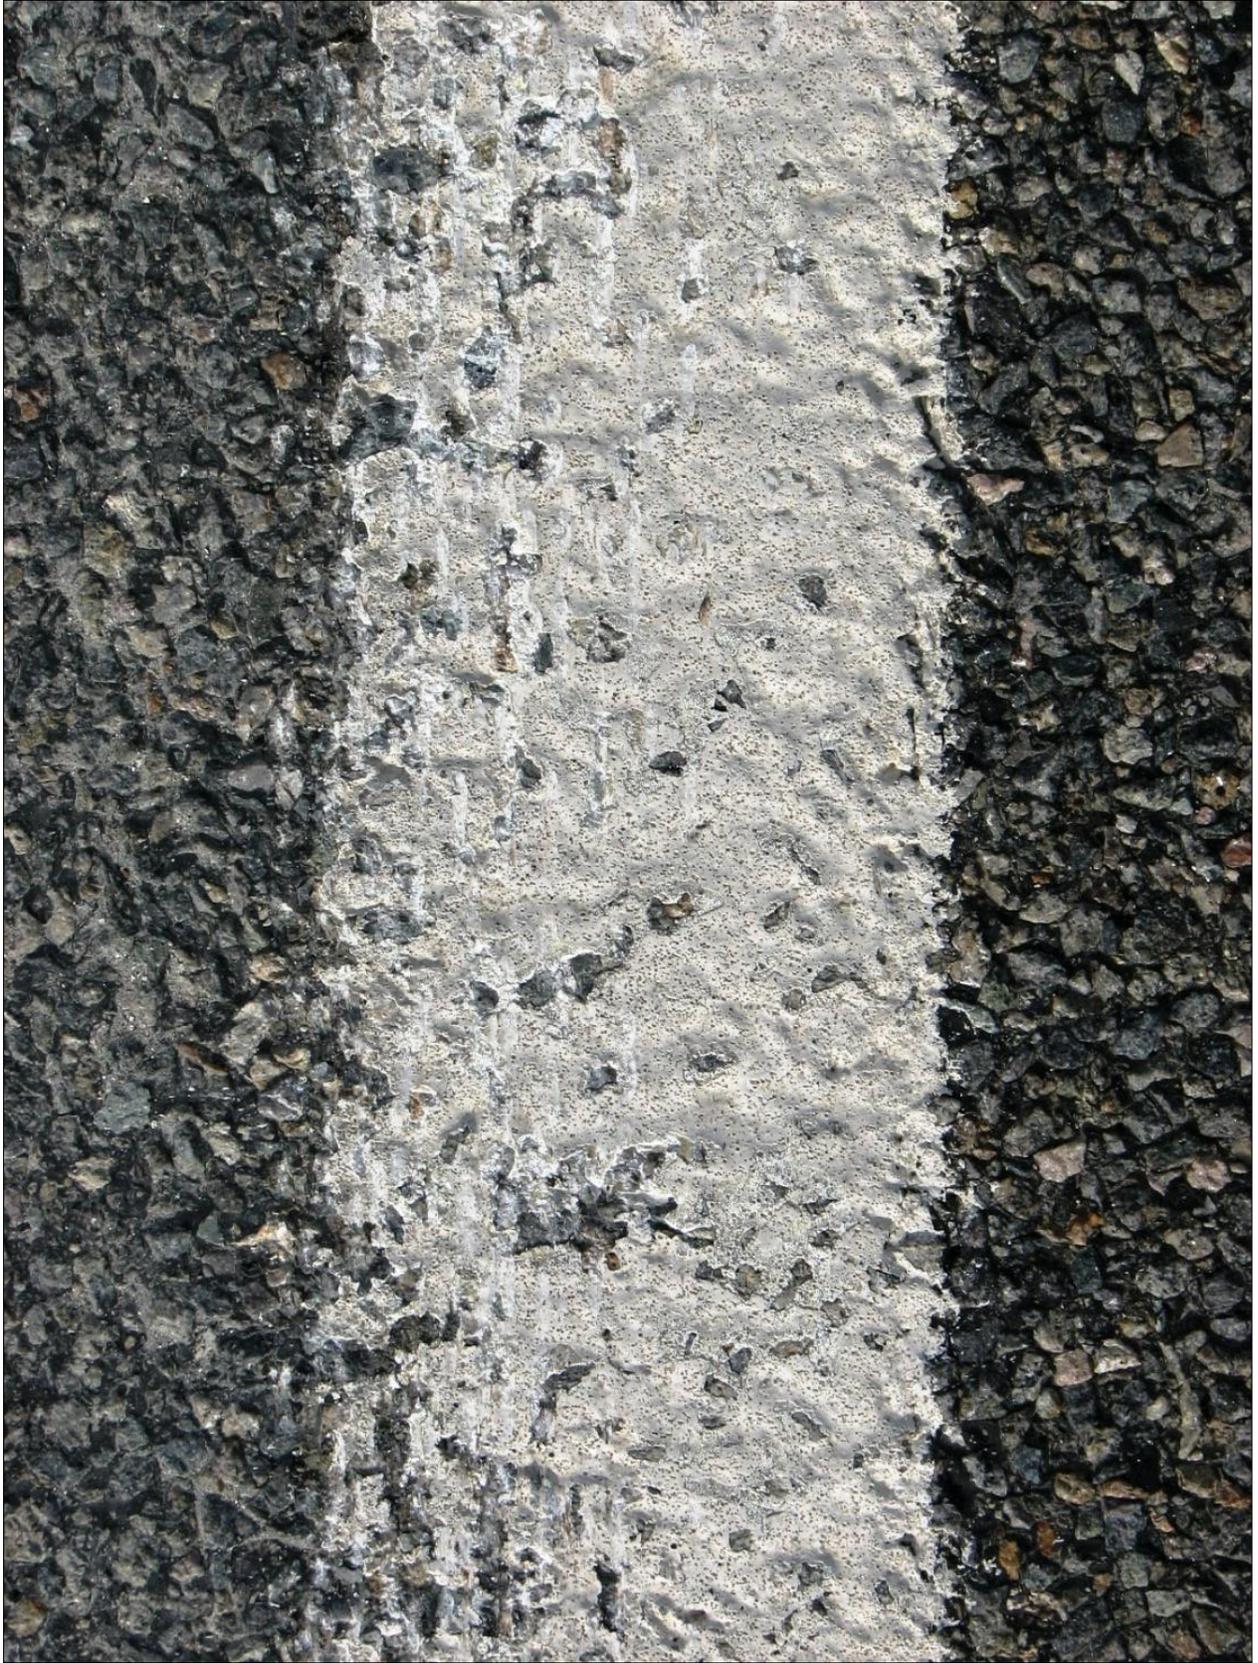
### **LIGHT GRIND: PolyCarb SB Only**

The following are representative images of the grinding phase of the pavement marking application. A light grind was only applied to the Poly-Carb SB test section (MP 143-153). A heavy grind was applied on all other sections of the project.

The effective level of grinding either on light or heavy applications can be dependent on many variables associated with pavement surface and existing marking. The contractor (as in a heavy grind) has to balance the intent of removing as much current material as possible without damaging the underling chip seal. In regards to a light grind the intent is to scuff the surface to provide a cleaner bond.

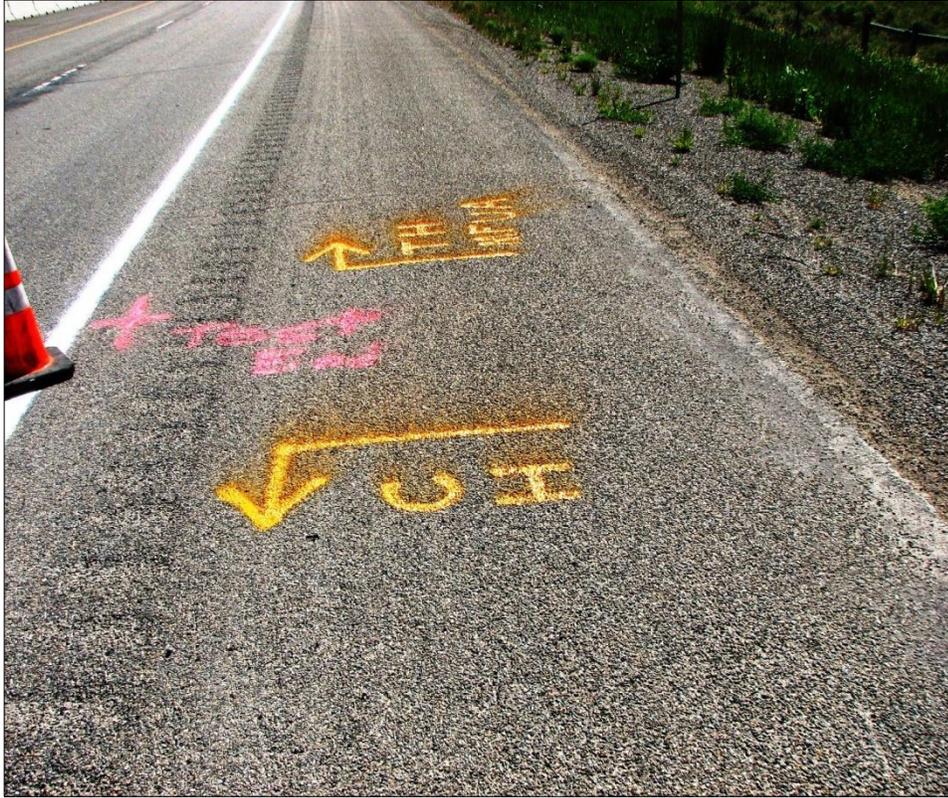
← Image shows how test and control sections are marked in the field.

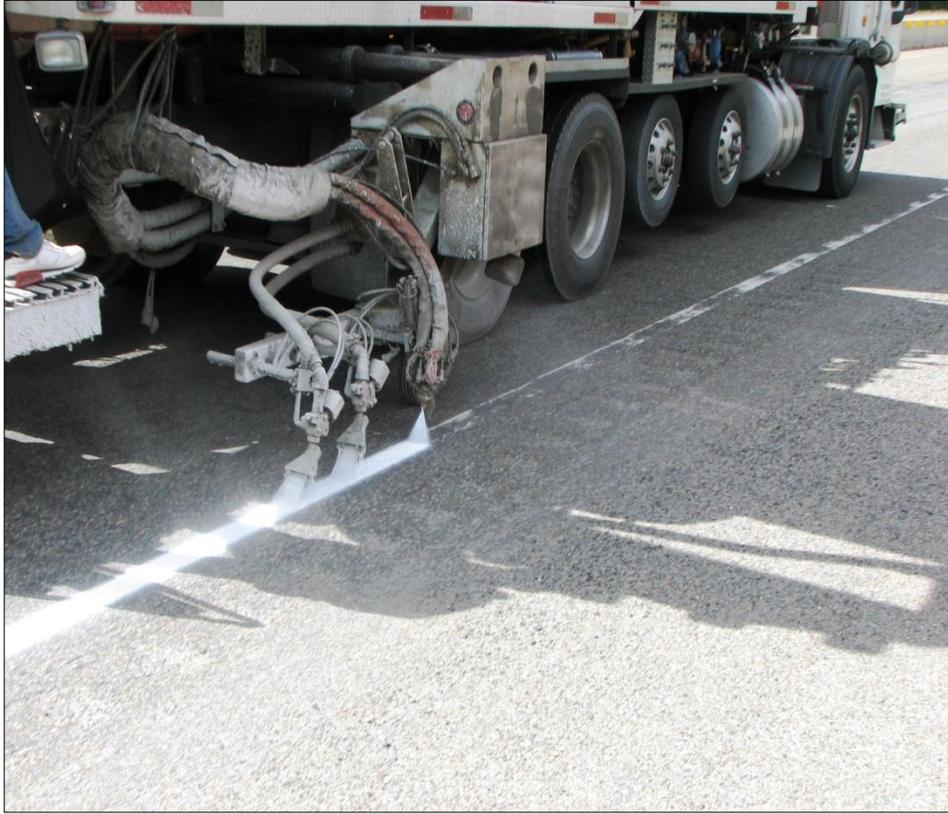
← Sample image of binder and reflective bead application.

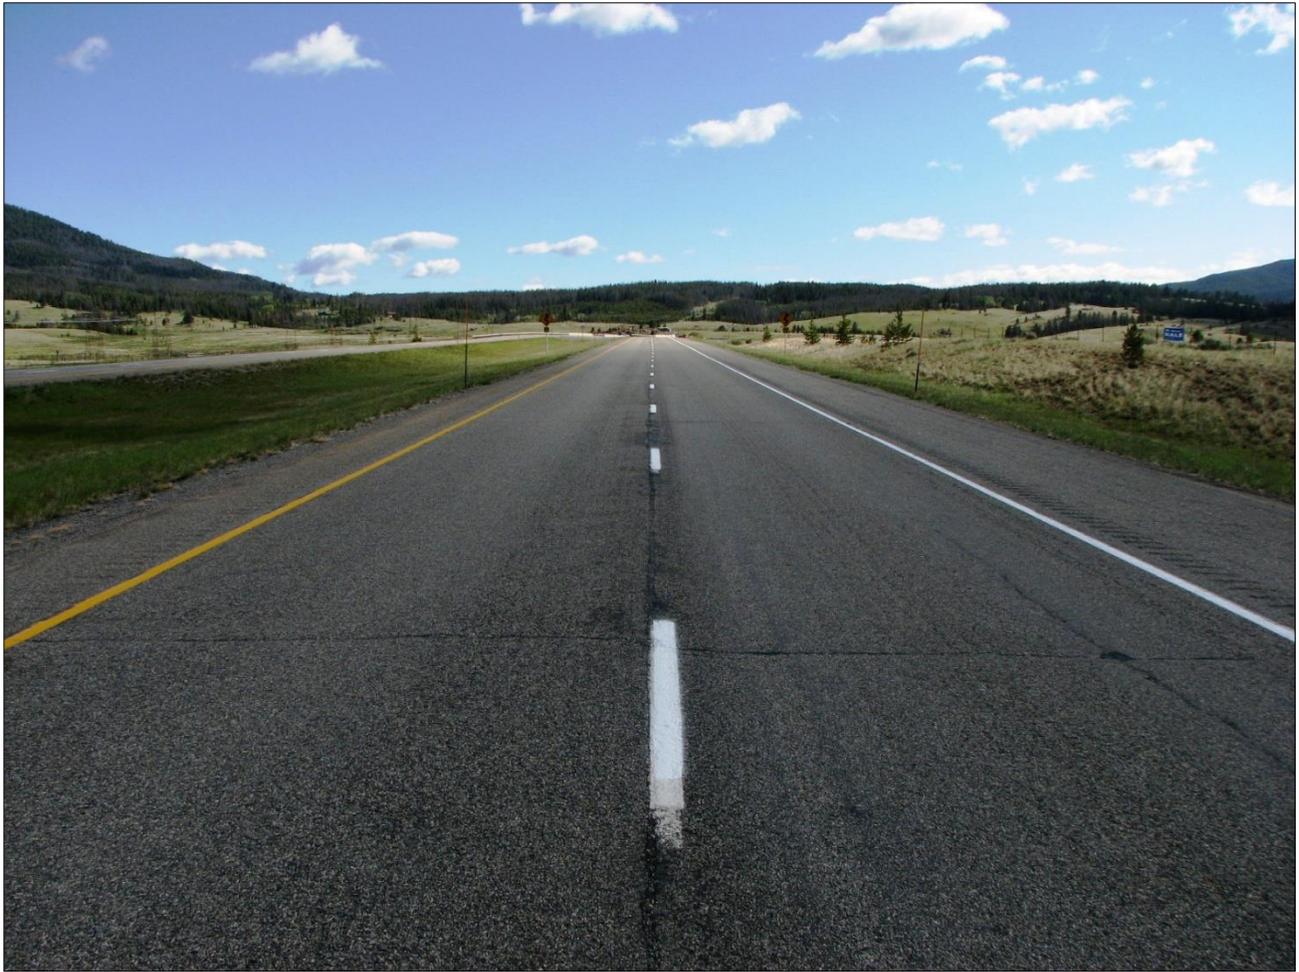
↑ Representative image of completed striping (northbound Poly-Carb control section).

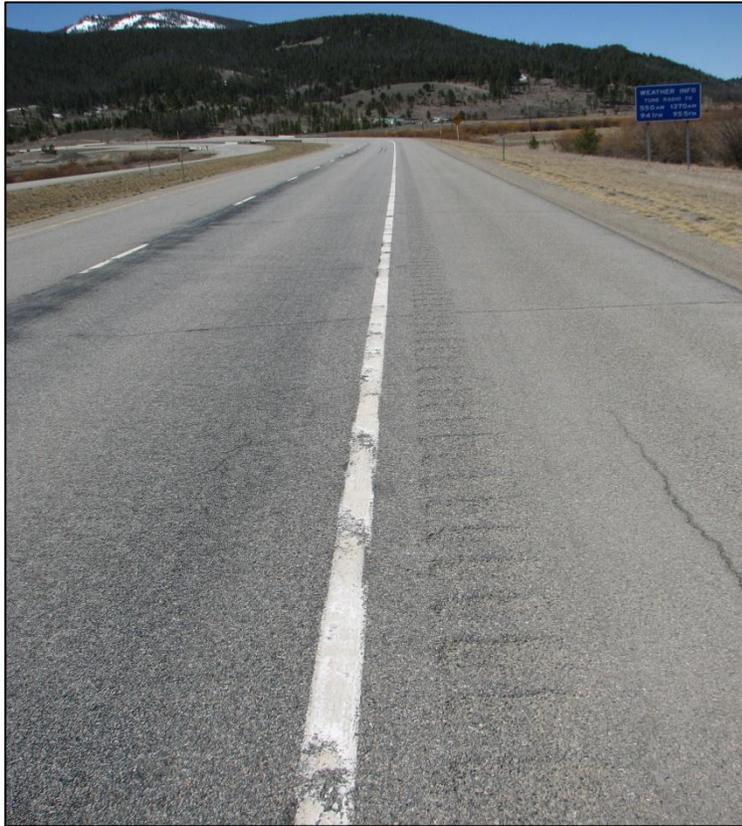
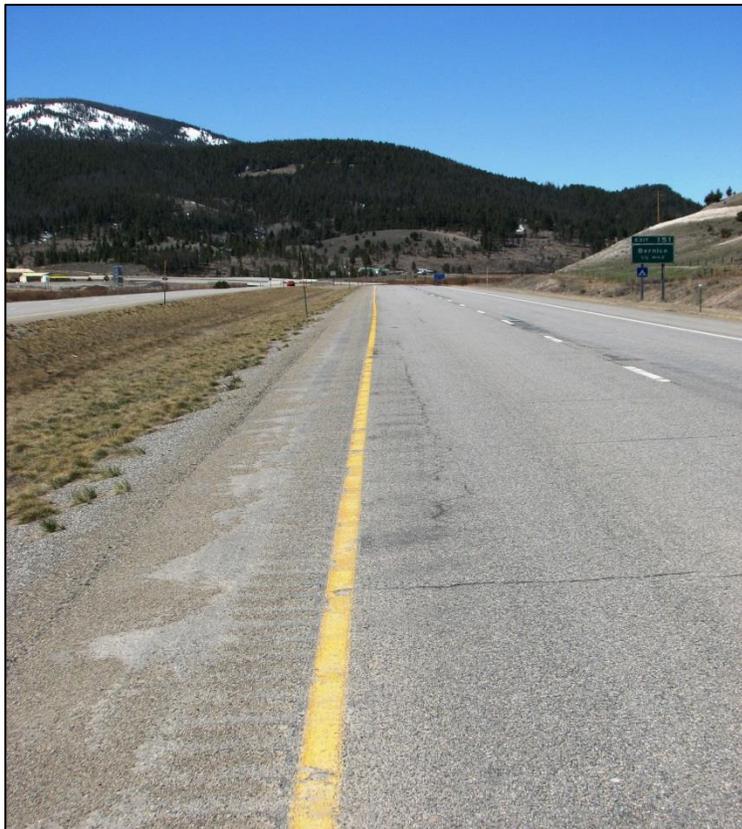
**Site Inspection April 2014 – Poly-Carb Light-Grind MP 143-153 Southbound**

↙↘ Representative images of the white and yellow striping on the project asphalt surface.

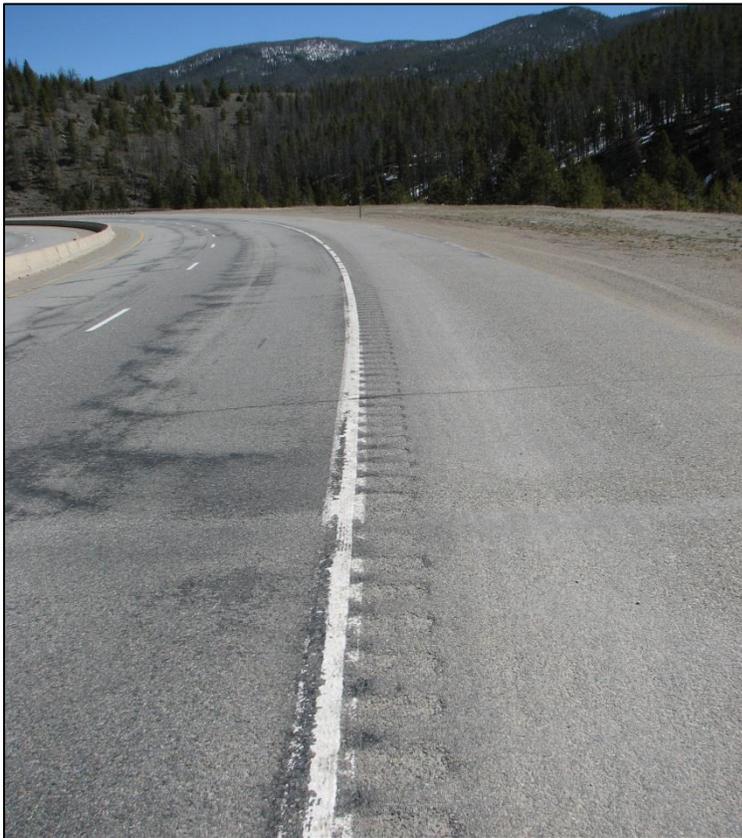
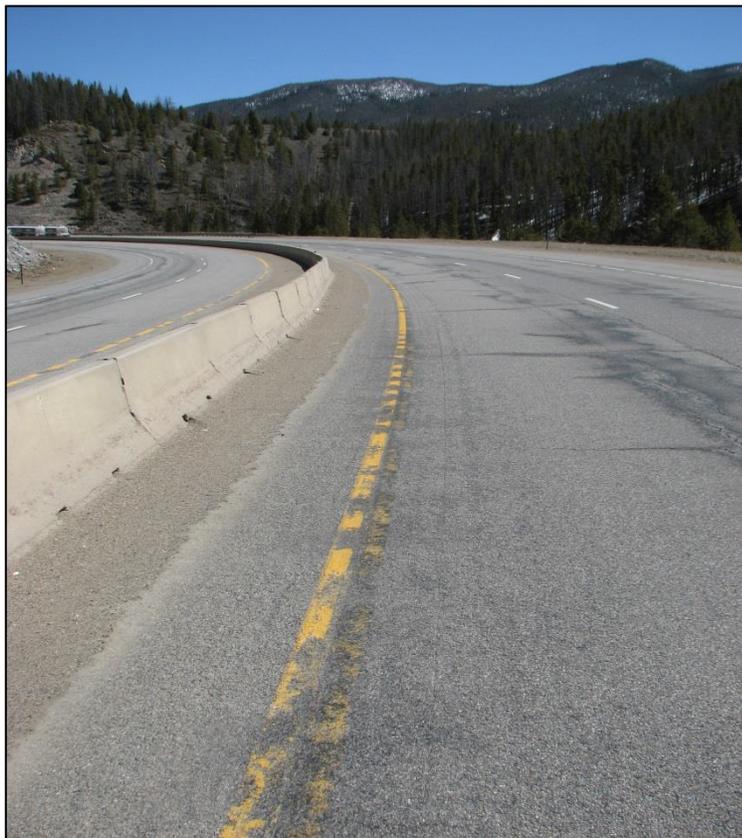
**Site Inspection April 2014 – Poly-Carb Heavy-Grind MP 143-153 Northbound**

↙↓ Representative images of the white and yellow striping on the project asphalt surface.

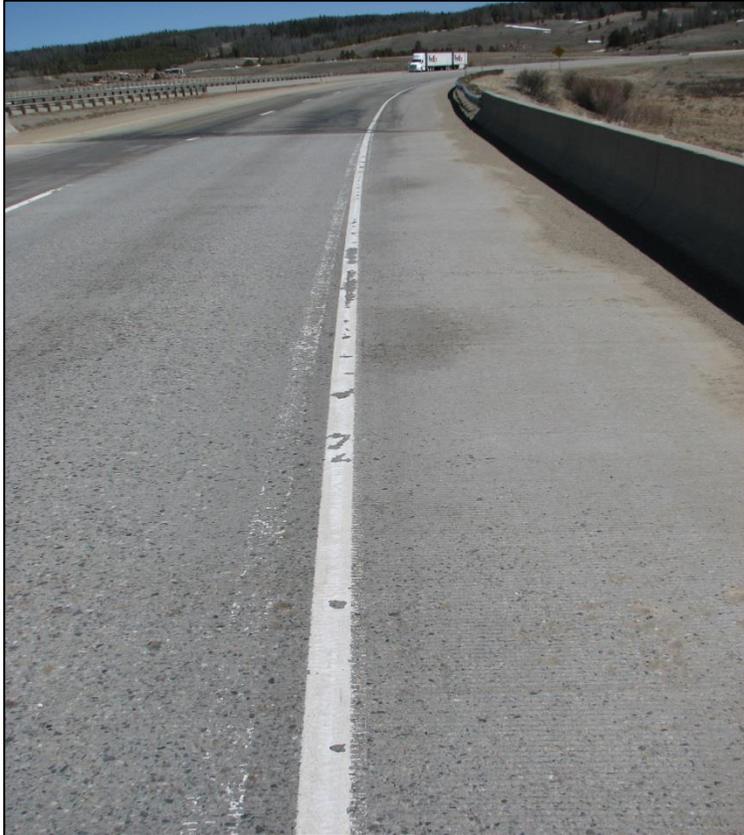
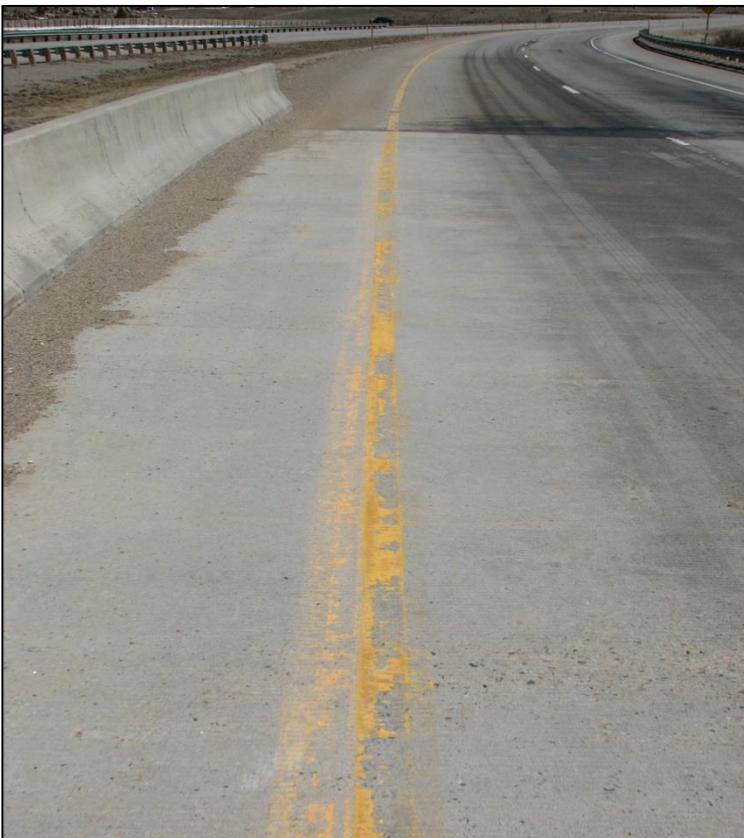
↩️⬇️ Representative images of the white and yellow striping on the project concrete deck surface.

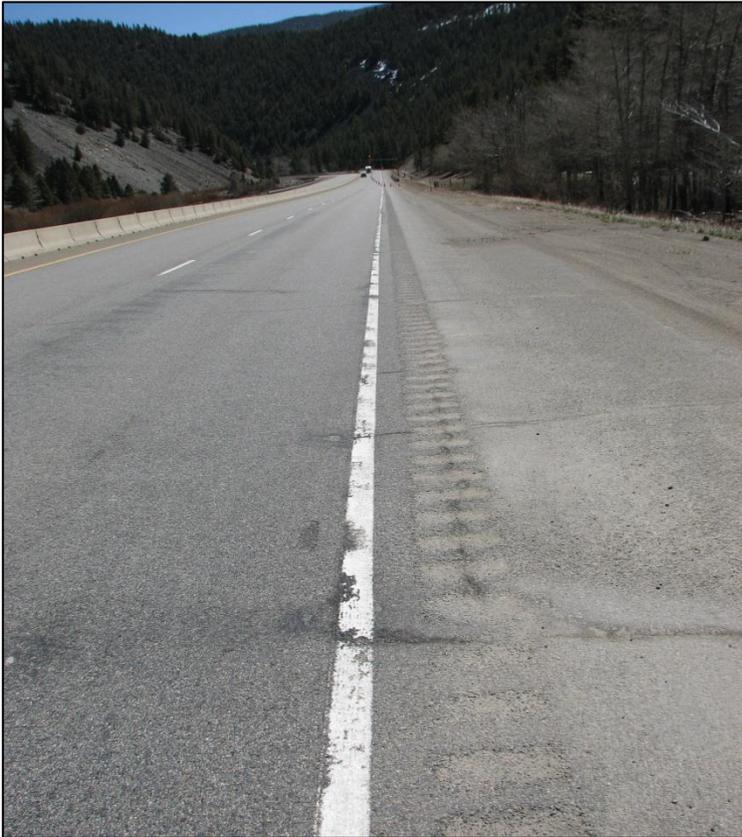
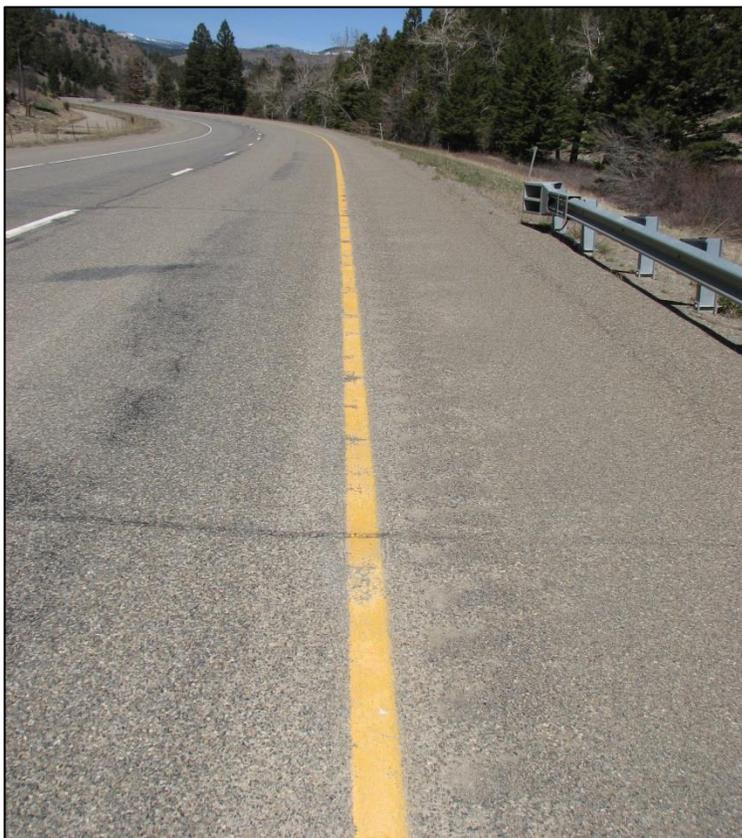
**Site Inspection April 2014 – Swarco MFUA-10 Heavy-Grind MP 153-163 Northbound**

↙↘ Representative images of the white and yellow striping on the project asphalt surface.

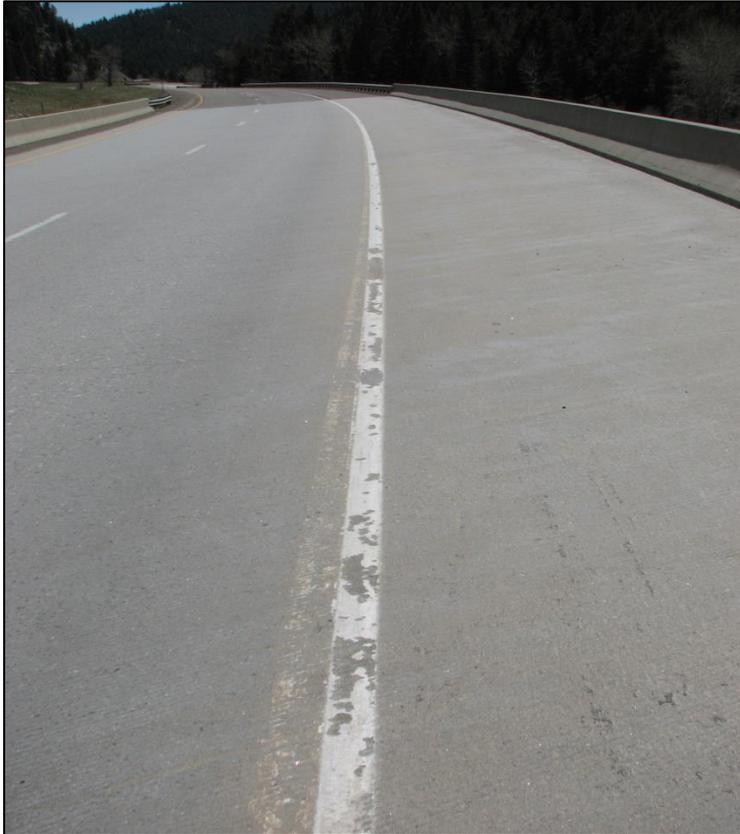
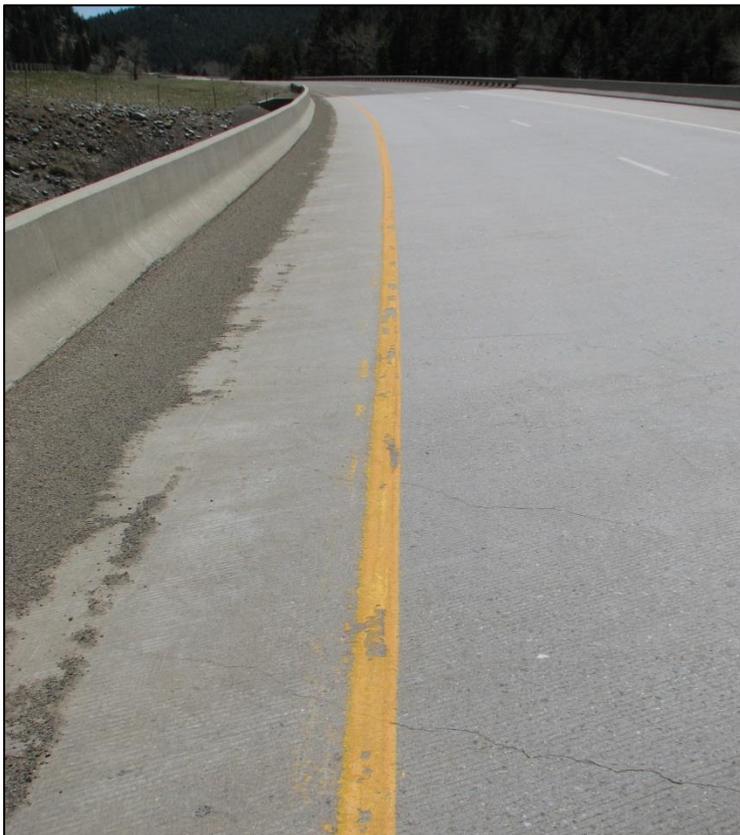
↩️ Representative images of the white and yellow striping on the project concrete deck surface.

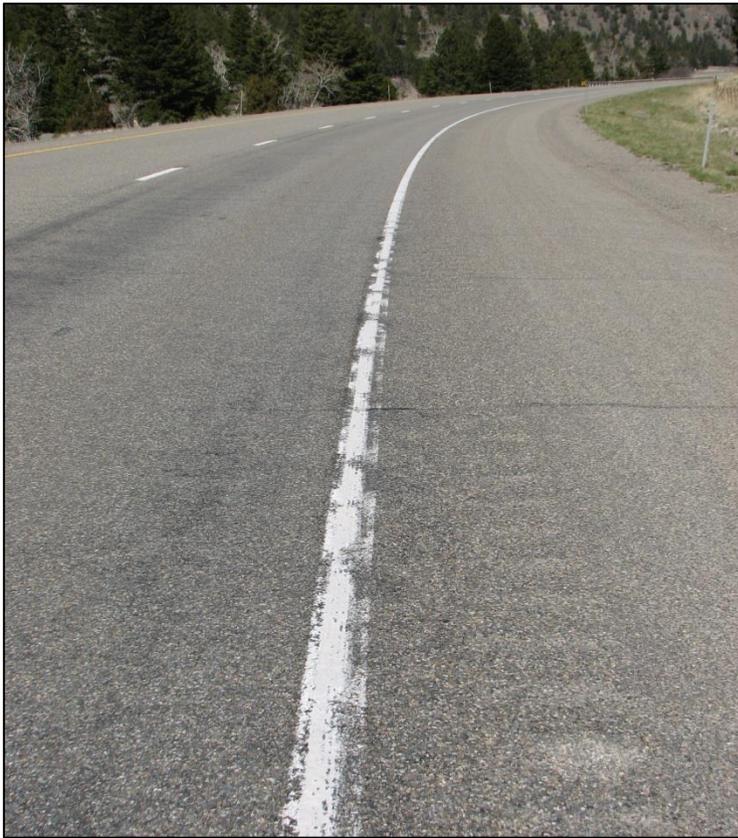
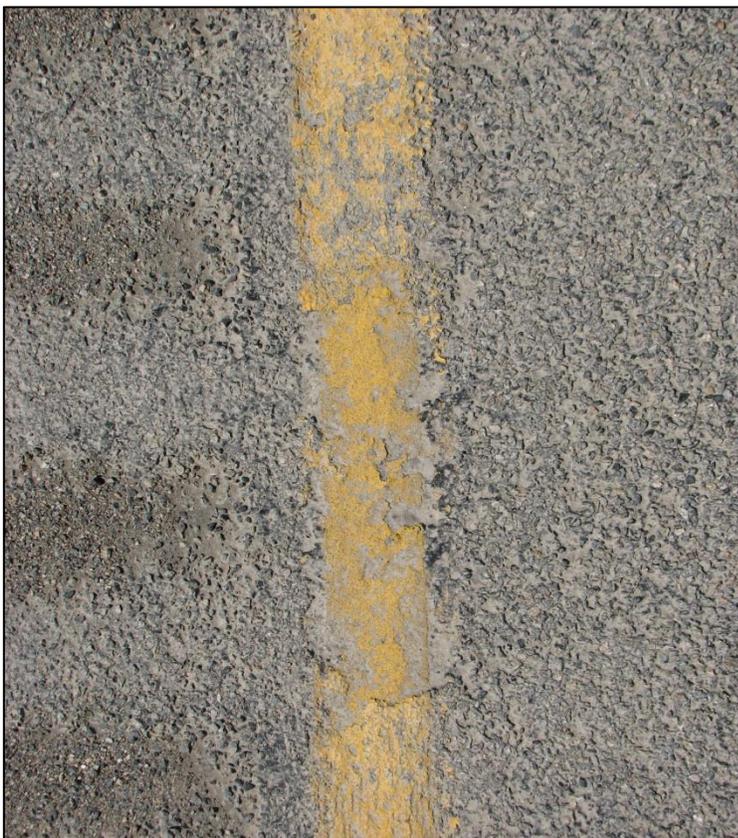
**Site Inspection April 2014 – Ennis HPS- 4 Heavy-Grind MP 153-163 Southbound**

↙ ↓ Representative images of the white and yellow striping on the project asphalt surface.

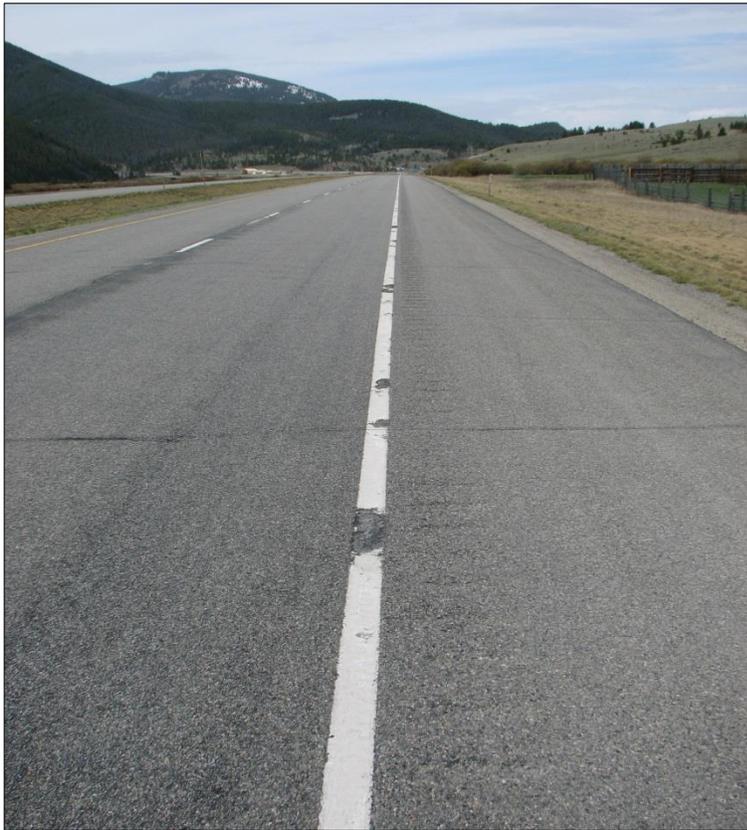
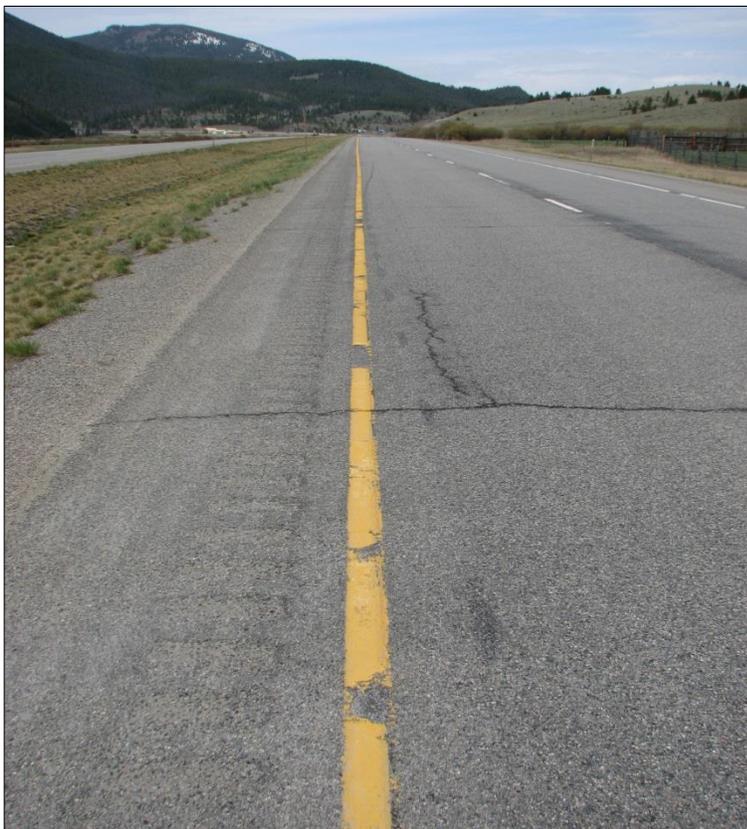
**Site Inspection: May 2015 – Poly-Carb Light-Grind MP 143-153 Southbound**

↙ Representative images of the white and yellow striping on the project asphalt surface (view south).

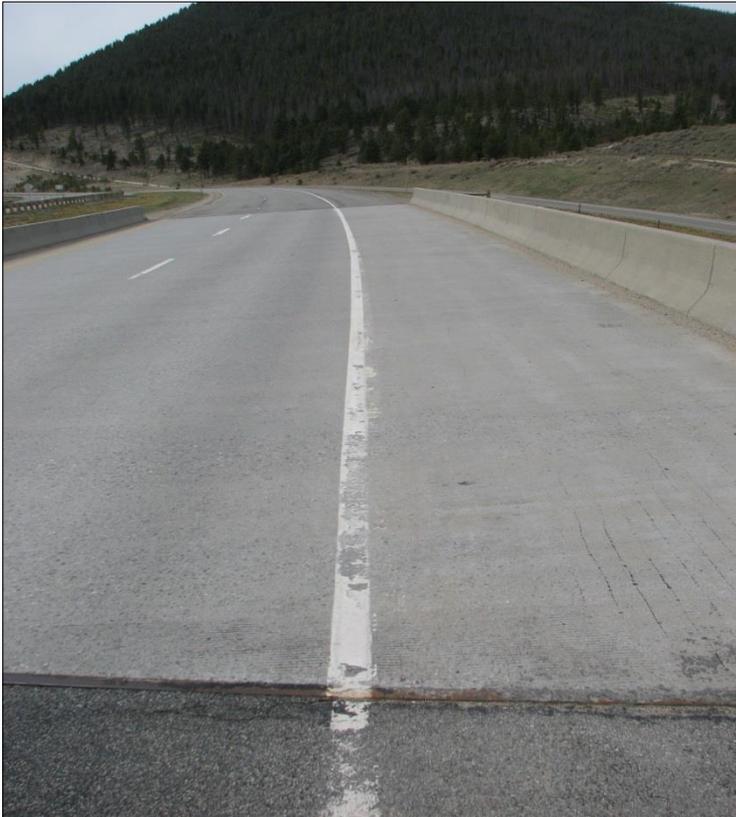
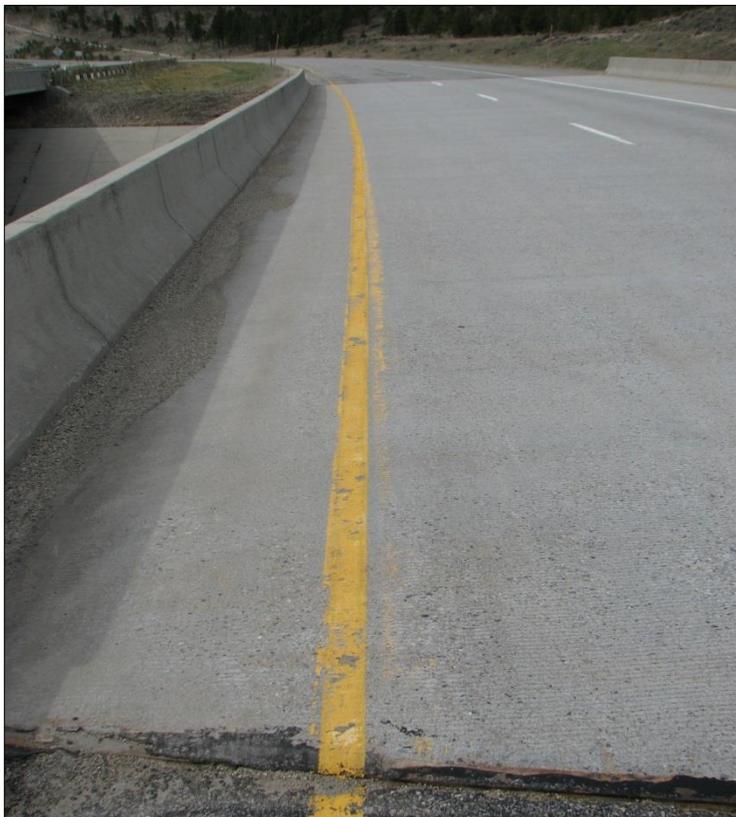
**Site Inspection: May 2015 – Poly-Carb Light-Grind MP 143-153 Southbound/PCCP**

↙↓ Representative images of the white and yellow striping on the project bridge deck surface (view south).

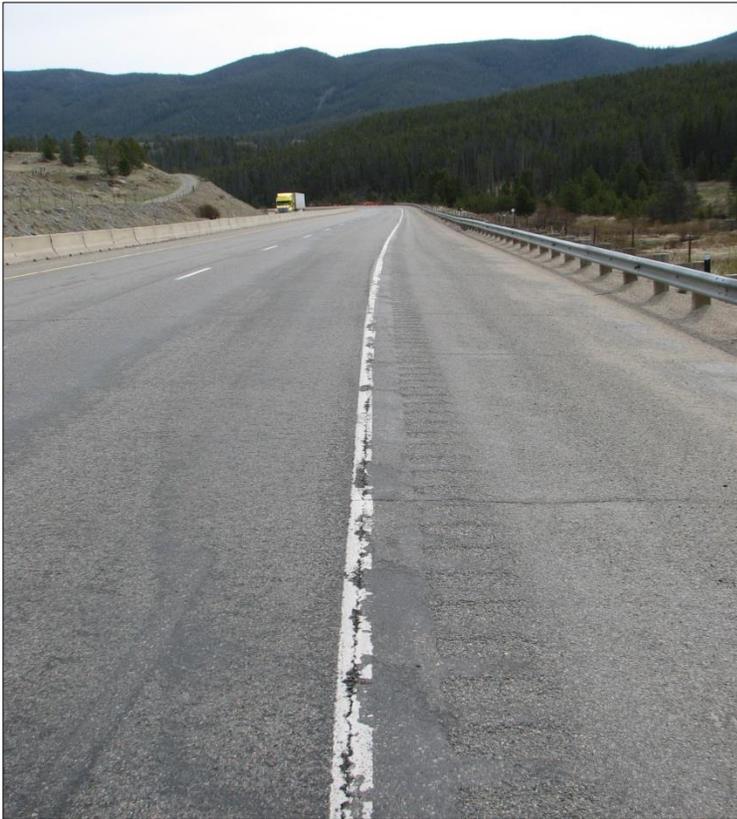
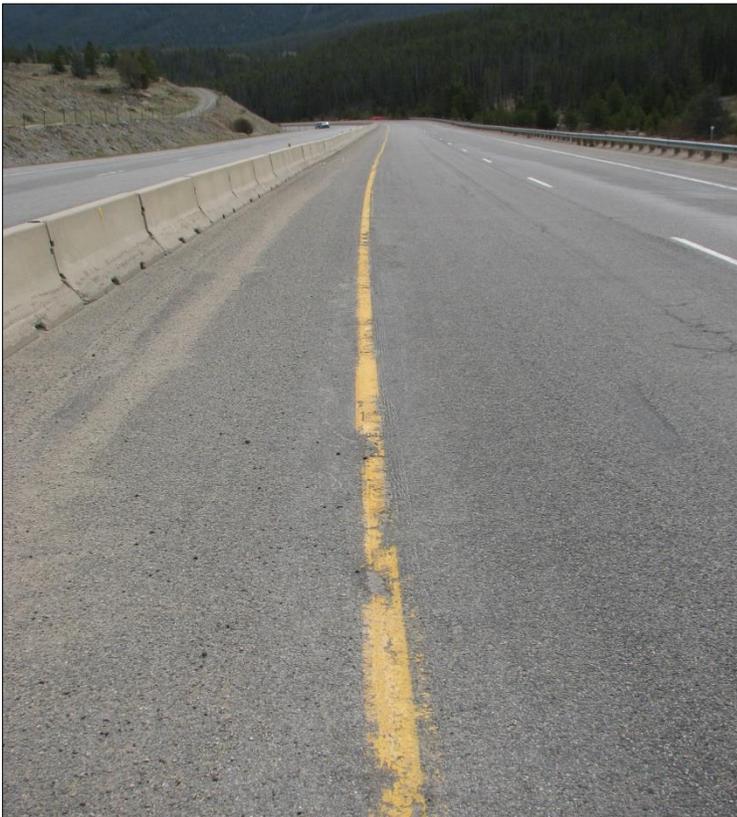
**Site Inspection May 2015 – Poly-Carb Heavy-Grind MP 143-153 Northbound**

↙ ↓ Representative images of the white and yellow striping on the project asphalt surface (view north).

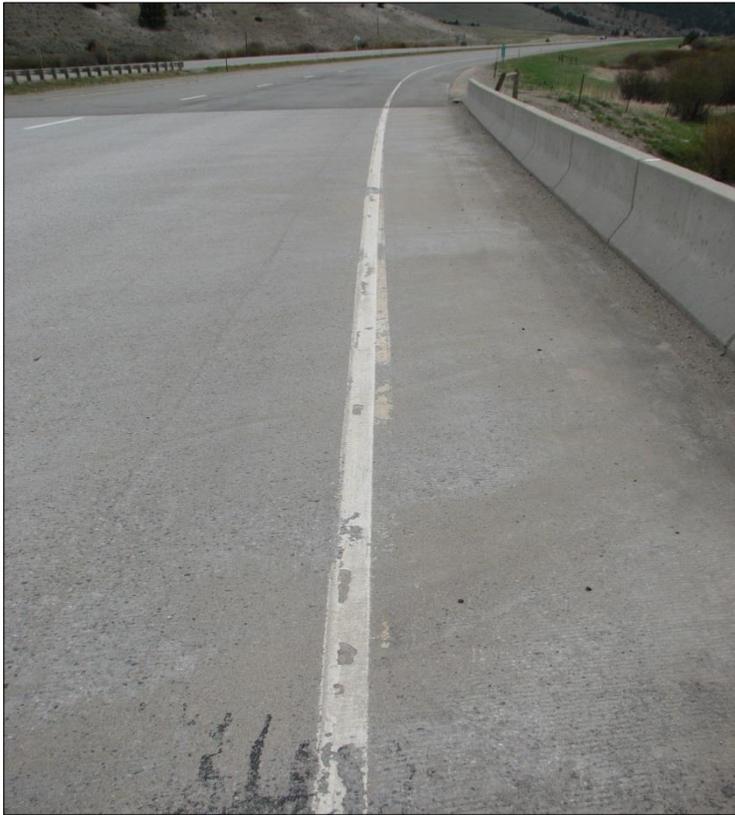
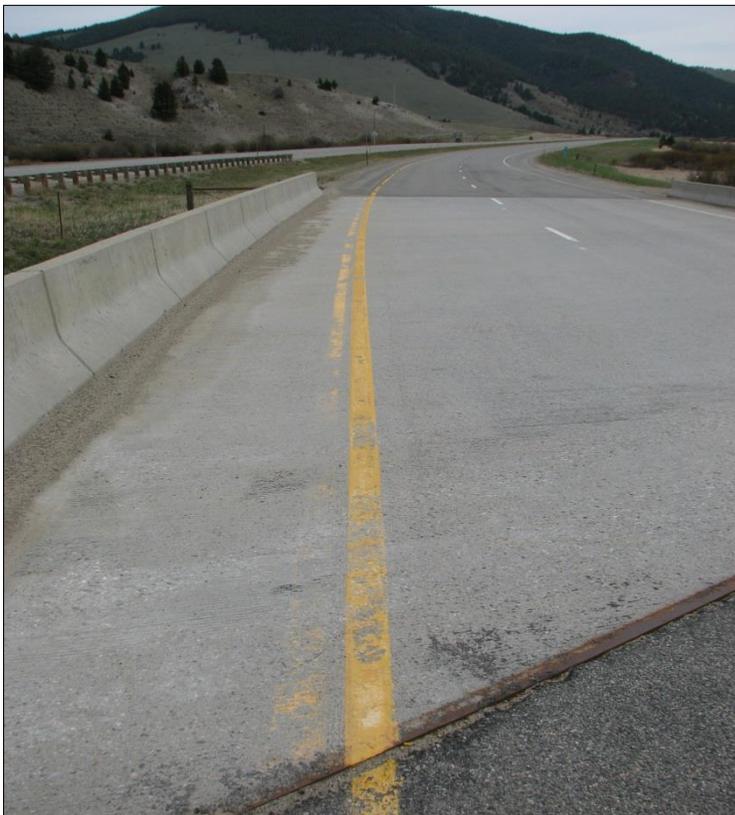
**Site Inspection May 2015 – Poly-Carb Heavy-Grind MP 143-153 Northbound/PCCP**

↙ ↓ Representative images of the white and yellow striping on the project bridge deck surface (view north).

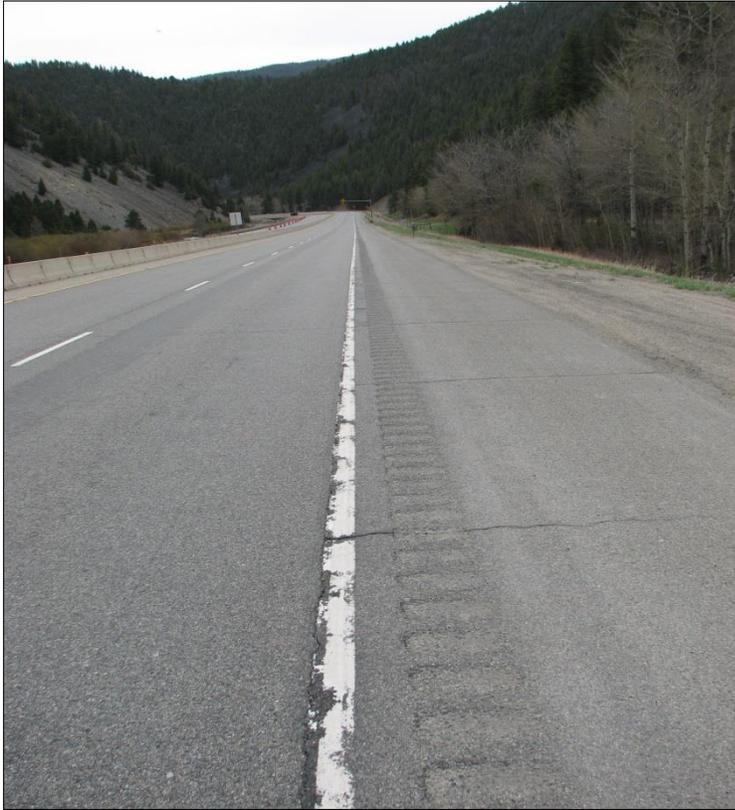
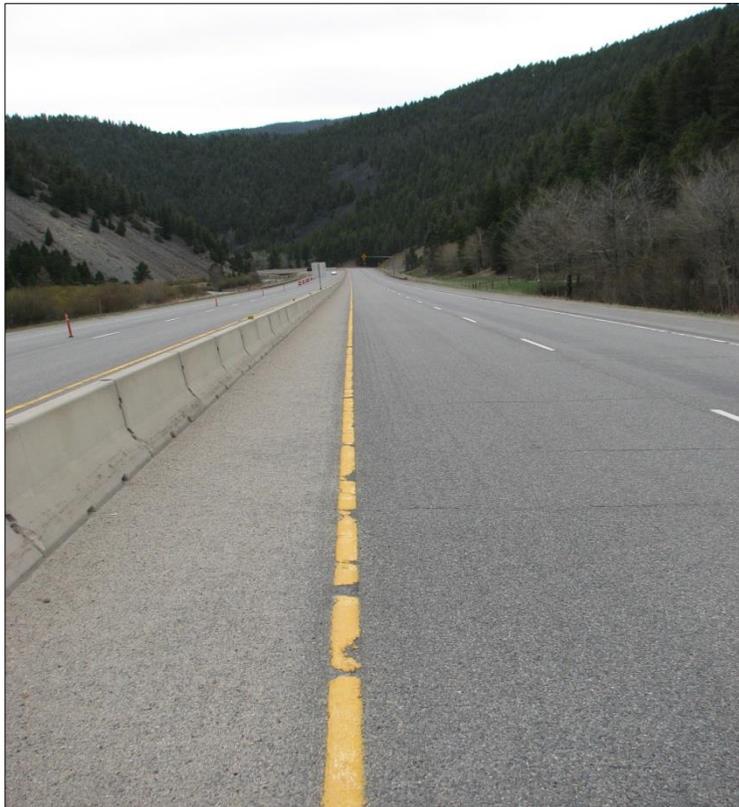
**Site Inspection May 2015 – Swarco MFUA-10 Heavy-Grind MP 153-163 Northbound**

↙ Representative images of the white and yellow striping on the project asphalt surface (view north).
