**EXPERIMENTAL PROJECTS FINAL REPORT**  
**URETHANE EPOXY PAVEMENT MARKINGS**

**Project Name:** Elk Park

**Project Number:** HWY-310386-RP

**Experimental Project No.** MT-12-02

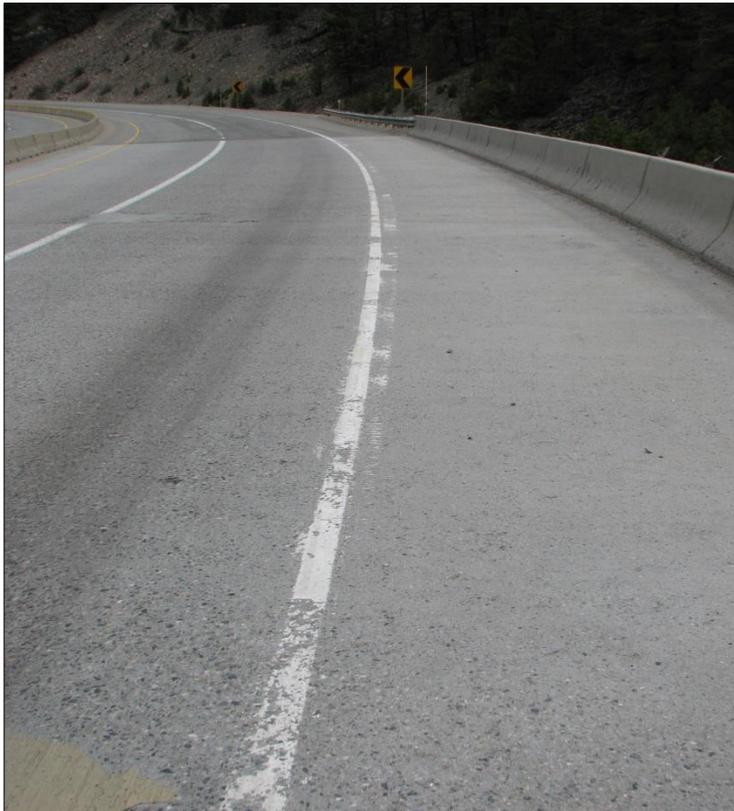
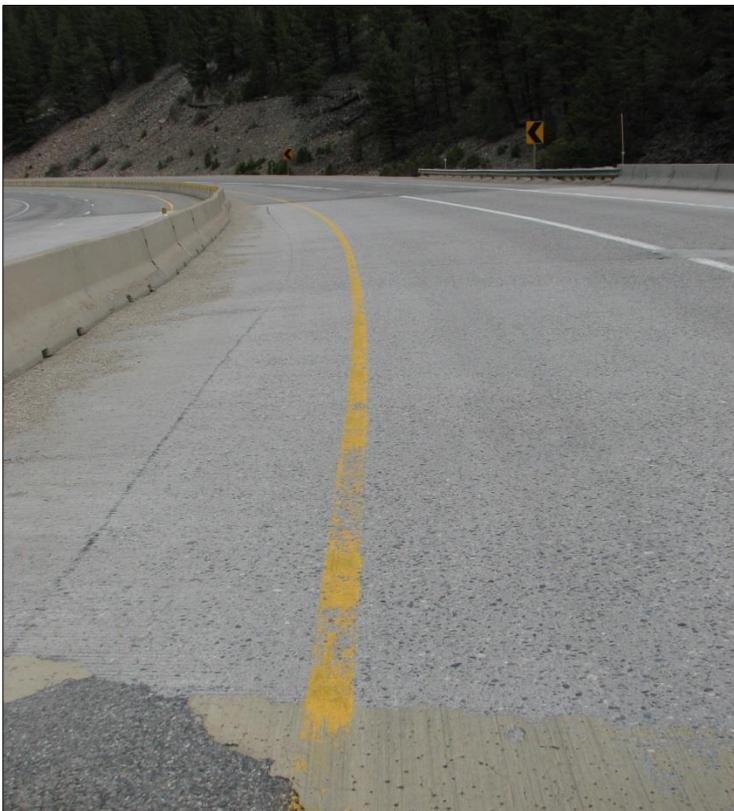
**Site Inspection May 2015 – Swarco MFUA-10 Heavy-Grind MP 153-163 Northbound**

↙ Representative images of the white and yellow striping on the project (PCCP) bridge deck surface (view north).

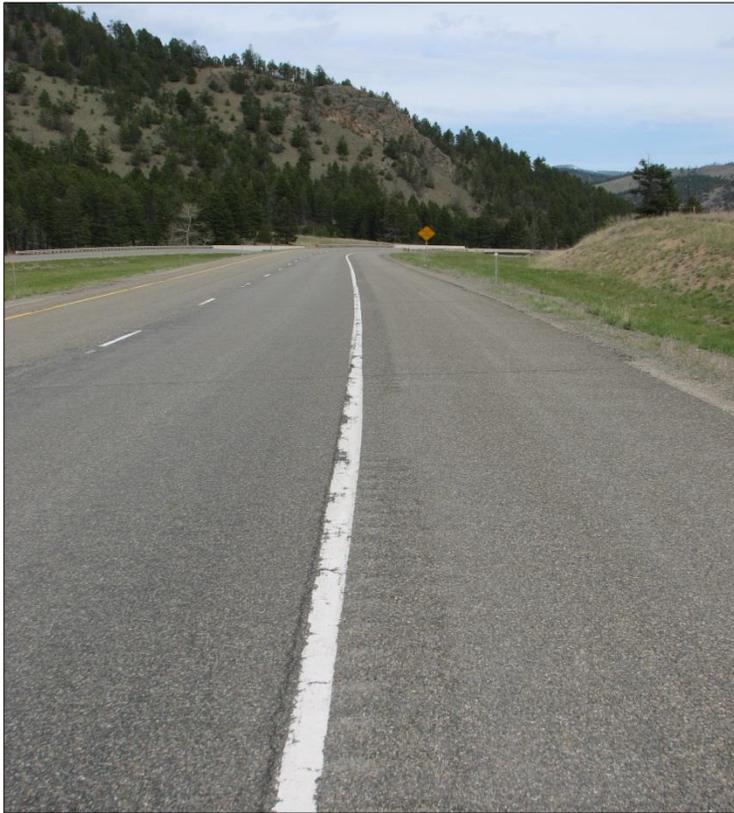
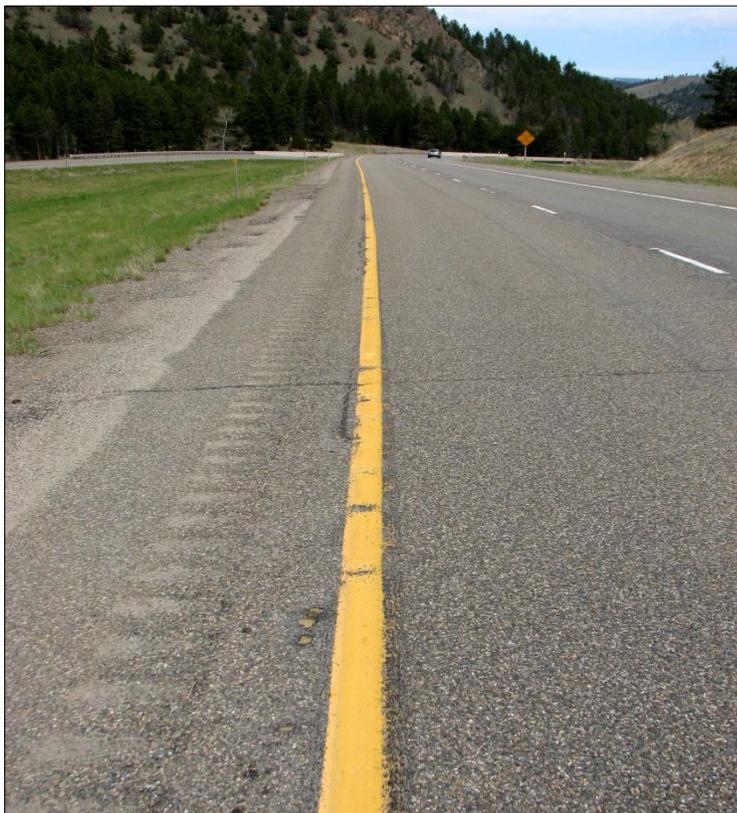
**Site Inspection May 2015 – Ennis HPS-4 Heavy-Grind MP 153-163 Southbound**

↙↓ Representative images of the white and yellow striping on the project asphalt surface (view south).

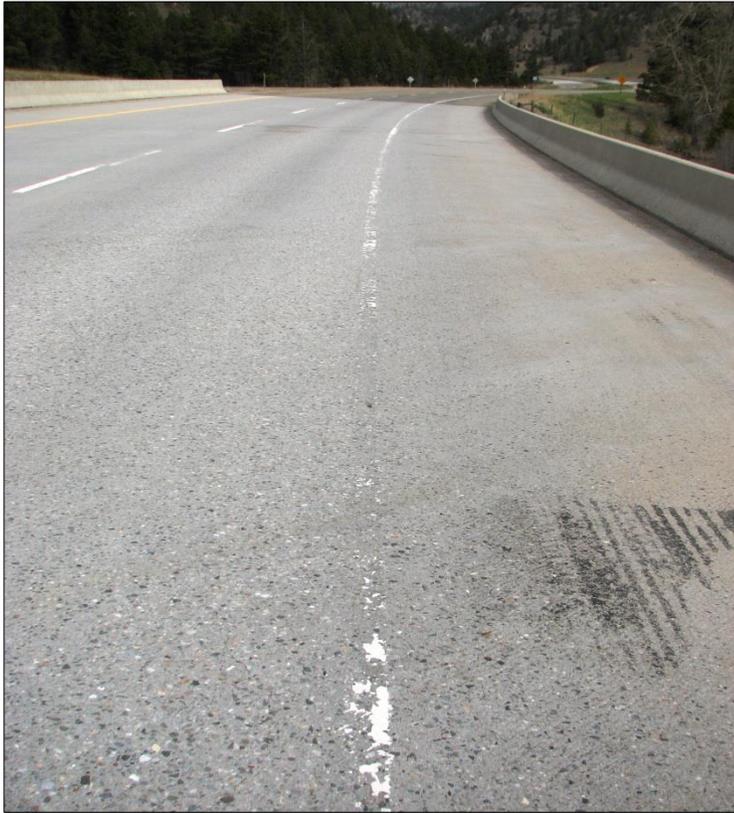
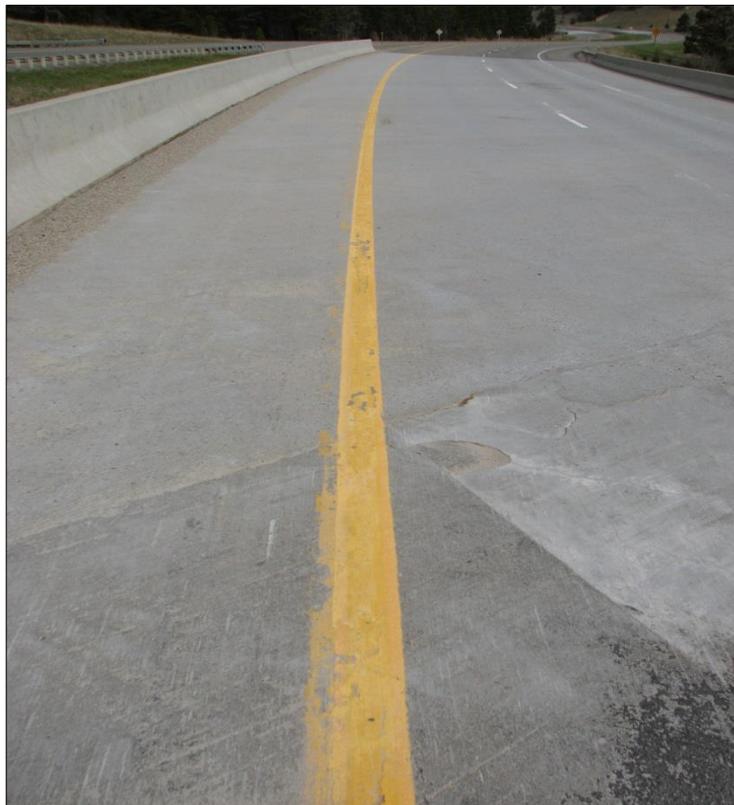
**Site Inspection May 2015 – Ennis HPS-4 Heavy-Grind MP 153-163 Southbound/PCCP**

↙↘ Representative images of the white and yellow striping on the project bridge deck surface (view south).
