**EXPERIMENTAL FEATURES PROJECT  
CONSTRUCTION REPORT**

**EVALUATION OF WARM MIX ASPHALT (WMA) PAVEMENT**

<u>Project Name</u>	<u>Project Number</u>	<u>Project Location</u>	<u>Project Length</u>
Monida-Lima (SB)	IM 15-1(109)0	Interstate 15, Beaverhead County, Butte District- approximate RP 0.0 to RP 17.1	17.1 miles

**FHWA Project Number:** MT 10-02

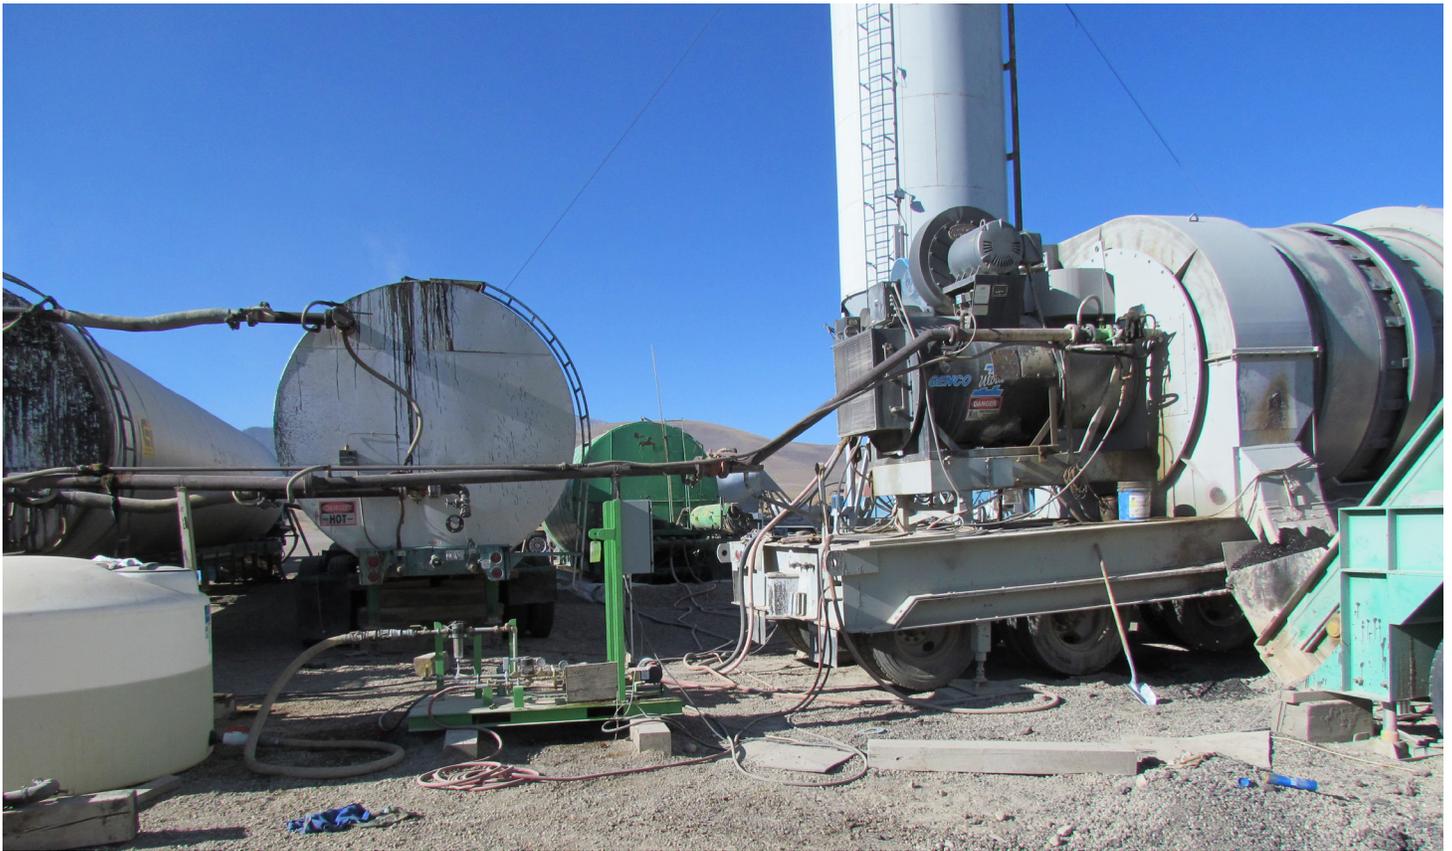
Figure 9- Foaming mix system at hot plant facility

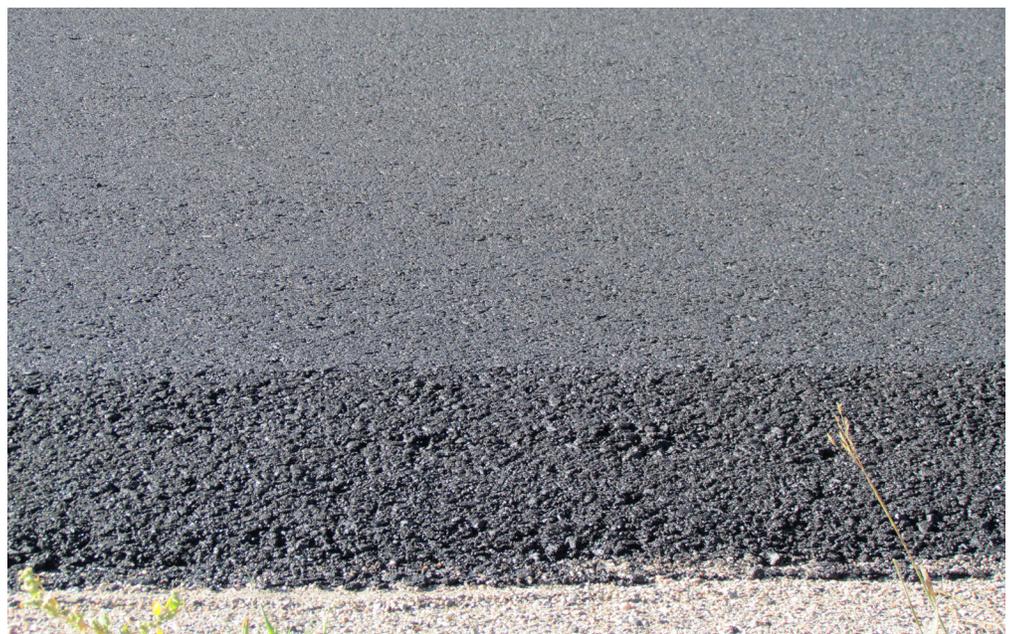
MDT Research visited the construction and hot plant sites on September 29, 2011 for this WMA technology. The plant temperatures started hot at 300°F as with the previous WMA technologies. The plant operator planned to lower temperatures to 270° F. The average discharge temperature for this technology was 285° F. According to the contractor, the foamed asphalt worked well and was the easiest to work with compared to the other WMA technologies.

Figure 10- Close-up of foam mixed asphalt
